Final Report no. 2161 by the Swiss Accident Investigation Board SAIB

concerning the accident involving the
EA500 aircraft, registration N177EA

on 14 March 2011

Saanen aerodrome (LSGK) / BE

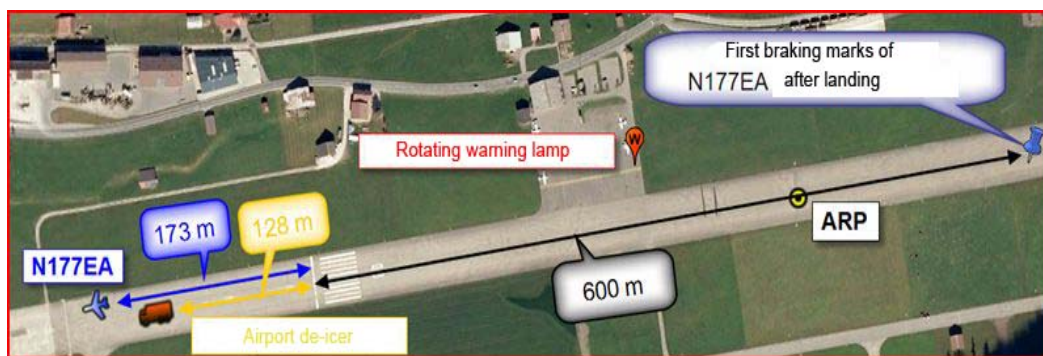
Damage to aircraft	Cracks in the airframe, damage to the left engine
Other damage	Spray arm of the vehicle damaged

Over the remaining 80 meters or so, the pilot attempted to steer the aircraft to the right of the vehicle but was unable to avoid a collision with the airport de-icer. The aircraft's left wing passed under the right spray arm of the vehicle. The front section of the left side of the fuselage and the left engine collided with the spray arm at an estimated rolling speed of approximately 30 to 40 kt. The aircraft came to a standstill at 13:05 LT a little over 130 m before the western end of the runway, at the northern edge of the runway.

Figure 1: Final position of the Eclipse EA500 (N177EA) on runway 26 in Saanen (LSGK); also cf. Annex 1: AD-INFO of Saanen aerodrome

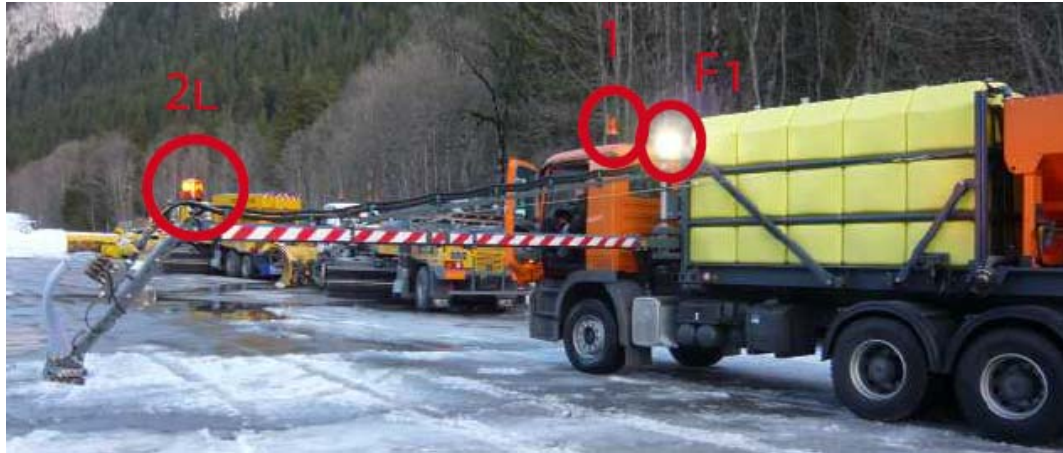
Figure 2: Airport de-icer with warning lamps 2L and F1 (photo does not date from the day of the accident).

When the lateral spray arms of the vehicle are extended, the warning lamps 2L and F1 mounted on the arms are activated automatically (cf. Figure 2). Warning lamp 1, mounted on the vehicle's cab, must be put into operation manually. At the time of the accident all the warning lamps were operational, but warning lamp 1 was not in use.

For the runway occupancy agreement a warning lamp was used which, at least from the end of the runway, was not clearly distinguishable and merely constituted one-way communication. This type of device therefore did not represent an adequate warning device.

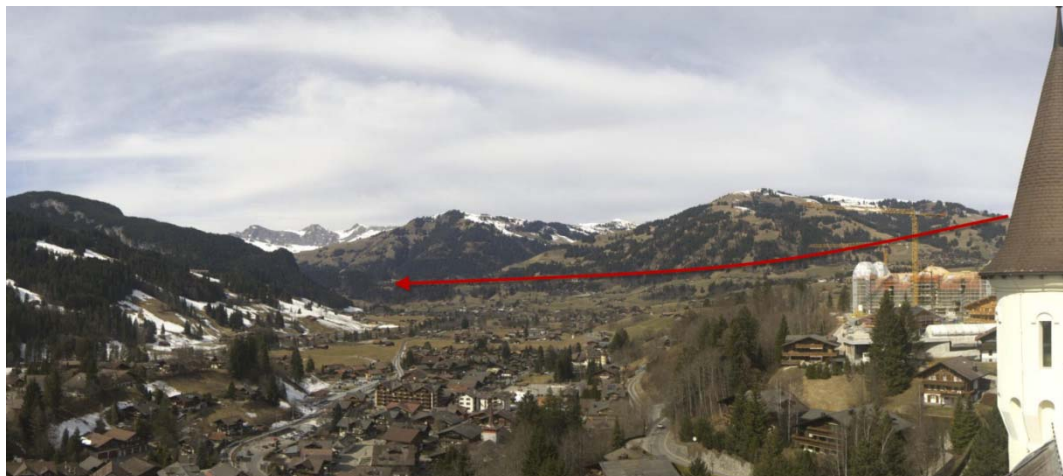
The picture below was recorded at 13:00 LT, thus shortly before the time of the accident, from the Gstaad Palace Hotel looking in a northerly direction. It provides an impression of the prevailing weather conditions when N177EA was on final approach to runway 26 in Saanen. This state of affairs is indicated here by the red arrow in Figure 3, from right to left.

Figure 3: Image from the camera at the Gstaad Palace Hotel in the direction of the final approach on runway 26 in Saanen.
