Final Report no. 2165 of the Swiss Accident Investigation Board SAIB

concerning the serious incident - Airprox
involving the Airbus A319 aircraft, registration D-AKNK,
operated by Germanwings GmbH
under flight number GWI 2529
and the Raytheon 390 Premier 1 aircraft, registration
D-IAGG,
operated by Hahn Air Lines
under flight number HHN 201
on 10 June 2011
18 NM NE Fribourg VOR/DME

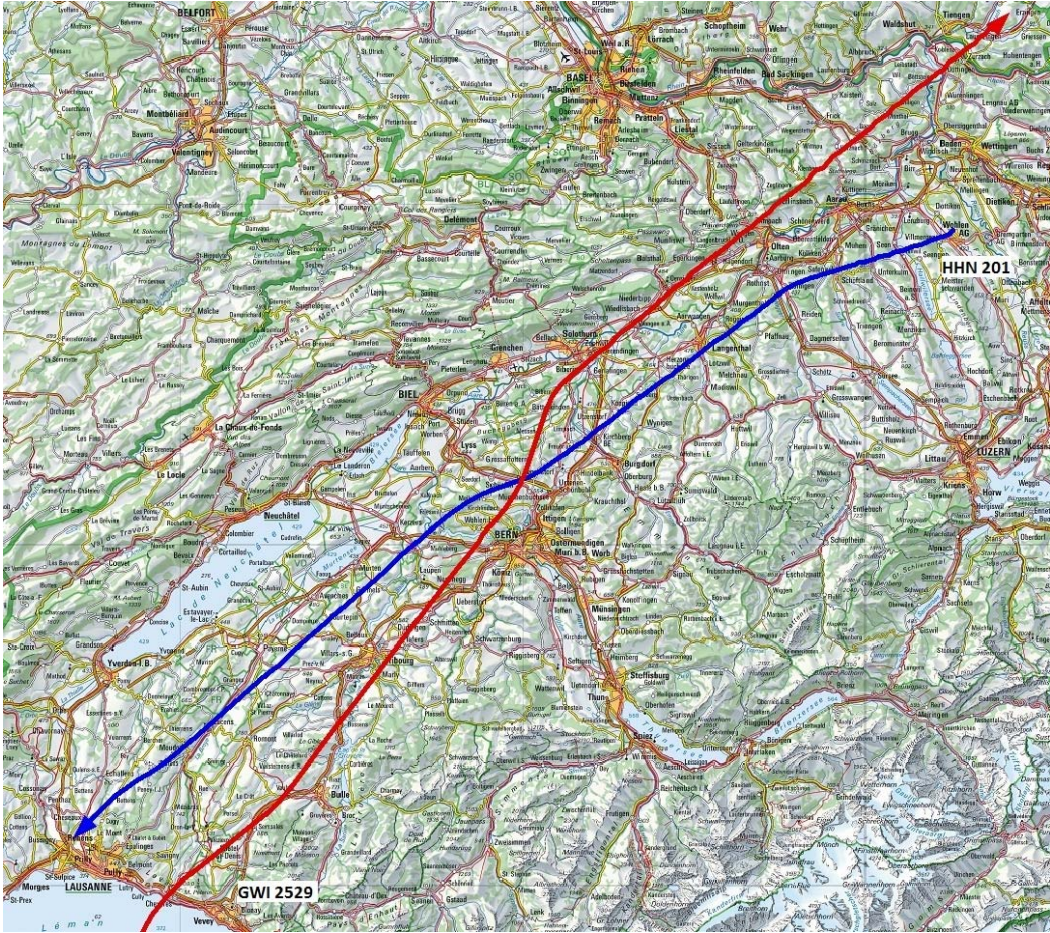
Figure 1: Flight paths of GWI 2529 and HHN 201

At the time of the closest approach at 08:37:35 UTC, the distance between the two aircraft according to the STCA log was 0.52 NM in the horizontal plane and 236 ft in the vertical plane. The distance measurements of the radar system at

this time indicated a lateral separation of 0.6 NM and an altitude difference of 50 ft.

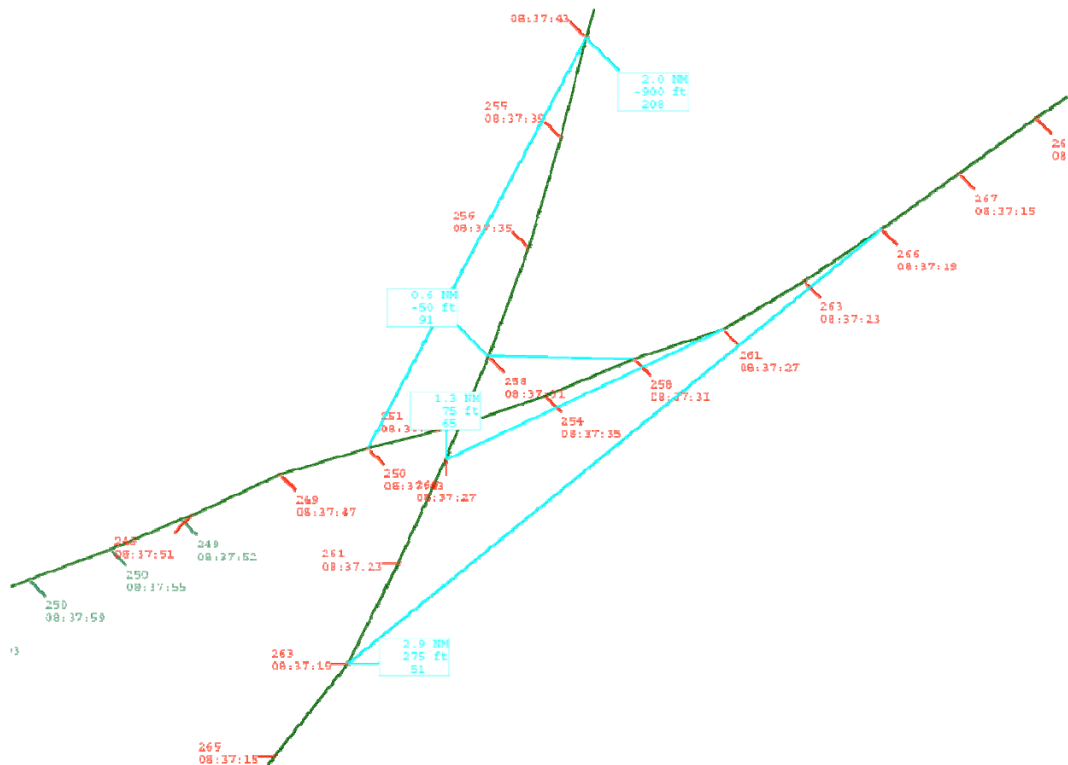
According to the radar recording, at the crossing point the lateral separation was 1.3 NM and the altitude difference was 75 ft.

Figure 2: The radar recording shows the situation during the crossing of the two aircraft. GW2529 passes the crossing point at a lateral distance of 1.3 NM and a vertical distance of 75 ft ahead of HHN 201. At the time of the closest point of approach, the distance is 0.6 NM in the lateral plane and 50 ft in the vertical plane. This evaluation is based on the radar image, which is updated in a 4-second cycle.

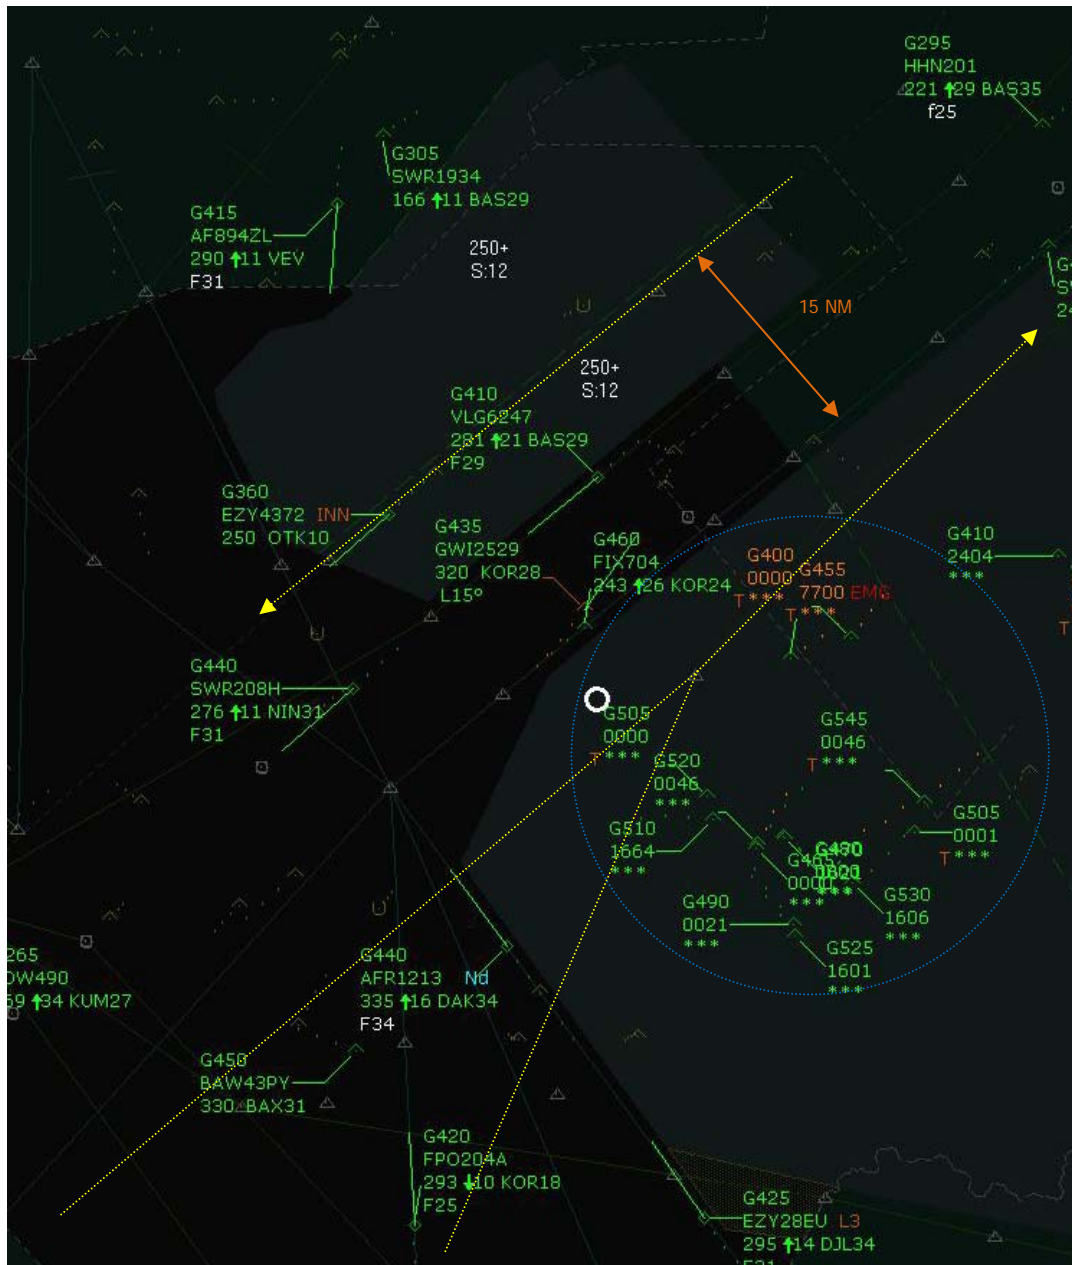
At this time, the Air Force air traffic control centre was carrying out an exercise which simulated a restricted representation of the air situation as a so-called degraded air picture. This had the effect that transponder codes which are normally hidden for civil air traffic control were being displayed on the radar screen (cf. figures 5 and 6). Hence the radar picture was encumbered with information which was not necessary for traffic management, and this made readability more difficult for the air traffic controller.

Figure 5: Radar image of Sector L12 in Geneva ACC at the time of the first radio contact with GWI 2529 at 08:33:40 UTC. The blue circle shows the area in which additional transponder codes or symbols of aircraft are shown which are normally suppressed.

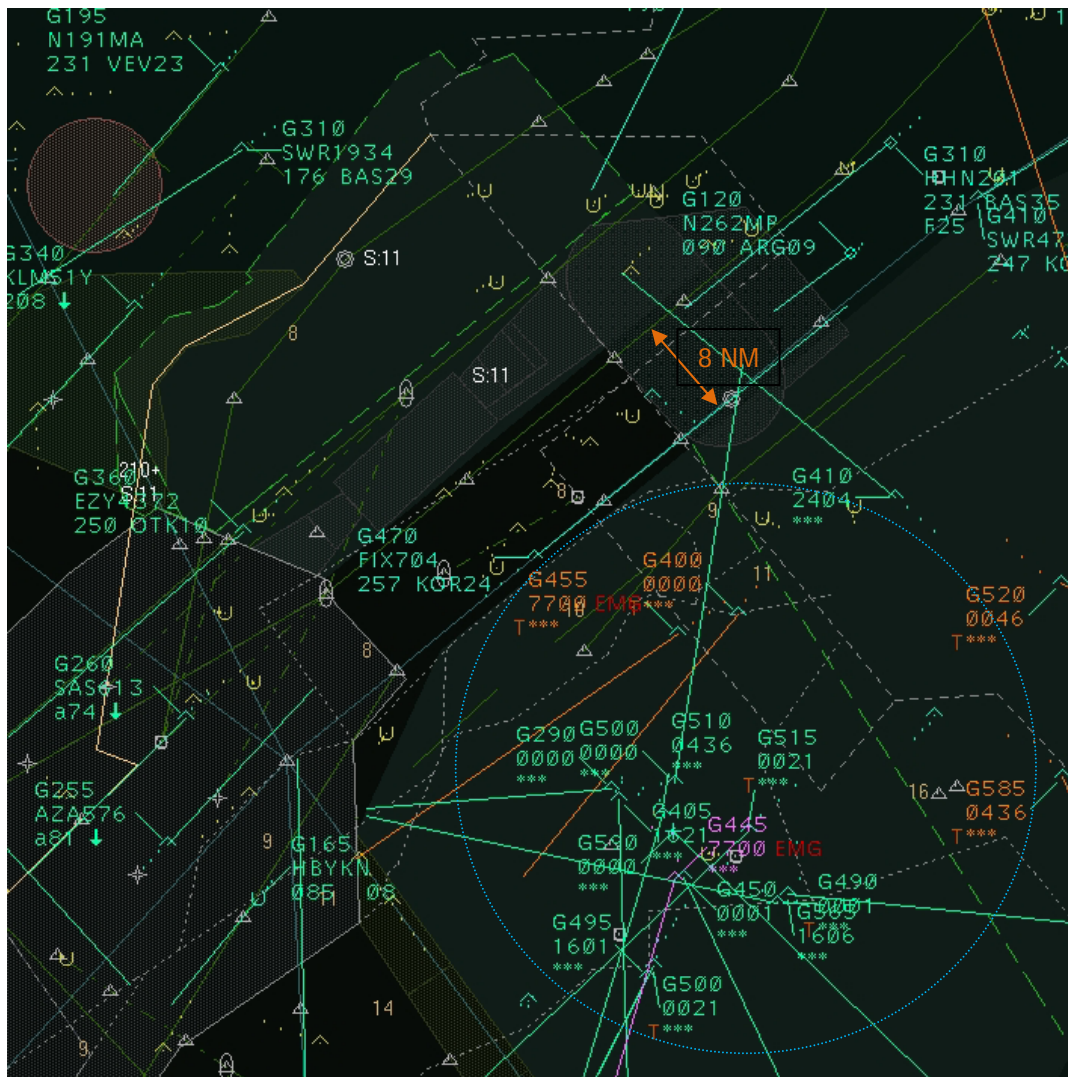
Figure 6: Radar image of Sector INSE in Geneva ACC at 08:34:00 UTC. The blue circle shows the area with additional radar symbols and transponder codes which complicated the overall view. Aircraft GWI 2529 was not shown in this sector because its entry into this sector was not envisaged.

Since GWI 2529 was not expected to fly into Sector INSE, the latter had no knowledge of its flight data, because of the system, and the flight was also not therefore displayed on the radar screens either. When an STCA alert suddenly triggered, the ATCOs realised that there was a conflict between HHN 201, of which they were aware, and a hitherto unknown flight which now appeared on their radar screens as GWI 2529 and with which they had no radio contact. The only possibility of intervening to resolve the hazardous convergence was to give HHN 201 appropriate instructions, which then happened immediately. Since GWI 2529 was at this time still above HHN 201, it was appropriate to give it an instruction to descend immediately, followed by a change in heading to the right as an

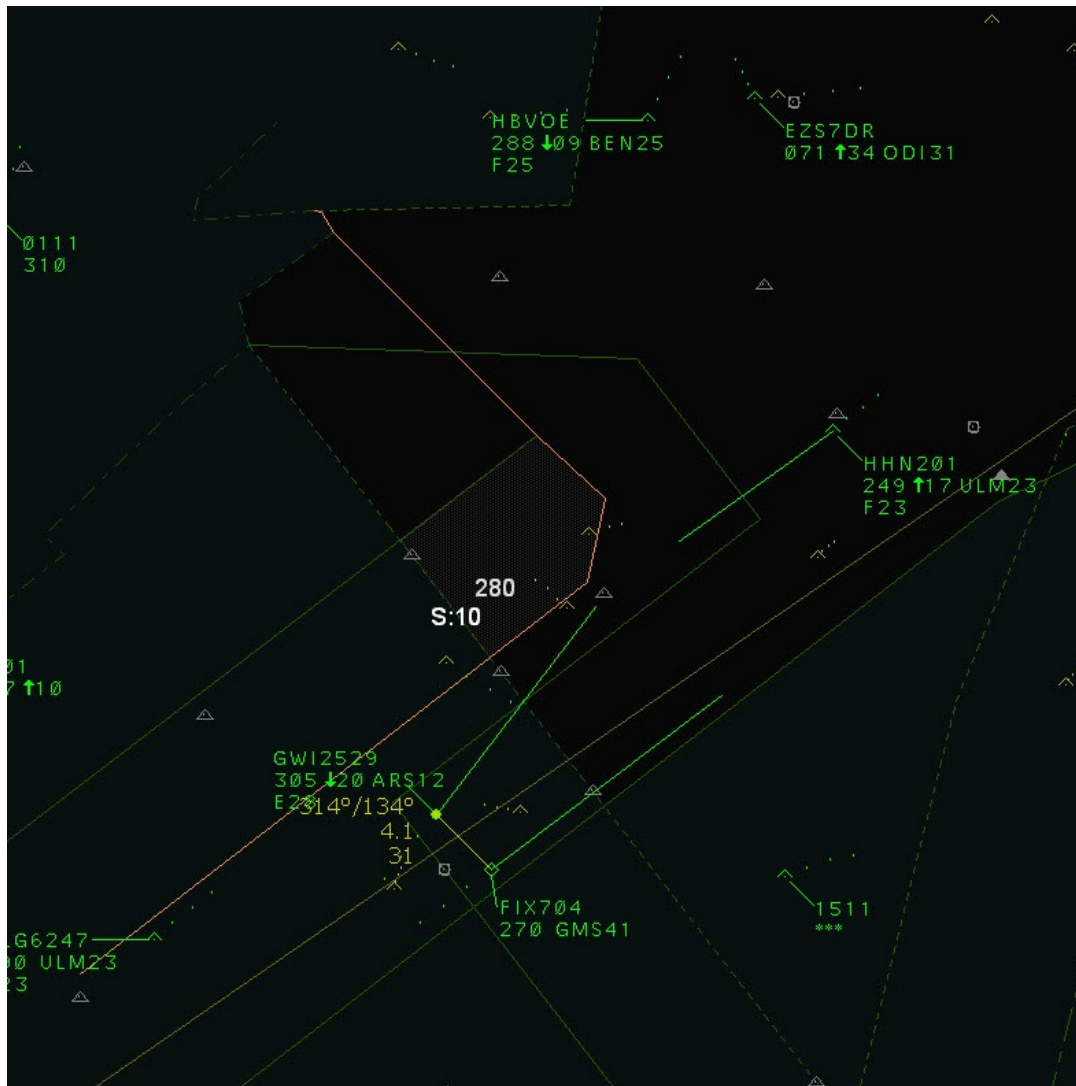
Aircraft GWI 2529 was flying on a north-easterly radar heading in order to ensure horizontal separation from flight FIX 704, which was climbing (see figure 7). The possibility of achieving separation on an easterly heading, and therefore avoiding crossings with flights on an opposite heading, did not exist, as the Air Force was using this airspace. This had the effect that flights GWI 2529 and HHN 201 could only be separated vertically.

Figure 7: Radar image of the western part of Sector M2 in Zurich ACC at the time of the first radio contact with GWI 2529, at 08:35:18 UTC.
