Final Report No. 2166 by the Swiss Accident Investigation Board SAIB

concerning the serious incident – Airprox

involving the Airbus A320-232 aircraft,
under radio call sign CFG 366

and the Airbus A340-642 aircraft,
under radio call sign QTR 020

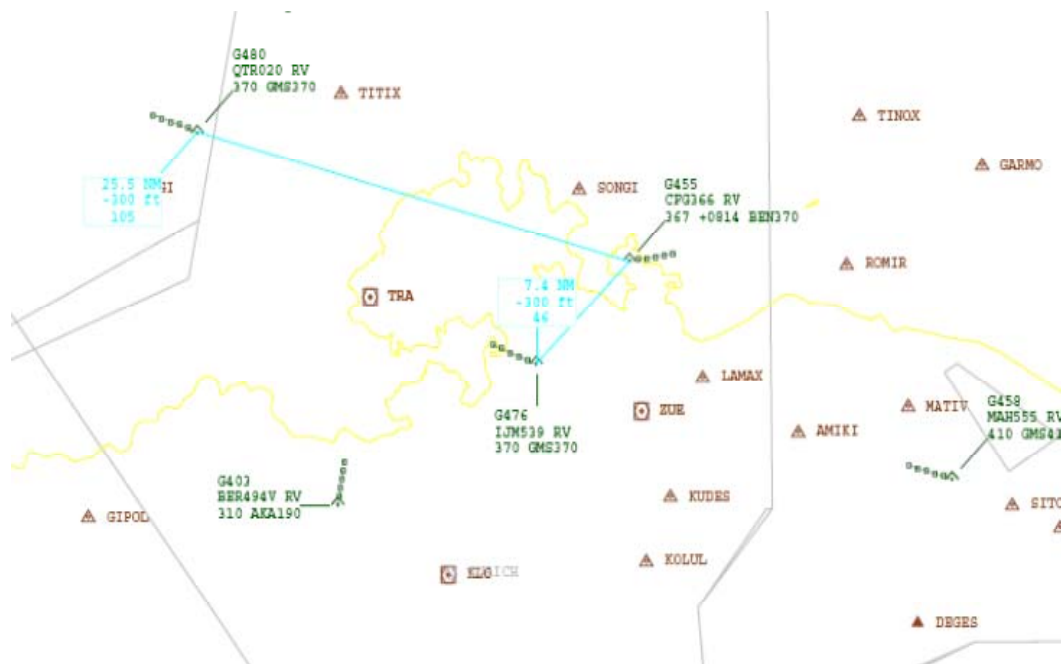
Figure 2: Recording of the radar data display shortly before the serious incident.

At the time of the serious incident, among other aircraft, three aircraft were at or climbing to flight level (FL) 370 under the control of sector M5/M6 of the Zurich Area Control Centre (Zurich ACC). Two of them, QTR 020 and IJM 539, were flying eastward at FL 370. The third aircraft, with the ATC call sign CFG 366, was climbing from FL 350 to FL 370 in a westerly direction. The control sector M5/M6 air traffic control officer had planned its flight path between the other two with a distance close to the required minimum separation.

The two aircraft involved closed to a lateral separation of 3.1 NM and an altitude difference of 500 ft.
