Final Report No. 2169 by the Swiss Accident Investigation Board SAIB

concerning the accident involving
the Aero AT-3 R100 aircraft,
registration HB-SRA

on 12 August 2011

Worboden, Worb/BE

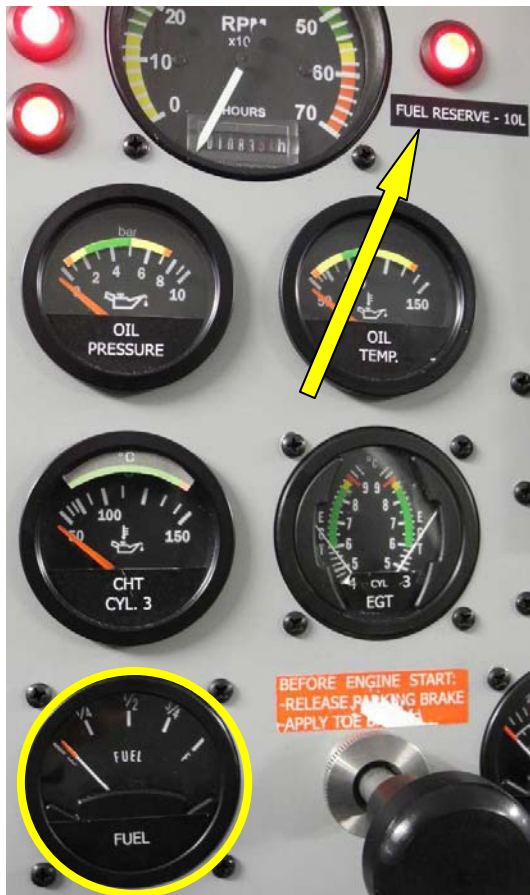
Figure 1: Fuel gauge (yellow circle) and red FUEL RESERVE warning lamp (yellow arrow)

- The signals for gauging the fuel level and triggering the "FUEL RESERVE - 10 L" warning lamp were generated by the same sensor.
- If the float is lying on the connecting pipe, the indication in the cockpit remains at approximately 1/3 and the "FUEL RESERVE - 10 L" warning lamp does not light up. This corresponds to the situation found after the accident.

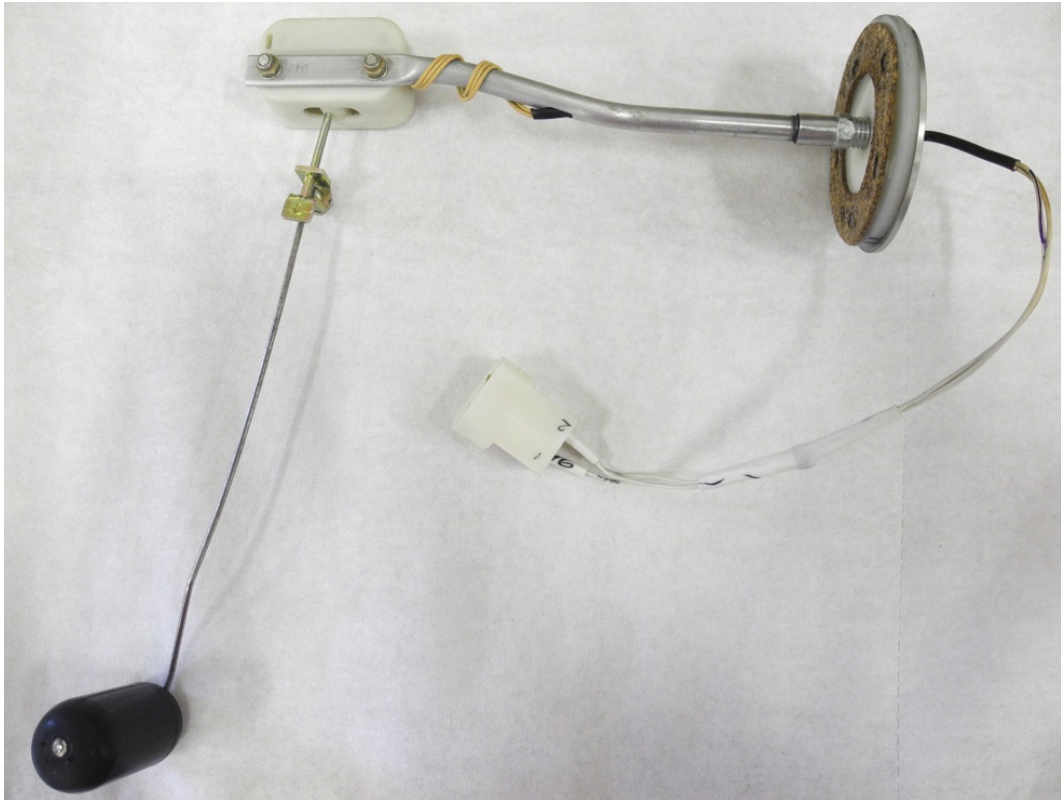
Figure 3: Sensor "Variant IV", P/N AT3.61.460.0 for aircraft up to S/N AT3-053

The sensor consists of a cover which is screwed onto the tank. In the middle of this cover there is a thread with a sleeve. An aluminium tube is inserted into this sleeve. At the lower end of the aluminium tube, a plastic housing in which the potentiometer is located is screwed on. A 21 cm long float is mounted on the axis of rotation of the potentiometer.

The fuel gauge in the cockpit received the signal from a sensor in the tank. The capacitive sensor originally fitted was replaced by the manufacturer with a sensor fitted with a float. This sensor had design shortcomings in that as a result of incorrect insertion of the dipstick the float could be twisted so that it ended up lying on a connecting pipe in the tank, as a result of which the indication in the tank remained blocked at approximately 1/3. Since the "FUEL RESERVE - 10 L" warning lamp also received its signal from the same float potentiometer, the corresponding warning would never be triggered in this situation. It is expected of a system with a low level warning lamp that the corresponding signal is generated by an independent system.

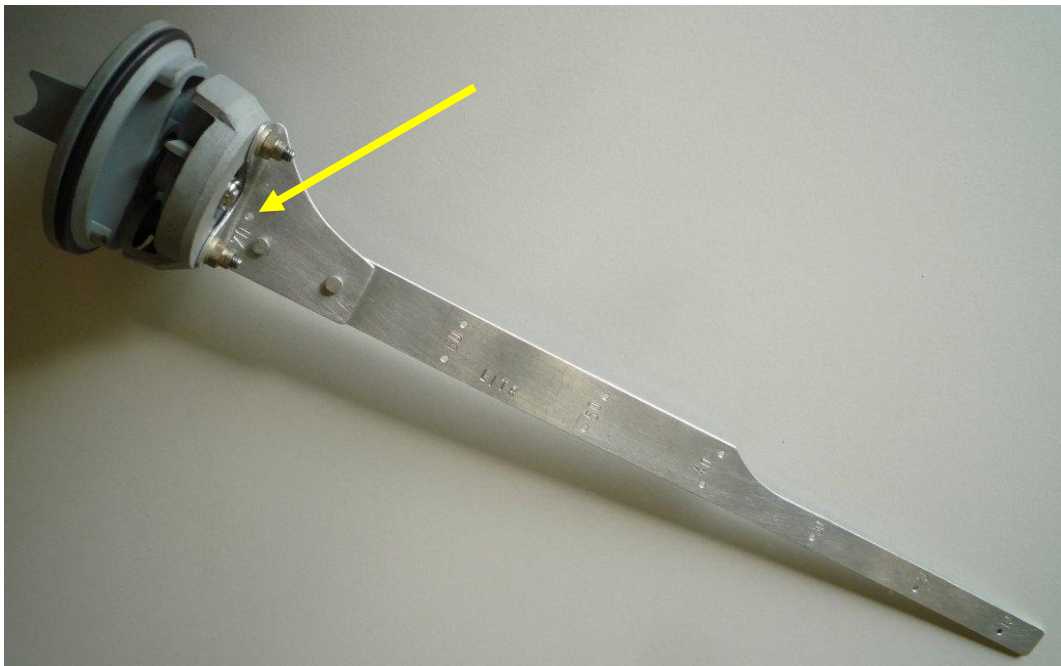
Figure 5: Dipstick with scale up to 70 litres (yellow arrow)

- The effective fuel capacity was 66 litres.
- The dipstick is very inaccurate in the range from the 10 to 30 markings and may indicate up to seven litres more than the actual value.
- As a result of the movement of the dipstick in the fluid, caused by insertion, closing and opening of the filler cap to determine the fuel level, a measurement may indicate up to 10 litres more than the actual value.
- It took at least three consecutive measurements to achieve a respective tolerance of 5 mm.
- When a value of 22 litres was measured using the dipstick, there were actually 18 litres of fuel in the tank.
- When a value of 25 litres was measured using the dipstick, there were actually 22 litres of fuel in the tank.

- A measurement with the dipstick could indicate up to 10 litres more than the actual value.
- The fuel measurement sensor had design deficiencies. If the filler cap was closed incorrectly, the dipstick could twist the float of the sensor over the connecting pipe in the tank.

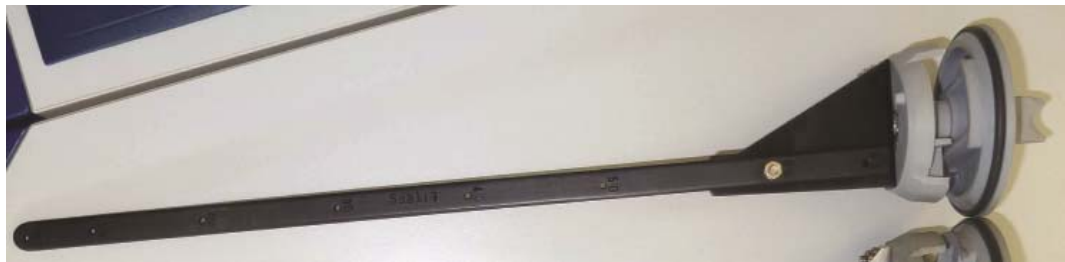
Another type of gauge with a scale up to 65 litres was found in the spare parts inventory of the maintenance company. It can be assumed that this dipstick was intended for use with fuel tanks with a 68.5 litre capacity.

Figure 6: Dipstick with scale up to 65 litres

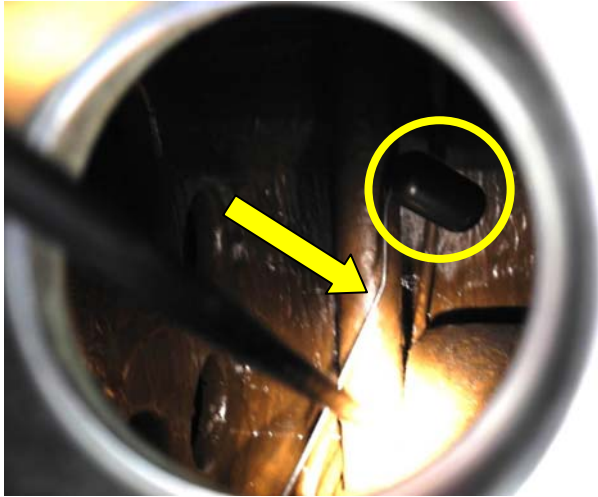
On the measuring sensor of the fuel tank, it was found that the aluminium tube to which the float is attached could be twisted clockwise, without any significant force, by up to 40° from its original position.

It was also found that as a result of this twisting, the float was resting in the tank on the connecting tube which carries through the throttle linkage of the pilot sitting on the right in the cockpit. The float was able to move freely upwards and was able to indicate fuel levels from full down to one-third.

Figure 7: Float (yellow circle) on connecting tube (yellow arrow)

„Der Certification Manager General Aviation der EASA wurde über die konstruktiven Mängel des Treibstoffmessensors informiert. Des Weiteren wurde durch das BAZL eine Flotten-Inspektion durchgeführt, wobei unter anderem sichergestellt wurde, dass sich der Eigentümer der betroffenen Flugzeuge der Problematik bewusst ist.“

Translation: EASA's certification Manager General Aviation has been advised about the constructive design deficiencies of the fuel measuring sensor. Furthermore the FOCA carried out a fleet inspection ensuring among other, that the owners of the aircraft became aware of the problem.

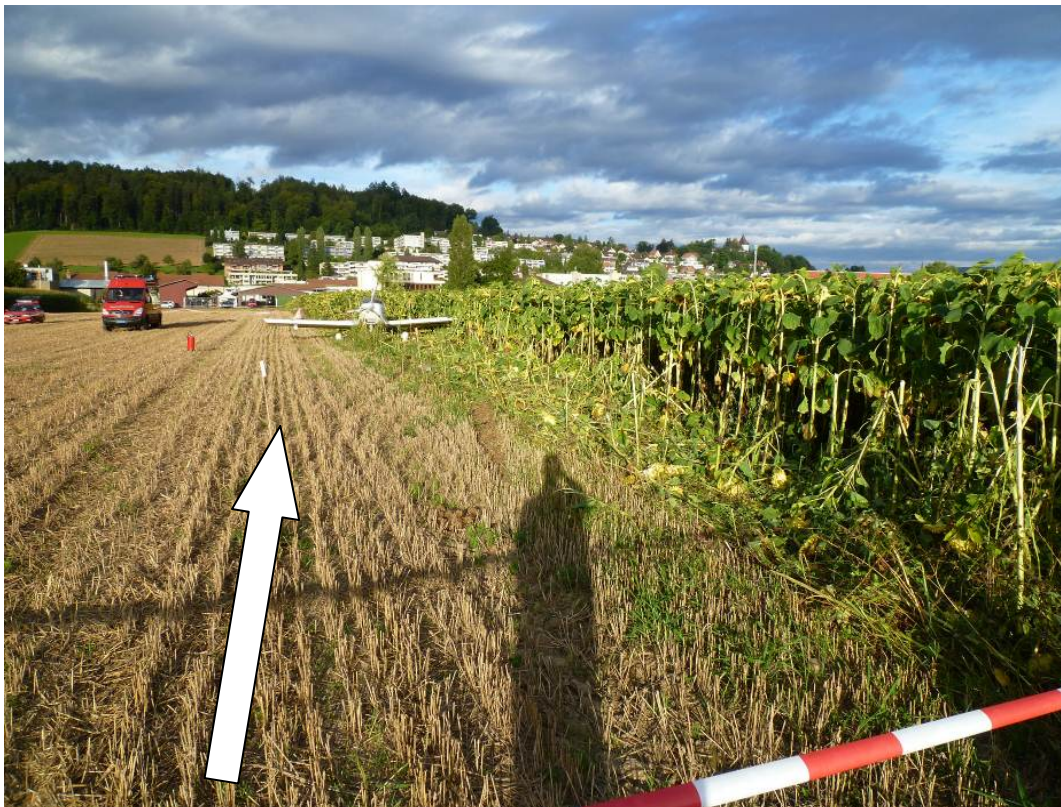
The aircraft initially touched down normally on the emergency landing site. Because of the diagonal approach, the right wing collided with the sunflower field in the roll-out phase. As a result, HB-SRA was rotated clockwise around its vertical axis by almost 180° and rolled backwards to come to a halt after approximately 25 m.

Figure 8: Scene of the accident – white arrow = direction of flight

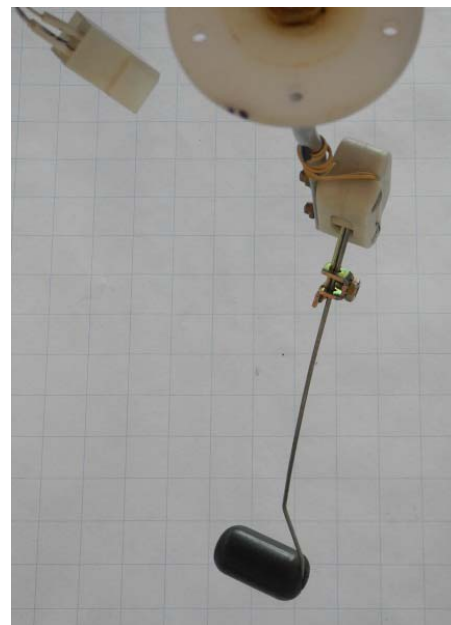
If the dipstick was inserted into the left half of the tank, it could come into contact with the left side of the float linkage. When the tank filler cap was closed, the aluminium tube of the float was twisted clockwise to such an extent that the float was brought above the connecting tube and rested on it as the level dropped.

This incorrect state may persist even if the dipstick is subsequently inserted correctly.

Figure 10: Float in skewed position
