Final Report No. 2178

concerning the accident involving the
Schweizer 269C helicopter,
registration HB-XYI

on 11 November 2010

Lanzenhäusern, Obereichi,
municipality of Wahlern/BE

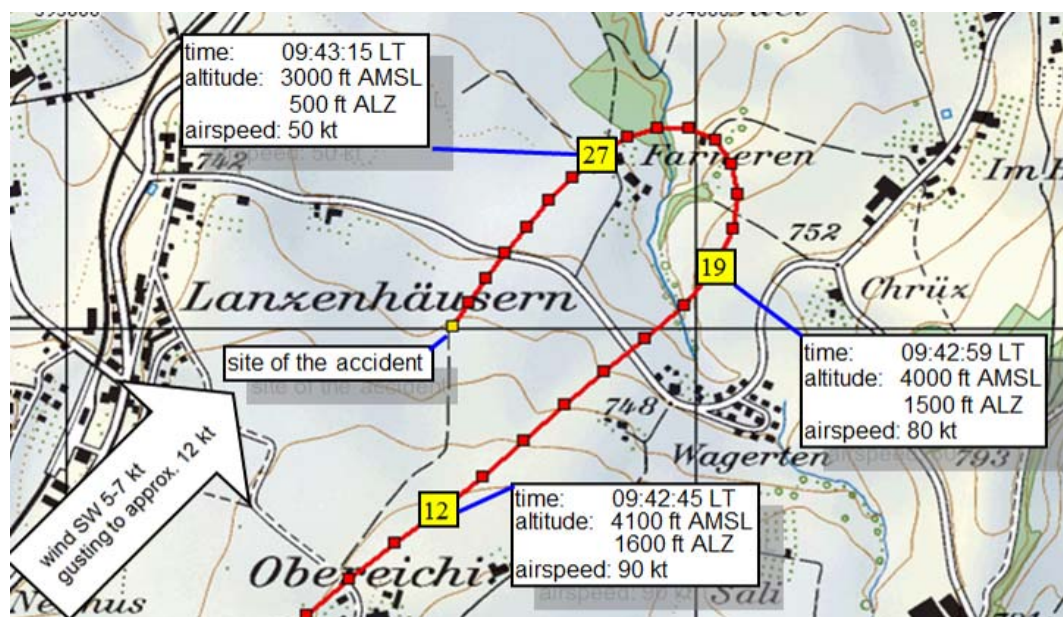
Shortly before 09:43 (see Figure 1 - reference point 12) the crew discussed the wind conditions and in the Wagerten area initiated an autorotation exercise with a 180° turn into the wind. According to the flight path recordings, the initiation of this manoeuvre took place at an altitude of approximately 4000 ft AMSL and some 1500 ft above the planned landing site (see Figure 1 - reference point 19). According to GPS recordings, in the subsequent 180° turn, within reference points 19 and 27, the average rate of descent was over 3500 ft per minute.

Figure 1: Flight path during the final phase. The data was recorded at two second intervals. ALZ corresponds to the height above the envisaged landing site (above landing zone). The specified speeds correspond to the ground speed.

The initiation of the autorotation exercise took place at an altitude of approximately 4000 ft AMSL, and at a ground speed of approximately 80 kt (reference point 19). To reach the landing zone, it was necessary to make a 180° turn. This resulted in an increase in the rate of descent, which in this phase attained an average value of over 3500 ft per minute. Coming out of the turn, a relatively low airspeed of approximately 50 kt was noted by the flight instructor. The subsequent instruction to the pilot to change the attitude to increase speed primarily resulted in the rate of descent increasing in this phase. The indicated rotor speed of 460 rpm was in the middle of the green range.

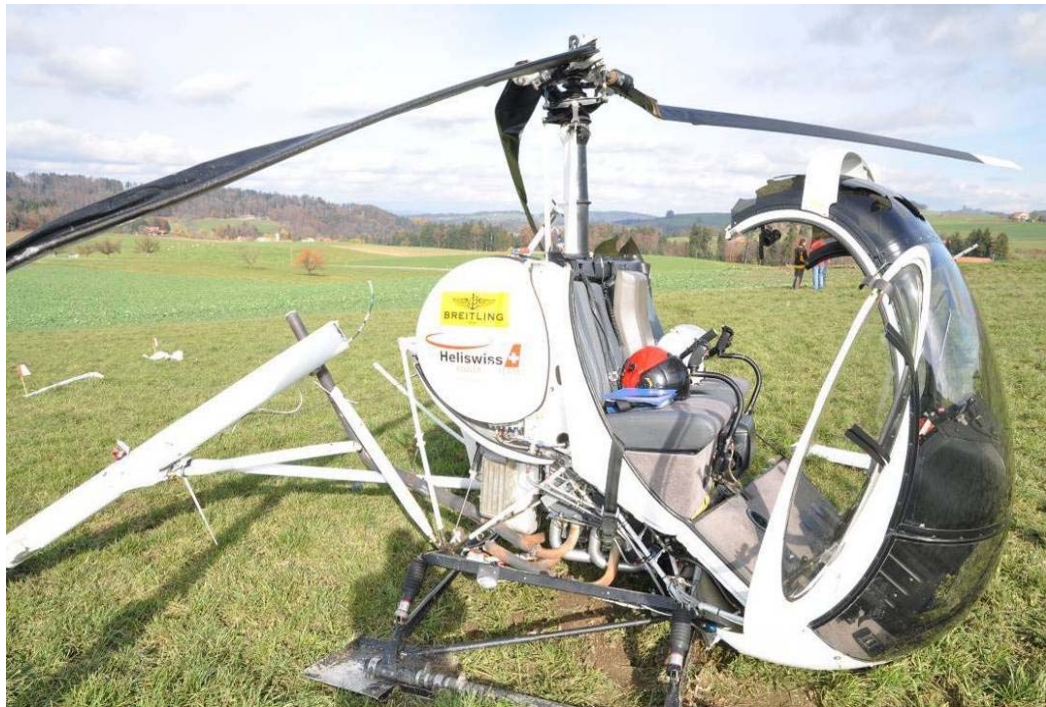
As a result of the forceful impact on landing, the landing skid was compressed and deformed. The cabin fractured in front of the two pilot seats and was bent forwards. All the main rotor blades were badly deformed.

Figure 2: Final position of the helicopter.

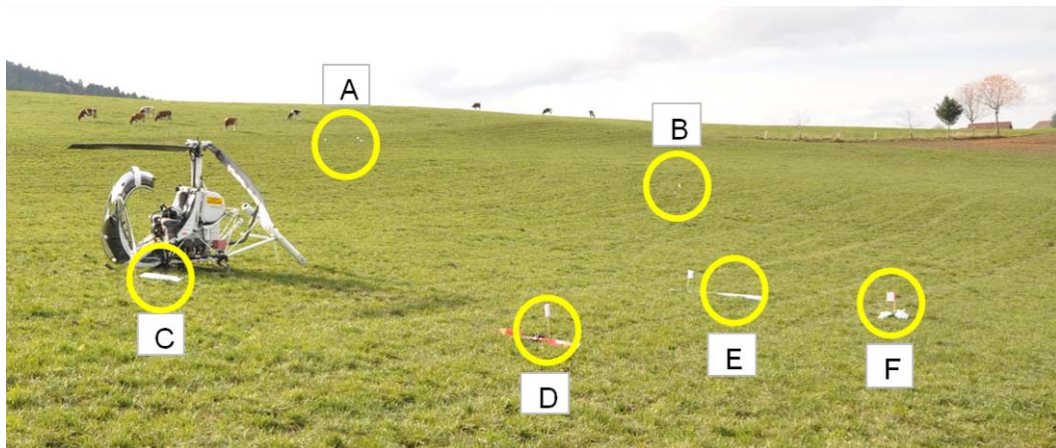
The tail and the drive shaft running inside it had broken off in the area of the central structure/tail boom mount) and broke into two parts. The tail rotor unit was separated from the tail. The rear section of the tail boom was thrown uphill (Figure 3, position A). The considerable distance from the main wreckage indicates high impact energy.

Figure 3: Overview of the location of the wreck.

- A: tail boom structure
- B: structural element
- C: horizontal stabiliser
- D: tail rotor and transmission
- E: tail rotor drive shaft
- F: structural element

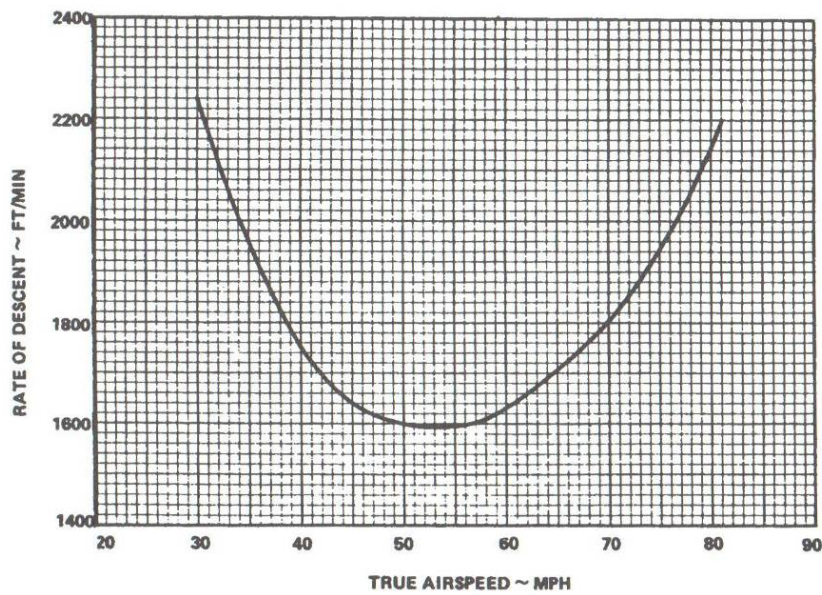
Figure 8-10. Rate of Descent

In the case of the Schweizer 269C helicopter, the two speeds can be estimated from figure 8-10 (see Annex 1) in the PFM. They are in the range of approximately 45 kt as the speed for the lowest rate of descent and approximately 60 kt as the speed for the best glide angle. At speeds outside this range, the rate of descent increases markedly. The basis for figure 8-10 was a rotor speed during autorotation of 471 rpm.

The forward speeds in this graph were specified in statute miles per hour (true airspeed – TAS). In the present case this can be roughly equated with the indicated airspeed.(indicated Airspeed - IAS).
