Final Report No. 2181 by the Swiss Accident Investigation Board SAIB

concerning the accident involving the
BAE146-200 aircraft, registration G-ZAPN

on 26 December 2011

Sion/VS airport (LSGS)

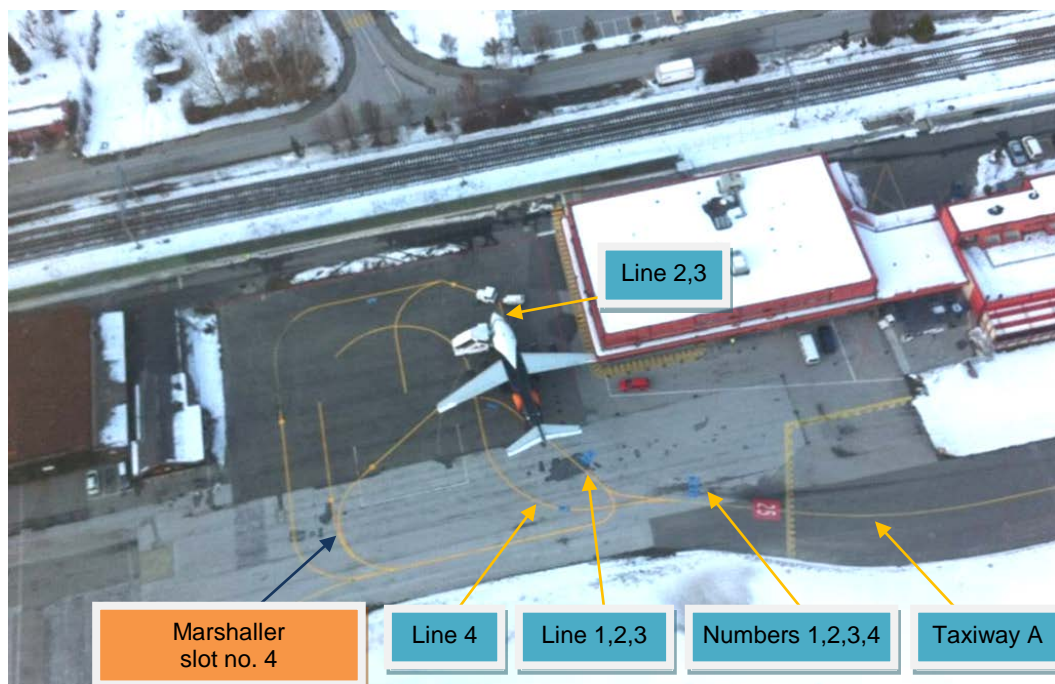
The ground controller did not issue any other instruction to the crew, who continued to taxi towards the marshaller following the yellow centreline of taxiway Alfa (see Figure 1), which is adjacent to the airport terminal.

The marshaller, wearing an orange jacket and with guide wands, was positioned in the extension of the line of stand number 4 intended as the final position of the aircraft (see Figure 1).

During the turn, the copilot, sitting on the right in the cockpit, observed the right wing and indicated to his commander not to turn further to the right, and then immediately afterwards he told him to stop. The captain stopped the aircraft when the wingtip contacted, and became lodged under, the eaves of the terminal, at the south-west corner of the building.

Figure 1: Aerial view of the *Transit Parking* after the accident

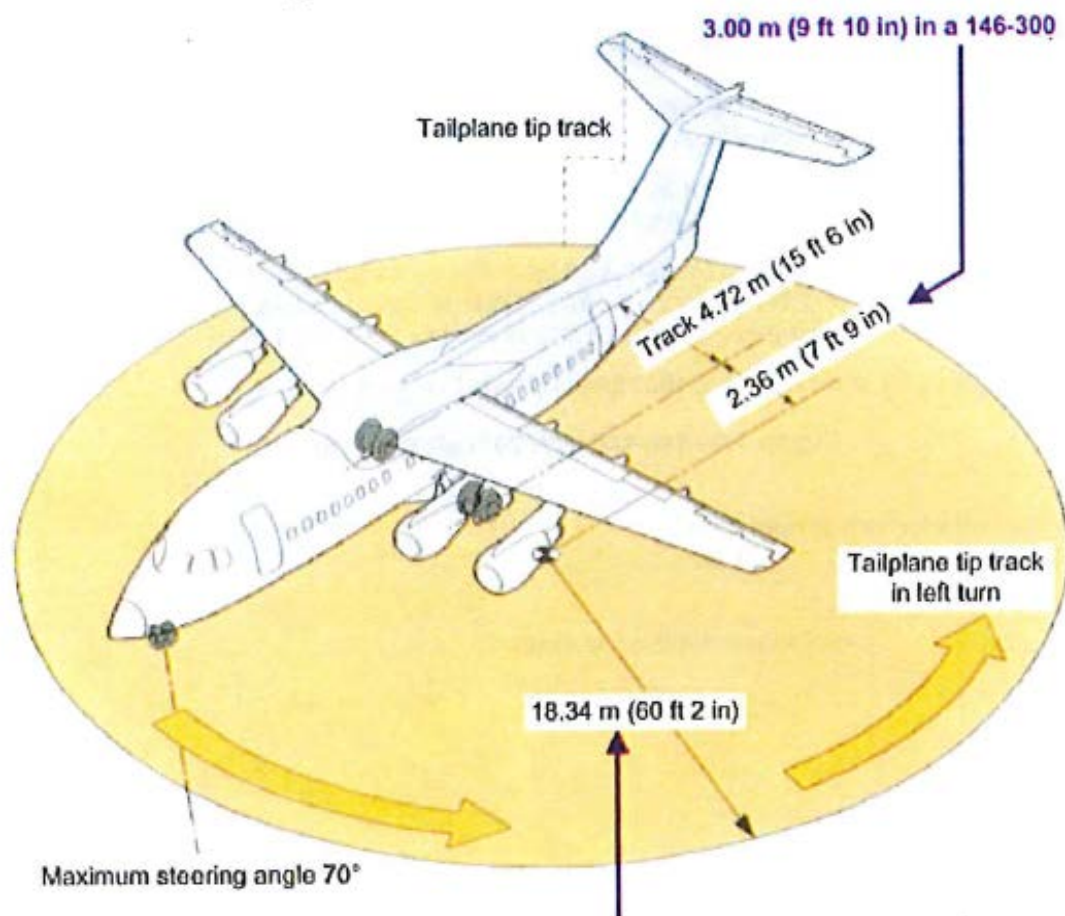
Figure 2: Turning radius, BAE 146-200 with 70° left steering
Minimum diameter permitting a 360° turn: 36.68 m

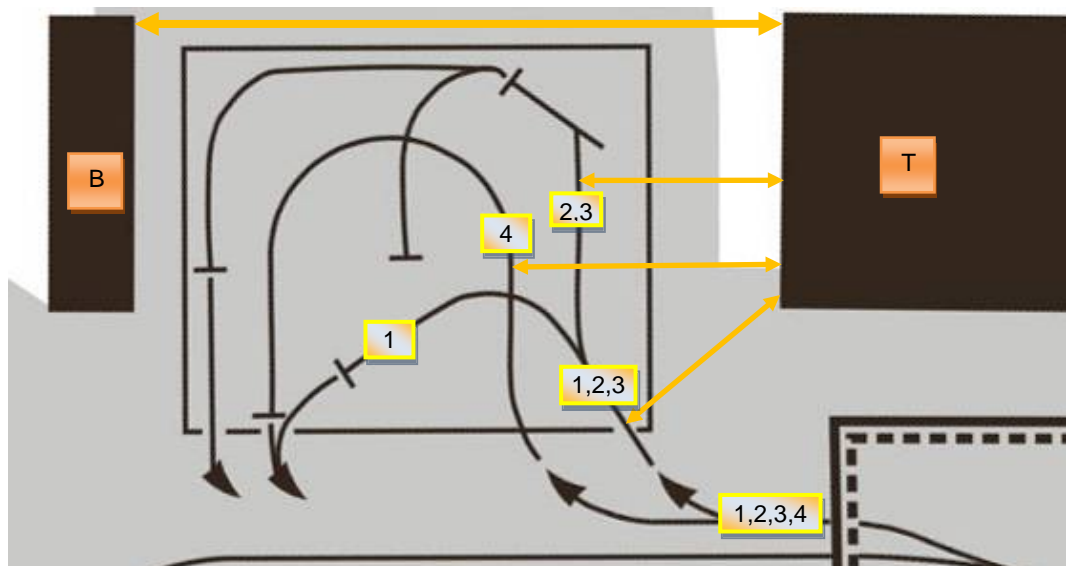
Figure 3: *Transit Parking* markings (source: AIP); the yellow arrows and the numbers have been added by the SAIB.

- Distance between Terminal T and line 1, 2, 3: 13.90 m
- Distance between Terminal T and line 2, 3: 12.60 m
- Distance between Terminal T and line 4: 19.55 m
- Distance between Terminal T and Building B: 61.10 m

The numbering of the stands was not shown on the AIP ground charts; this is the official source of all publications made available to crews. Furthermore, the square shown on the chart did not correspond to the existing marking on the ground (see Figure 3).

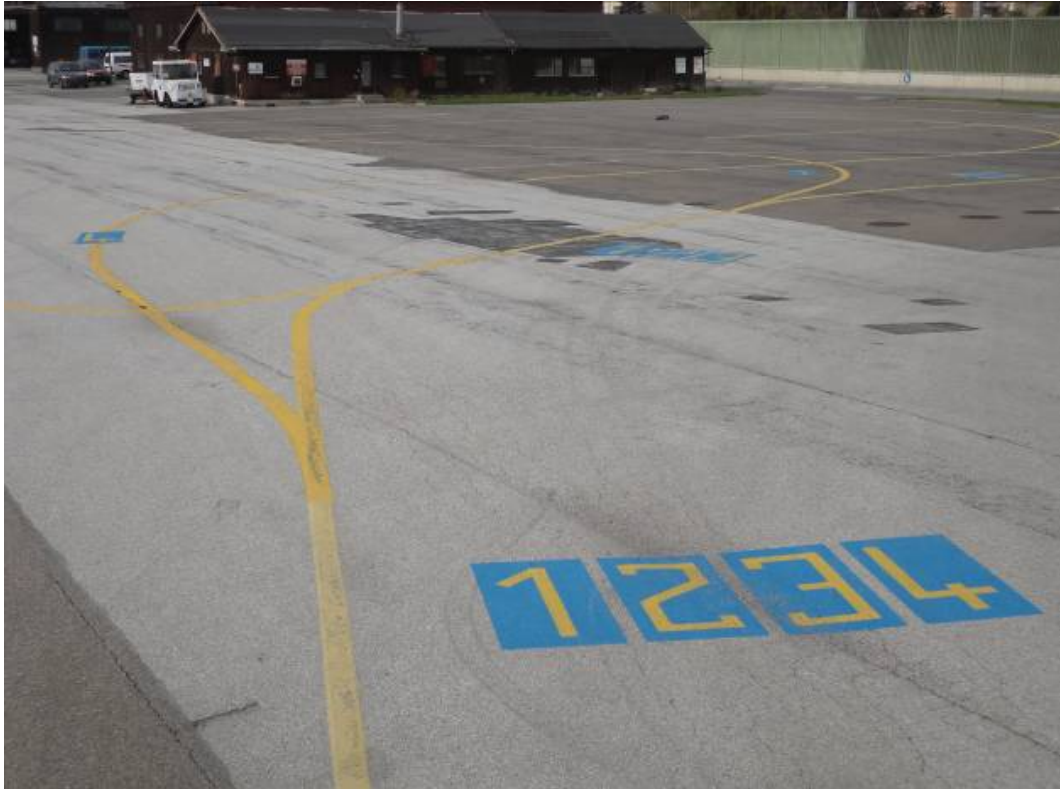
At the entrance to the *Transit Parking*, the yellow line of taxiway A splits into two lines of the same colour, one bearing the numbers 1, 2 and 3 and the other number 4, designating the parking stands (see Figure 4).

Figure 4: *Transit Parking* markings

The images above indicate the marking of the *Transit Parking* location as it was at the time of the accident. Figure 4 shows the numbering of the lines giving access to the four parking stands on the *Transit Parking*.

The markings on the ground and more particularly the numbering give rise to confusion. In addition, the documentation available to crews was not complete with respect to the marking of the *Transit Parking*.

- The yellow line "2/3" does not permit the passage of a BAE146
- The yellow line "4" does permit a BAE146 to park on the *Transit Parking*
- The illustration of the *Transit Parking* in the AIP does not mention any numbering of the tracks

- Demolition of the first wooden building on the west side of the *Transit Parking* (space saving 11meters).
- Change of marking of the yellow line 4 (plans sent to the FOCA for approval).
- Publication in the AIP of a *Ground Movement Chart* including the *Transit Parking* (ongoing by the charting of the FOCA).

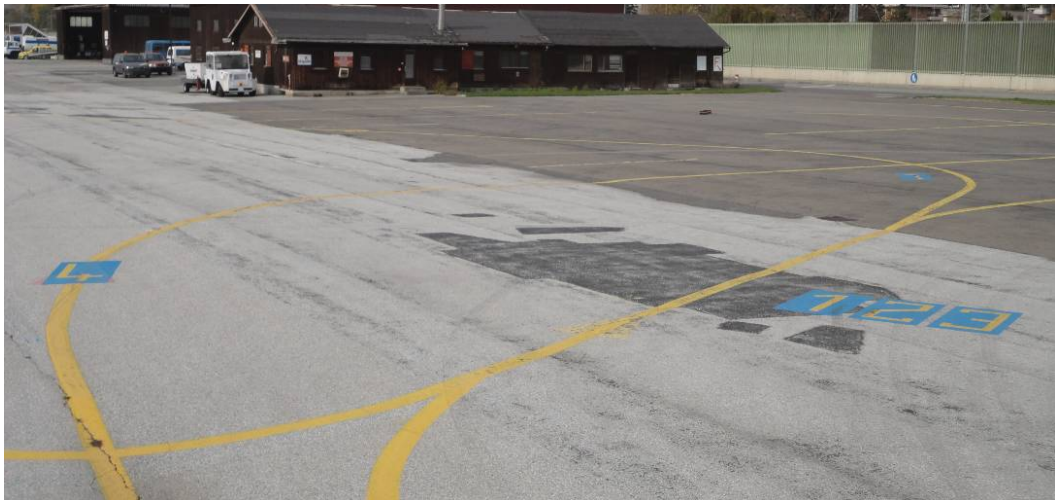
Figure 5: *Transit Parking* markings
