# **Final Report No. 2183 of the Swiss Accident Investigation Board SAIB**

Concerning the serious incident  
(AIRPROX)

involving an A319-111 aircraft, callsign  
EZS 98DJ

on 6 August 2011, 14 NM WNW of  
Geneva

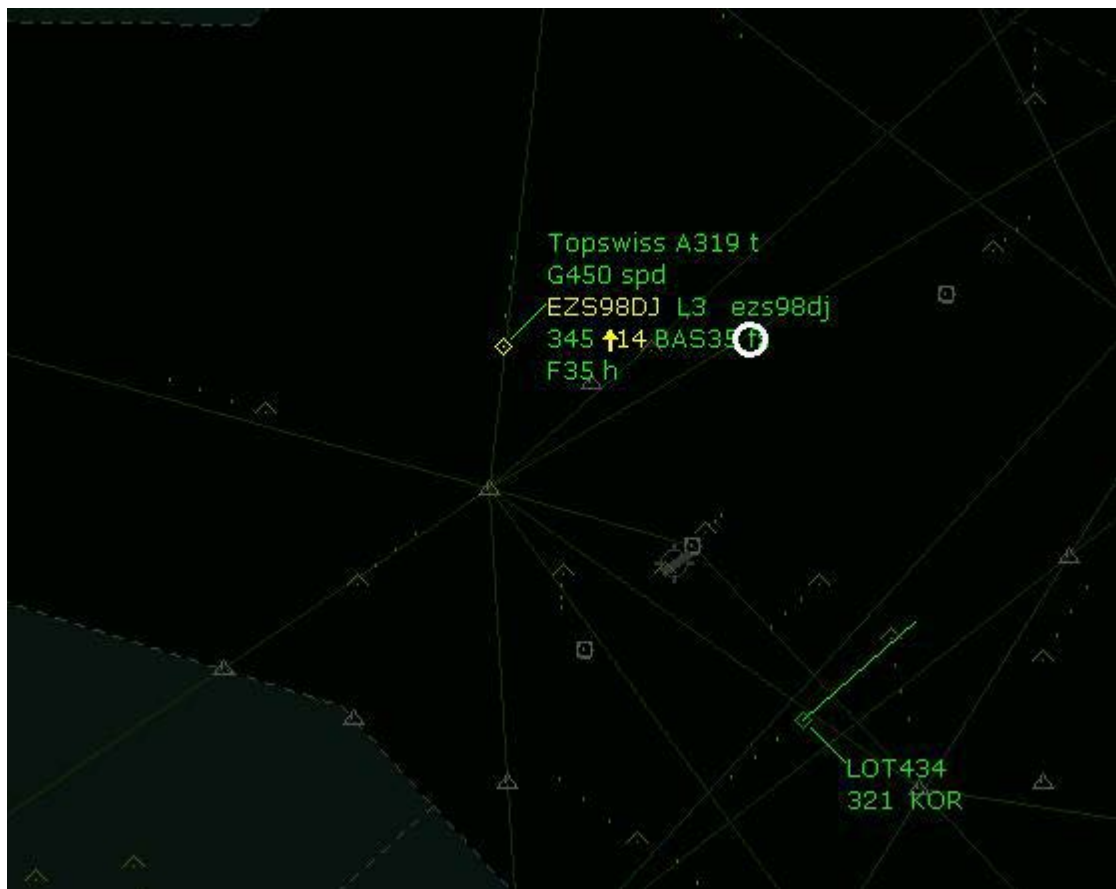
Fig. 3 Radar image at the time of the transfer of communication of flight EZS 98DJ from Swiss radar to the Marseille Control Centre

At 16:28:47 UTC, flight EZS 98DJ was transferred to the Marseille Control Centre frequency of 127.540 MHz. It was 8 NM north of waypoint MILPA, passing flight level FL 345 with a rate of climb of 1400 ft/min.

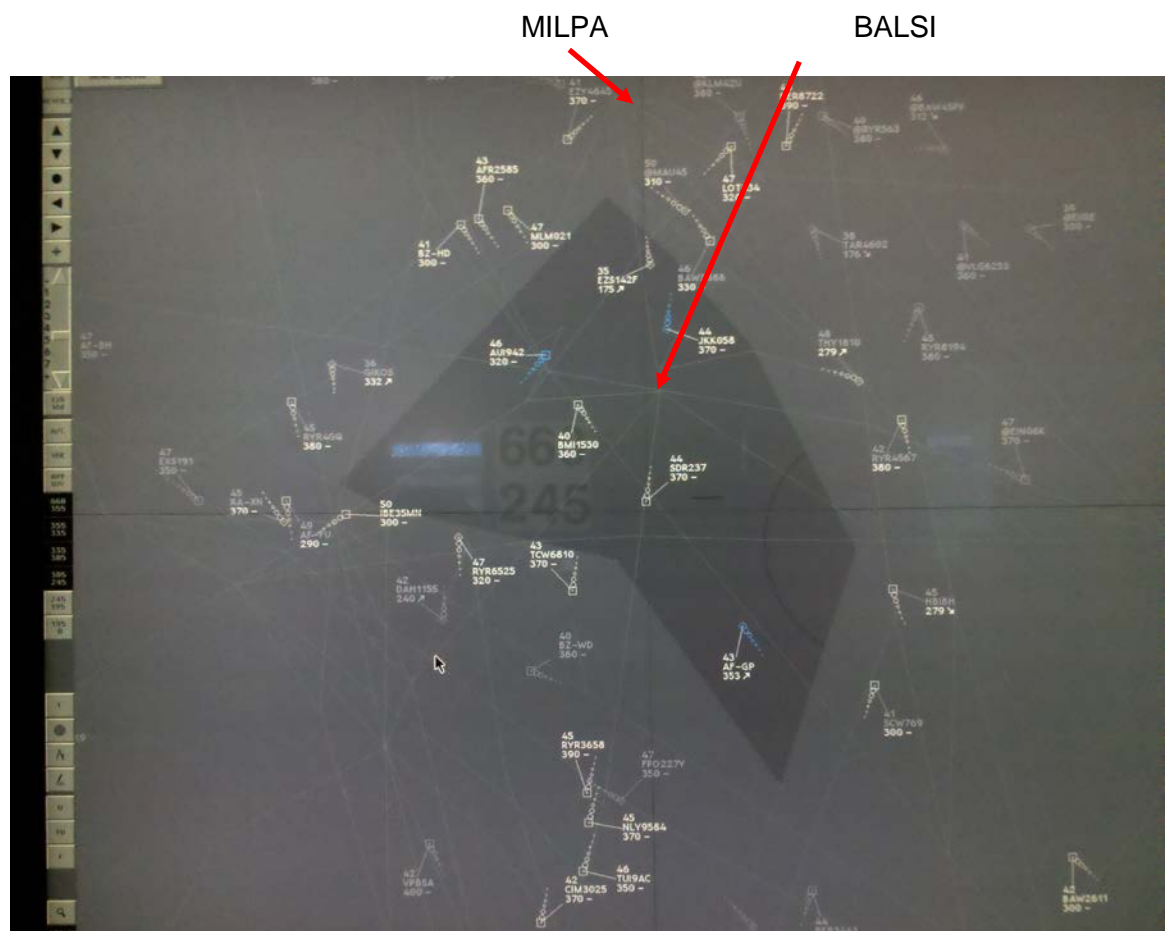
Fig.4 Image on the screen of the Marseille sector Y1 controller at 16:29:19 UTC at the time of the first call from the pilot of flight EZS 98DJ on this sector's frequency. The aircraft is not yet visible on the screen.

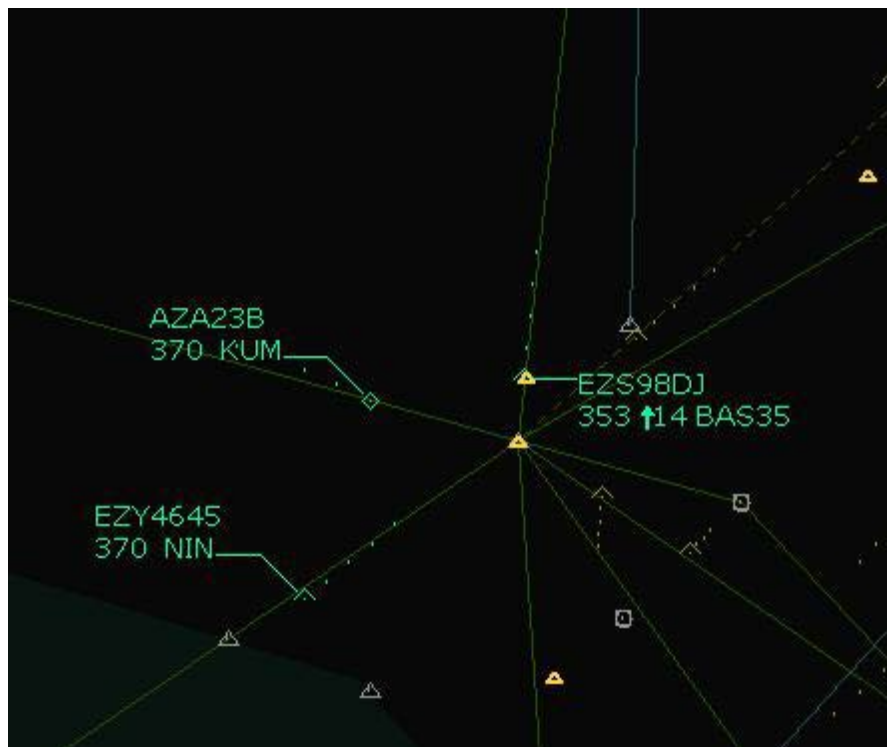
A little earlier, at 16:29:23 UTC, the label of flight EZS 98DJ appeared on the radar screens at Geneva Control Centre sector L56; the flight was passing flight level FL 353 in a climb. Since this flight was not known to this sector, the radar planner RP then initiated a telephone coordination with sector L34: "How high is that Topswiss climbing?" The sector L34 RP replied that this flight had been cleared to flight level FL 350 and that the pilot had read back this flight level. The sector L56 RP urged the sector L34 controllers to instruct flight EZS 98DJ to make an immediate descent and to inform it of converging traffic at flight level FL 370. The L34 RP replied that flight EZS 98DJ was in contact with Marseille.

Fig. 5 First appearance of the radar label of flight EZS 98DJ on the screens of sector L56

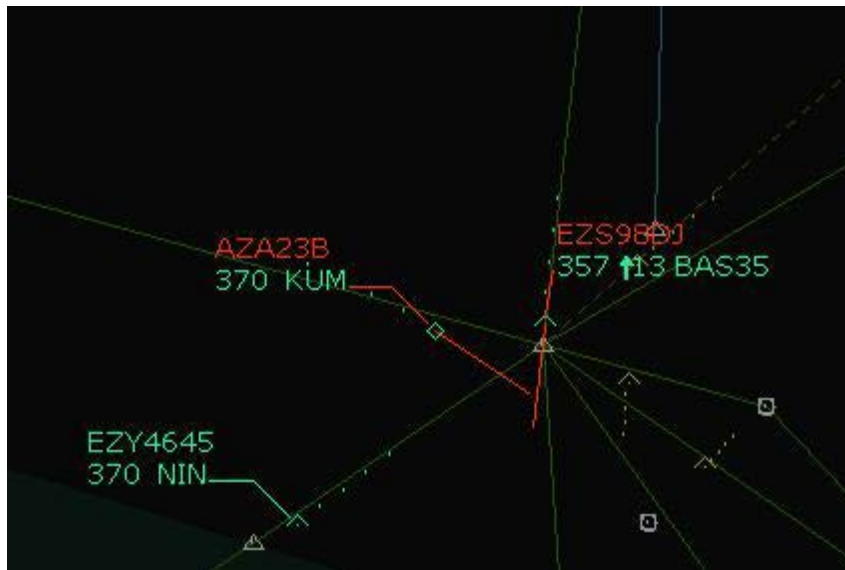
Fig 6 The STCA is triggered in Geneva sectors L34 and L56

At 16:29:38 UTC, the short term conflict alert (STCA) safety net was triggered in sectors L34 and L56; the distances between the two flights were 5.15 NM laterally and 1300 ft vertically.

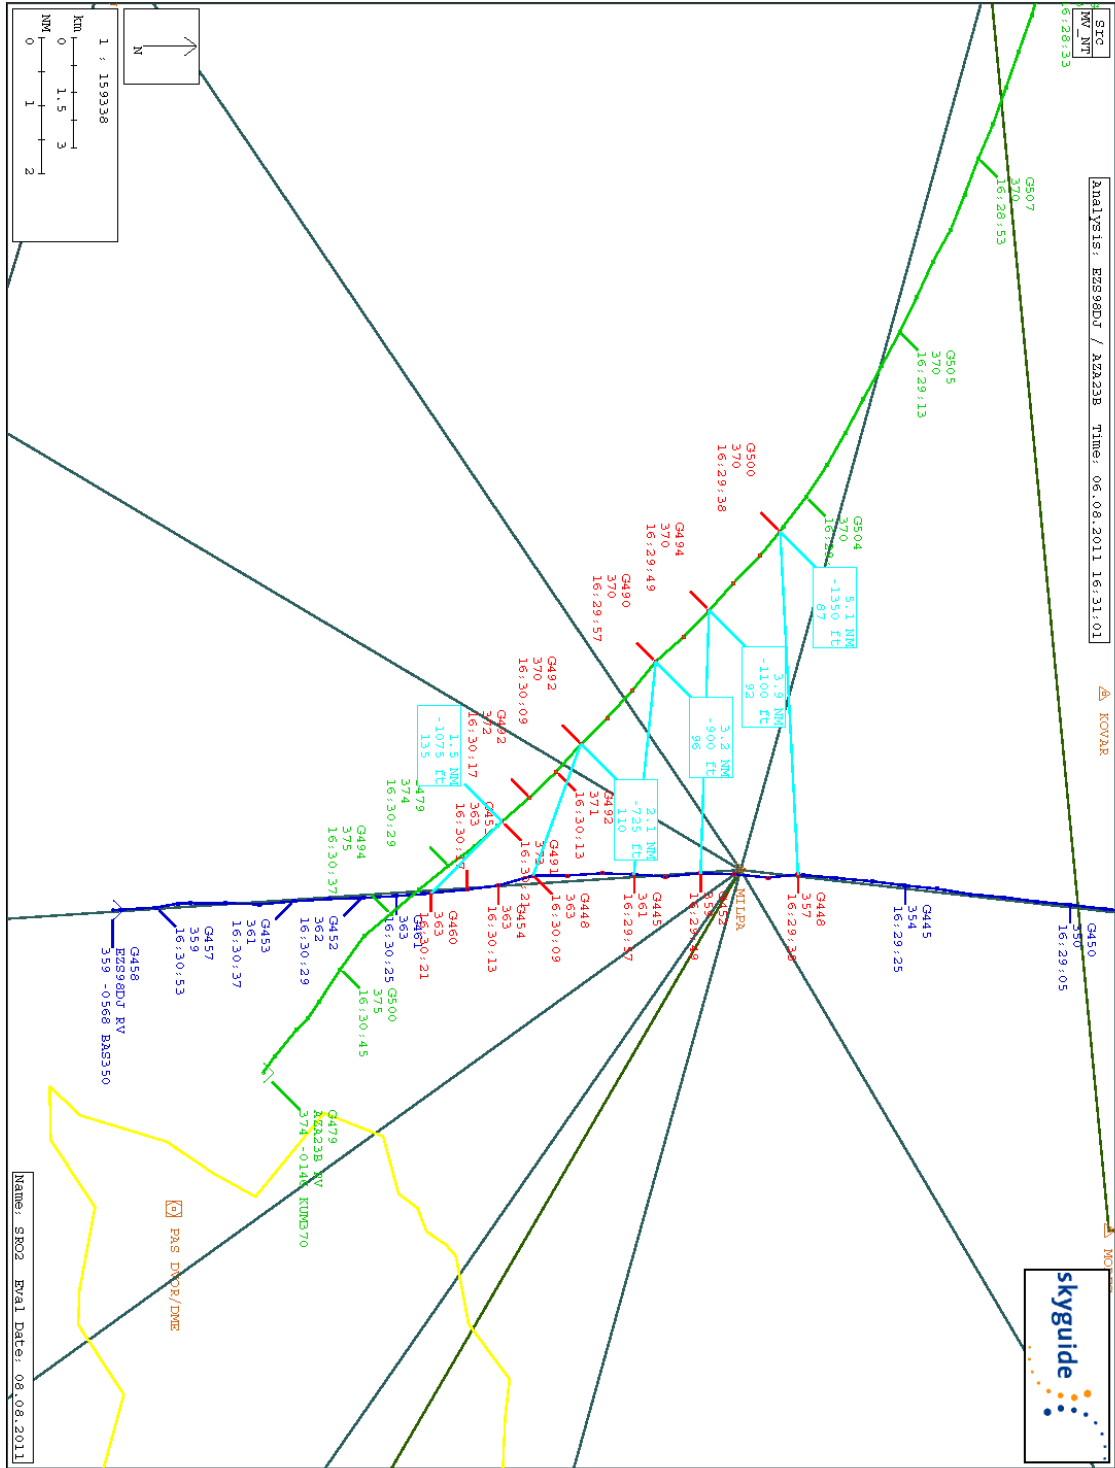
Annex 3 Radar plot

First call to sector Y1      STCA triggered at Y1      Frequency change from L34-Y1
