Final Report No. 2184 of the Swiss Accident Investigation Board SAIB

concerning the serious incident
(AIRPROX)

involving aircraft type A320, registration
SWR 194W

on 17 August 2011

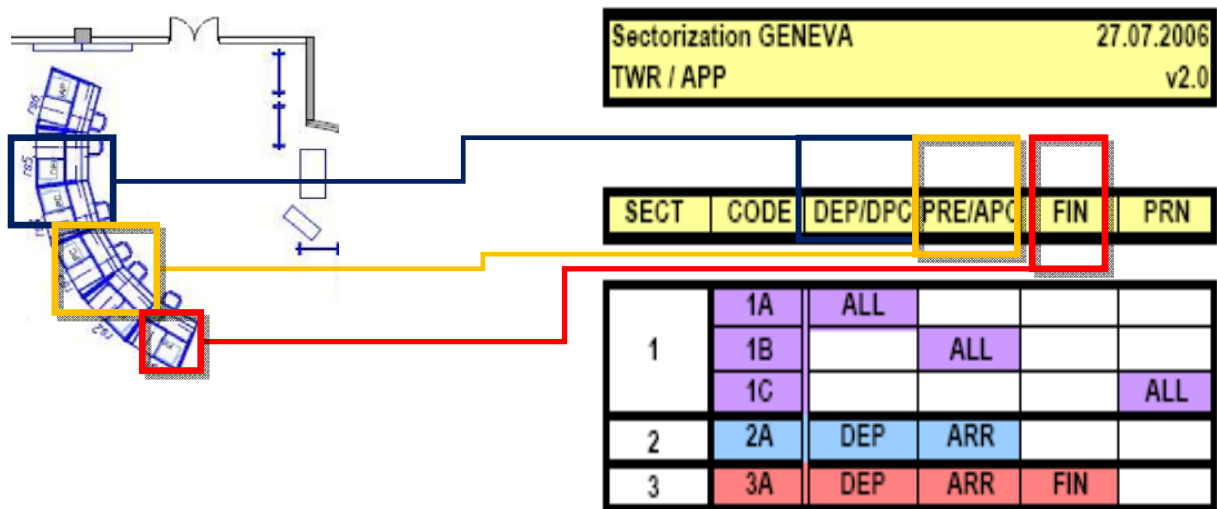
Figure 3: Sectorisation and layout of the workstations

At the time of the serious incident, the sectorisation was in the configuration according to code 3A

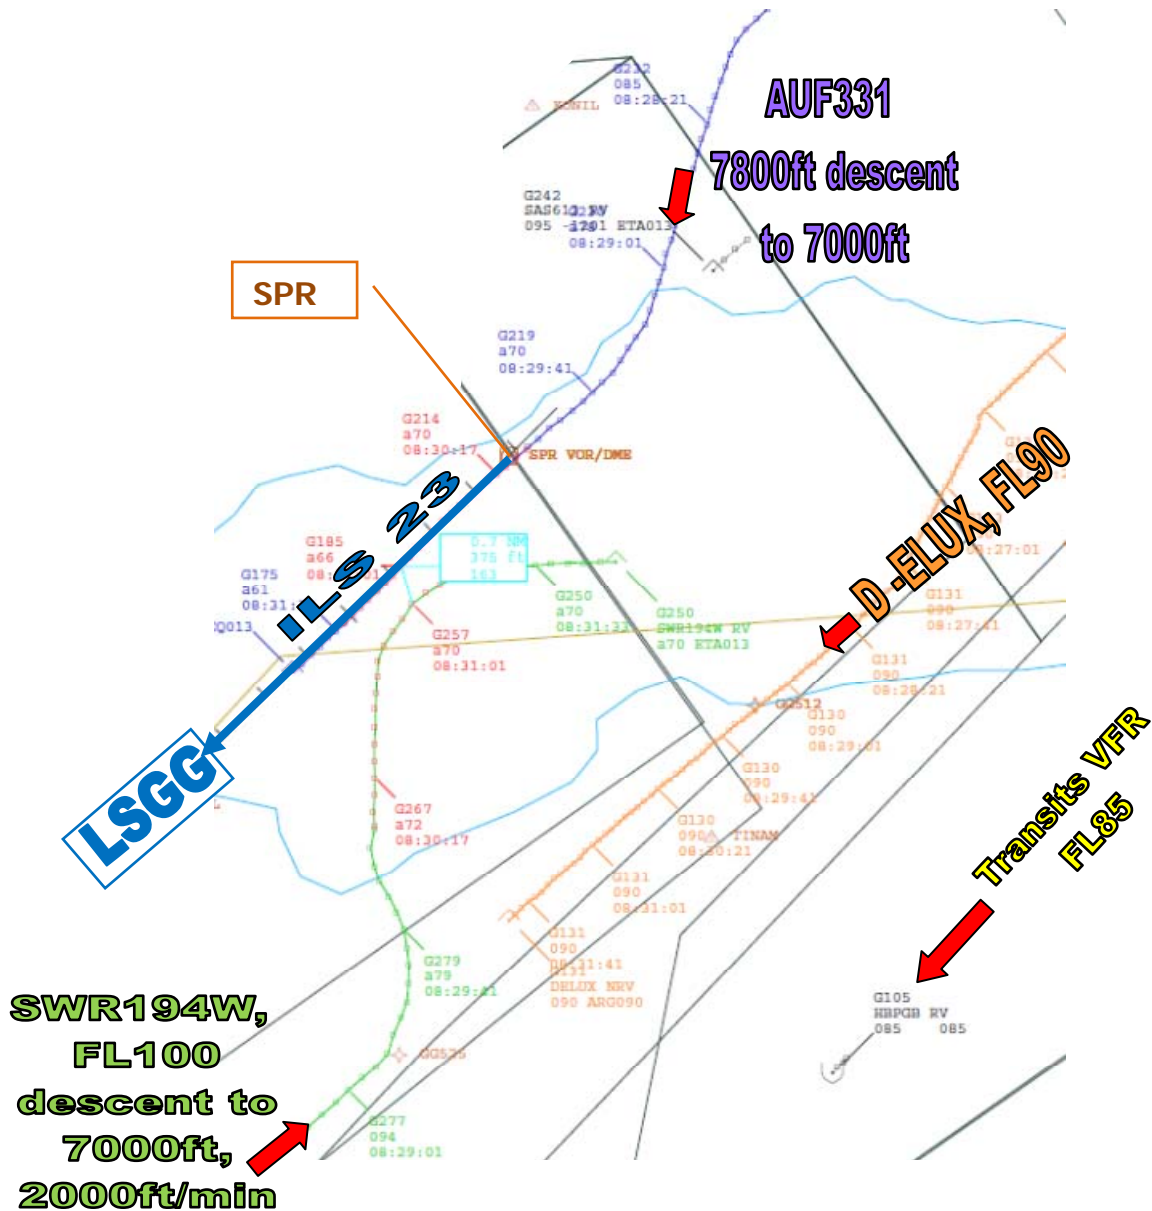
Figure 4: Positions of the aircraft

The radar situation at 08:28:51 UTC is reproduced in the image below.

At 08:28:57 UTC, judging the safety margin to be inadequate for the impending crossing, the instructor took over control from the adjacent FIN position and instructed SWR 194W to turn left onto heading 320° in order to distance it from D-ELUX.

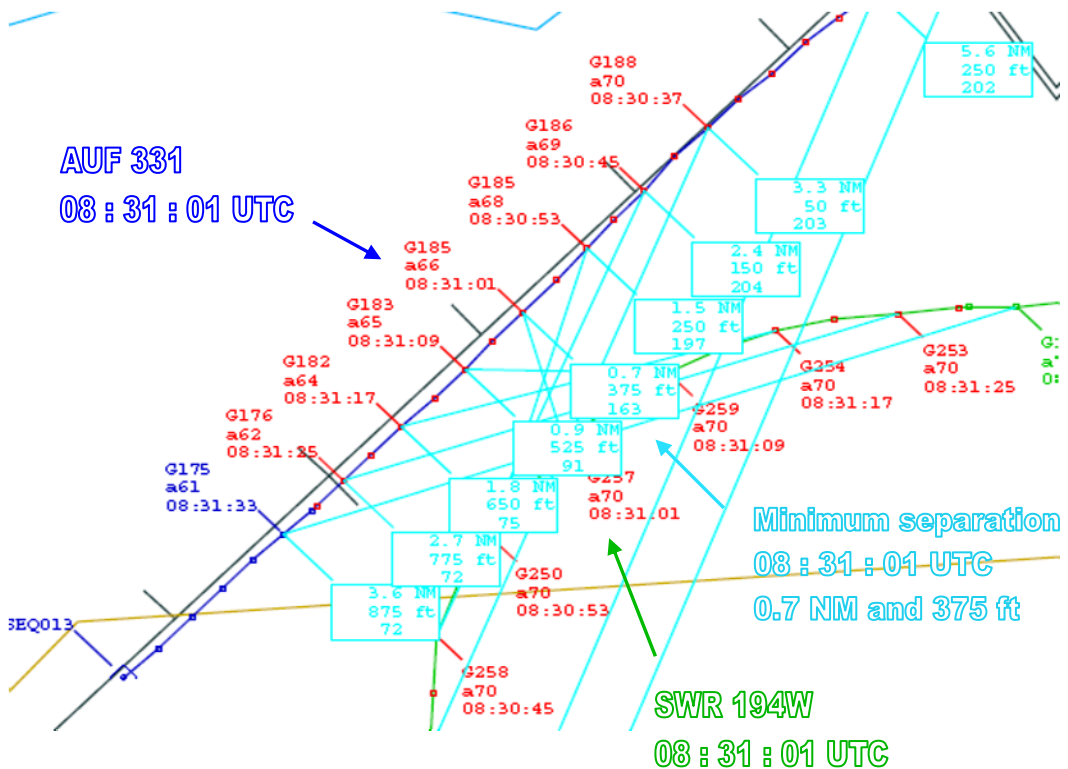
Fig. 5 Details of the dangerous convergence

A 08:31:01 UTC, the distance between the two aircraft was minimal. The trajectories never crossed. The dangerous convergence took place above Lake Geneva, 2.5 NM to the south-west of the SPR VOR. The radar recordings indicate a lateral separation of 0.7 NM and an altitude difference of 375 ft.
