Final Report No. 2185 of the Swiss Accident Investigation Board SAIB

concerning the serious incident
(AIRPROX)

involving the Cessna Citation C550B
aircraft, registration CS-DHI, callsign NJE
262Q

on 30 August 2011 in the Sion CTR, in the
immediate vicinity of the airport

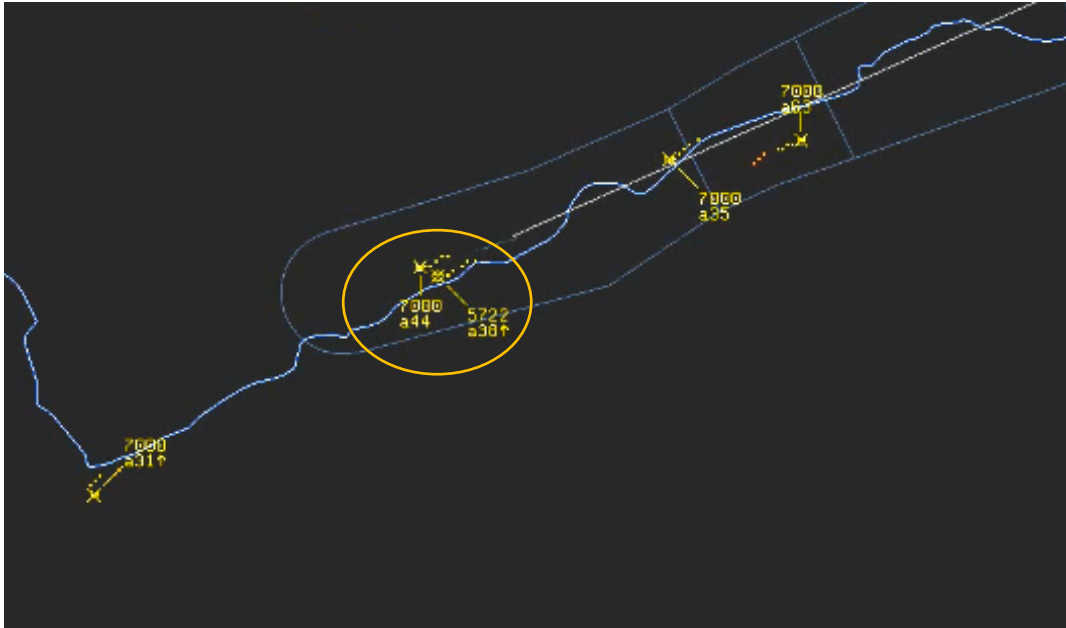
Figure 5: Image from the backup R2D2 Sion, radar data for 30 August 2011

The investigation did not reveal any technical defect which might have played a part in the incident. The quality of the radar image repeater available to Sion TWR does not make it possible to accurately monitor the movement of traffic in the immediate vicinity of the airport.
