Final Report no. 2189 by the Swiss Accident Investigation Board SAIB

concerning the serious incident – Airprox

involving the Saab 2000 aircraft,
under radio call sign DWT 9401

and the Cessna Citation C510 aircraft,
under radio call sign MXY 451

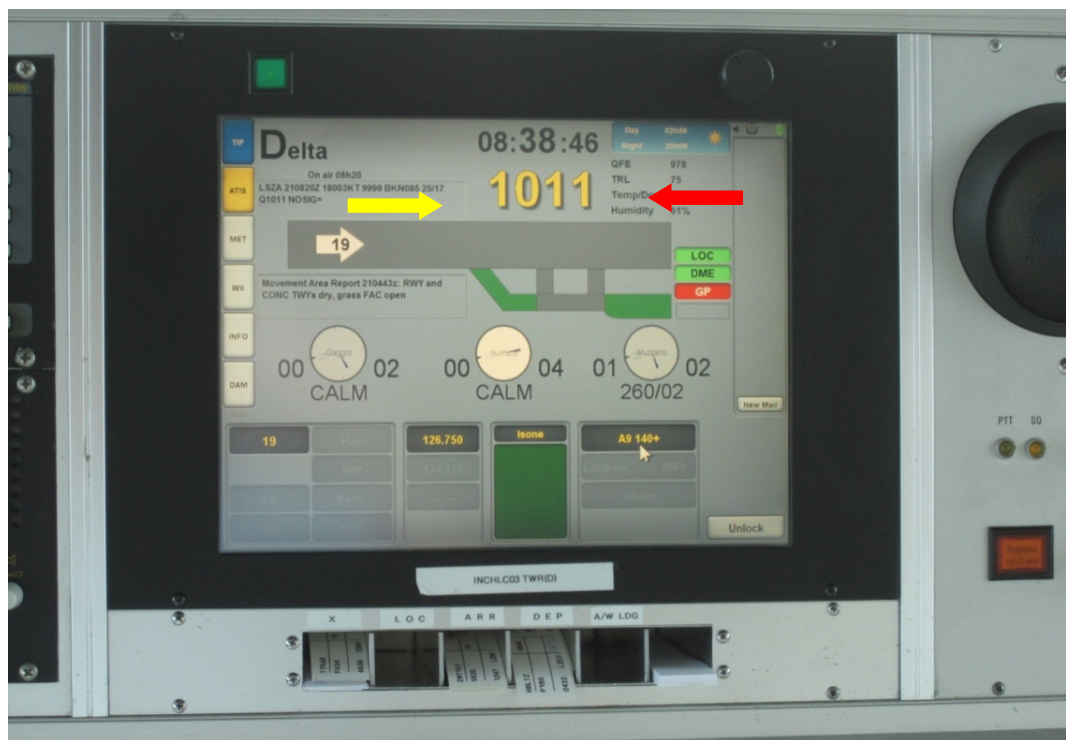
The transition level (TL) is determined on the basis of the current barometric pressure (QNH). In Lugano, it is FL 70 or less for a QNH of 1013.25 hPa or more, and FL 75 or higher for a QNH of less than 1013.25 hPa. The QNH and TL are displayed on an information screen at the ATCO workstation in the control tower (see Figure 1) and broadcast on the frequency of the airport terminal information system (ATIS). At the time of the serious incident, the QNH in Lugano was 995 hPa; the TL was therefore FL 75.

Figure 1: Depiction of the QNH (yellow arrow) and transition level (TL) (red arrow) on the information system at the ADC workstation. This photograph was not taken on the day of the serious incident and is purely for purposes of illustration.

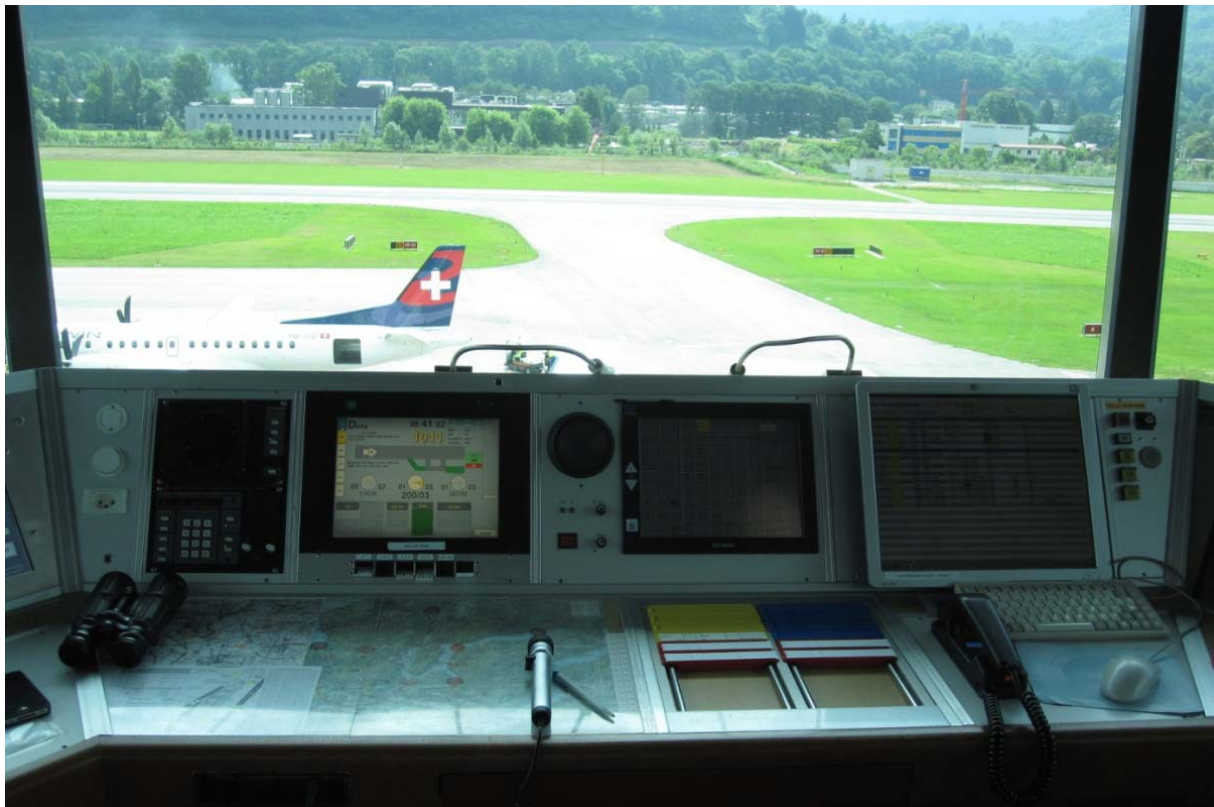
Annex 3: ADC workstation in the Lugano control tower

Like other comparable regional airports in Switzerland, the Lugano control tower has a radar display. It is configured as a distance from touchdown indicator (DFTI) and installed on the ground (GRO) workstation, approximately two metres away from the ADC workstation (see Annexes 3 and 4).

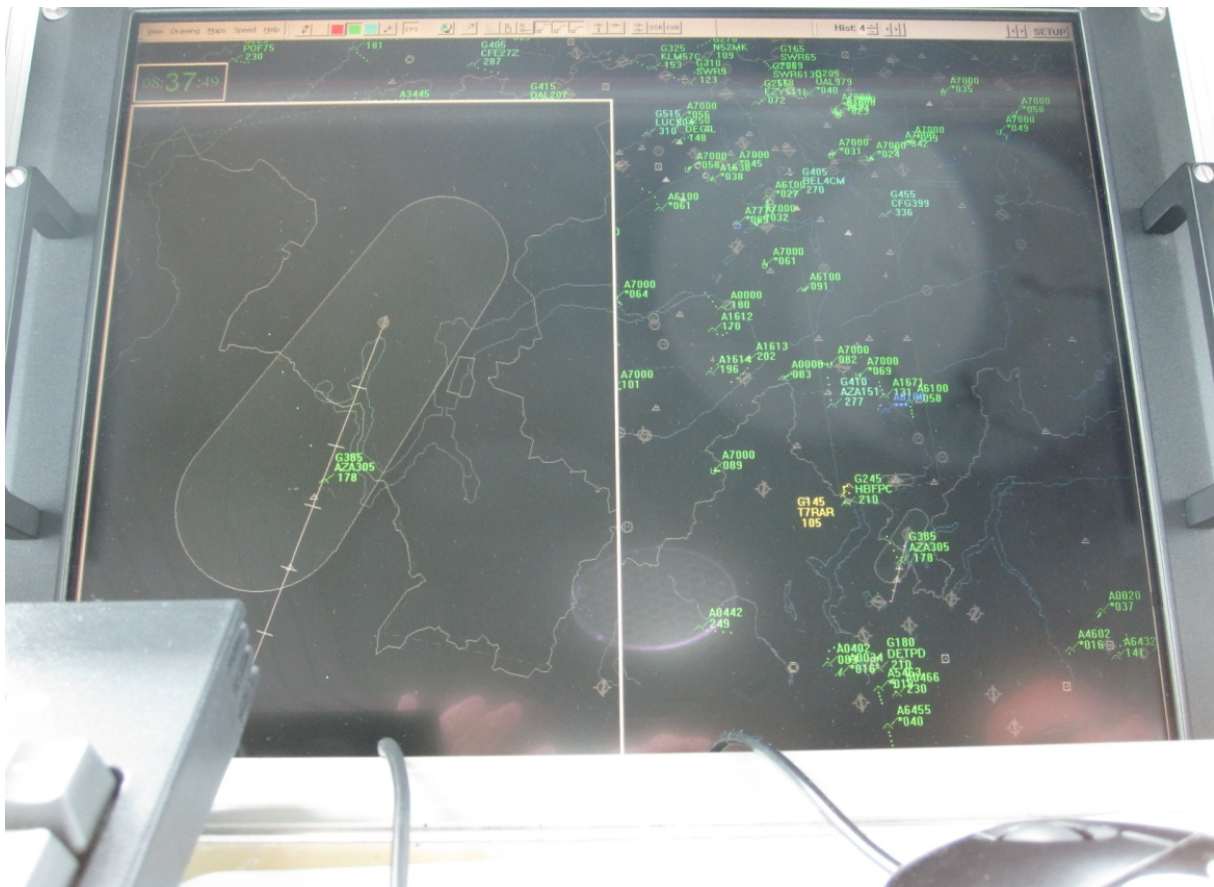
Annex 4: DFTI radar display

The radar indicator (distance from touchdown indicator – DFTI) in the Lugano control tower indicated DWT 9401 at 5700 ft and MXY 451 at 6200 ft respectively at the time of the serious incident. These indicated altitudes were based on the Zurich airport QNH of 984 hPa.

Even though the DFTI is not intended for the purpose of separation, it is amongst others intended as an aid in emergency situations. Especially in cases of emergency, time-critical stress situations may arise which might be further exacerbated by incorrect altitude information. For this reason, this configuration defect in the system constitutes a considerable risk from an aviation safety perspective.

After the crew of DWT 9401 had reported a resolution advisory (RA) from their TCAS, the ATCO noted that the DFTI radar display was indicating an altitude of 6200 ft for aircraft MXY 451. He then emphatically instructed the crew of MXY 451 to maintain flight level 70; this was confirmed by the crew. At this time the ATCO did not realise that the altitude of 6200 feet displayed for MXY 451 corresponded to the atmospheric pressure in Zurich, not that in Lugano, and that MXY 451 was therefore flying at approximately 6500 ft QNH, corresponding to flight level 70 at the prevailing atmospheric pressure. Although the radar display was not intended for comparisons of altitudes or to establish separation, the air traffic
