Final Report No. 2199 by the Swiss Accident Investigation Board SAIB

concerning the serious incident involving
the AVRO 146-RJ100 aircraft, registration
HB-IXW

on 2 July 2012

24 NM south-east of omni-directional radio
beacon Rolampont (RLP), France

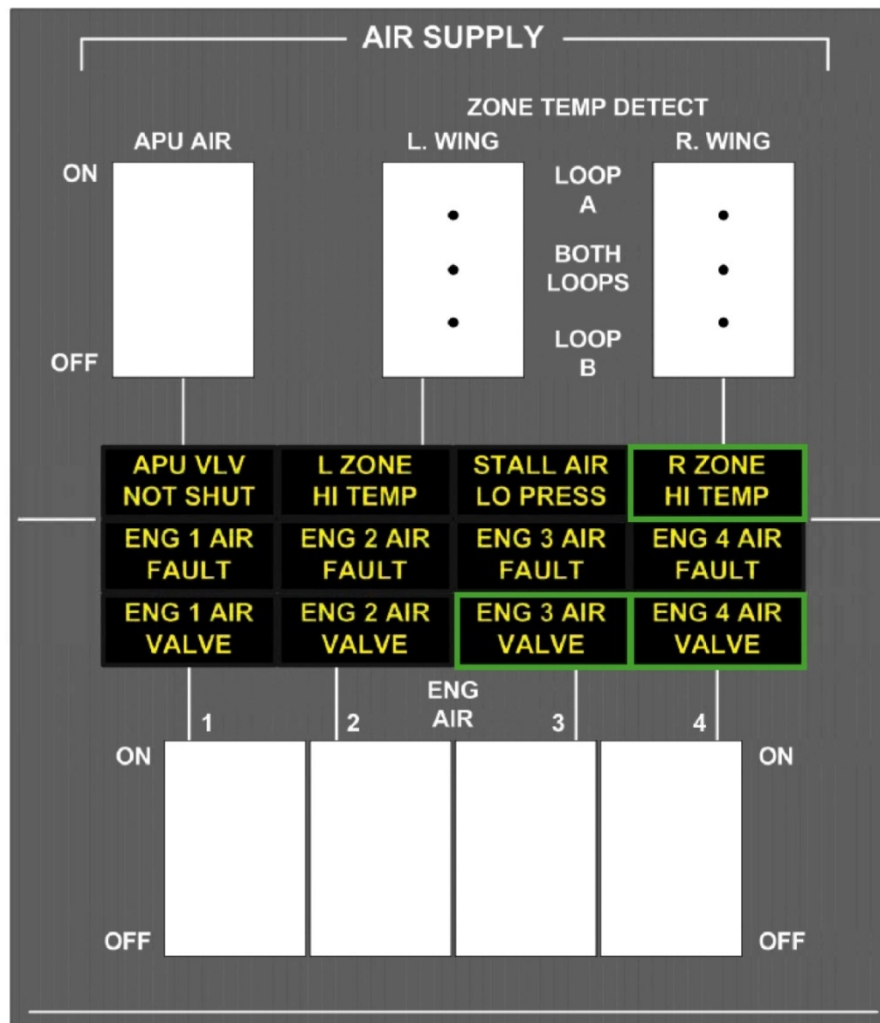
Annex 7: Air Supply Panel – Relevant warning annunciators

A leak in the right air supply, more specifically at the transition from the engine 4 pylon to the wing (cf. Annex 10) triggered the **R ZONE HI TEMP** warning annunciator. As a result, the following valves were automatically closed and the corresponding warning annunciators illuminated:

- **ENG 3 AIR VALVE** (cf. Annex 7 and 8)
- **ENG 4 AIR VALVE** (cf. Annex 7 and 8)
- **R INNER VALVE** (cf. Chapter 1.6.2.5)
- **R OUTER VALVE** (cf. Chapter 1.6.2.5)
- **TAIL VALVE 2** (cf. Chapter 1.6.2.5)
- **PACK 2 VALVE** (cf. Chapter 1.6.2.2)

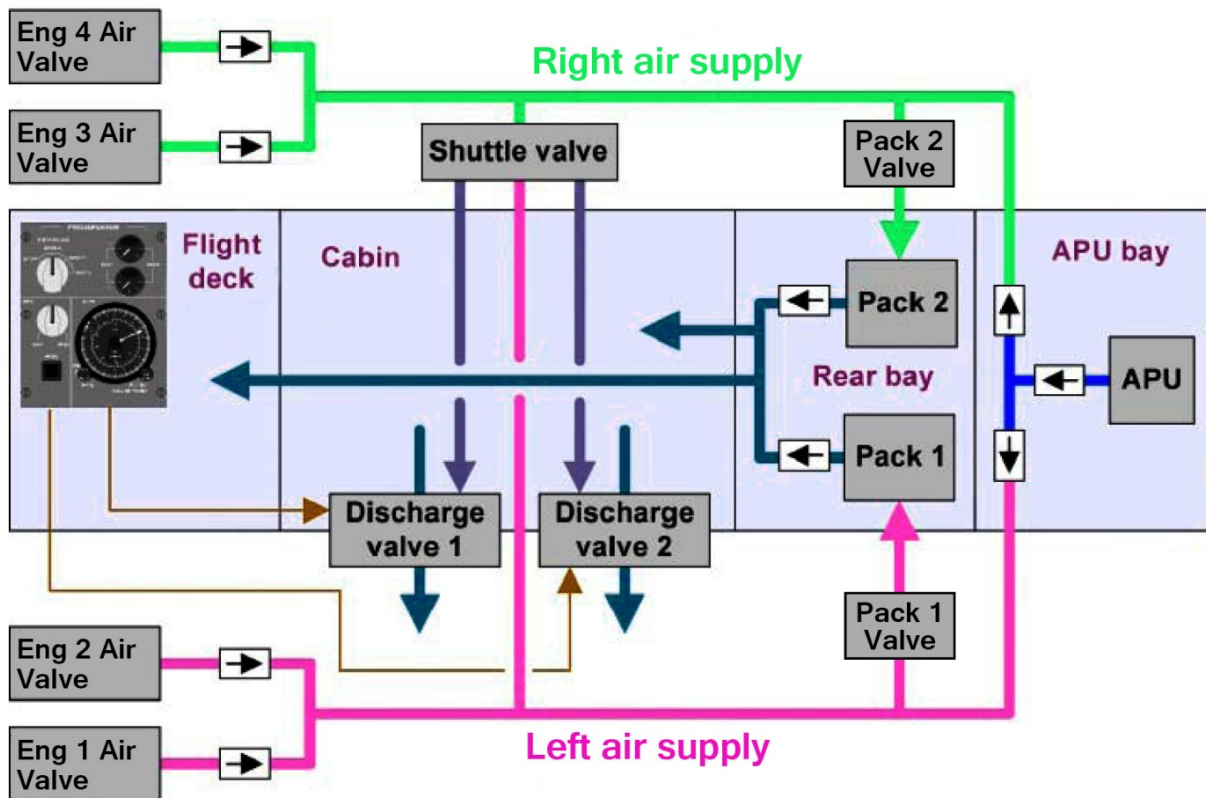
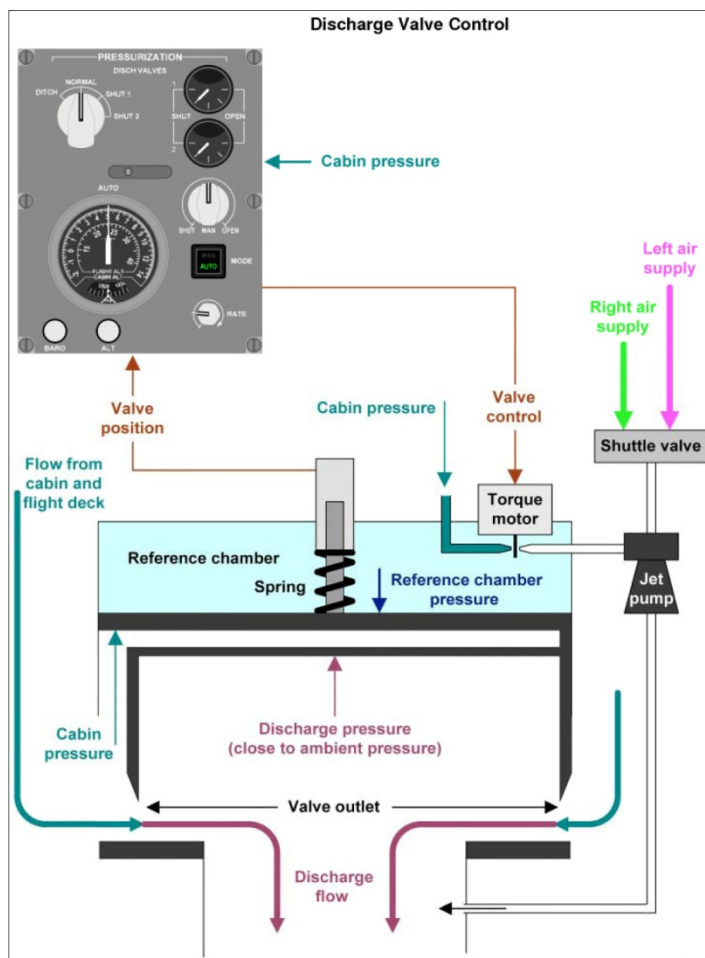
Annex 8: Schematic of the cabin pressurization system

At 10:08:22 UTC, during the climb to FL 244 (7437 m), as a result of a leak in the right air supply system various valves were closed (cf. Chapter 1.6.2.4). Consequently, the bleed air supply to air conditioning pack 2 was cut off. Since a cross-feed from the left air supply system is not possible and also since airconditioning pack 1 was inoperative, the entire air conditioning system failed.

The pack 1 valve was closed from take-off and therefore pack 1 was not available for flight LX 456.

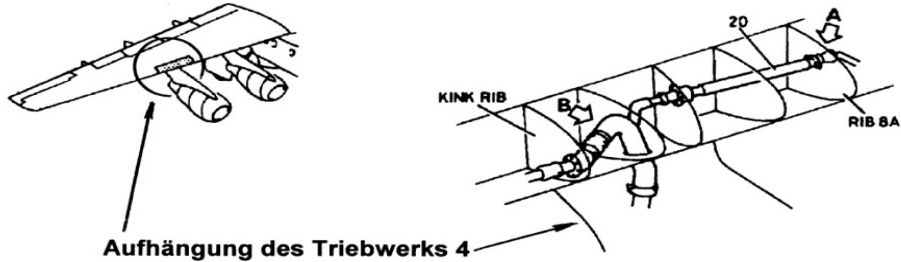
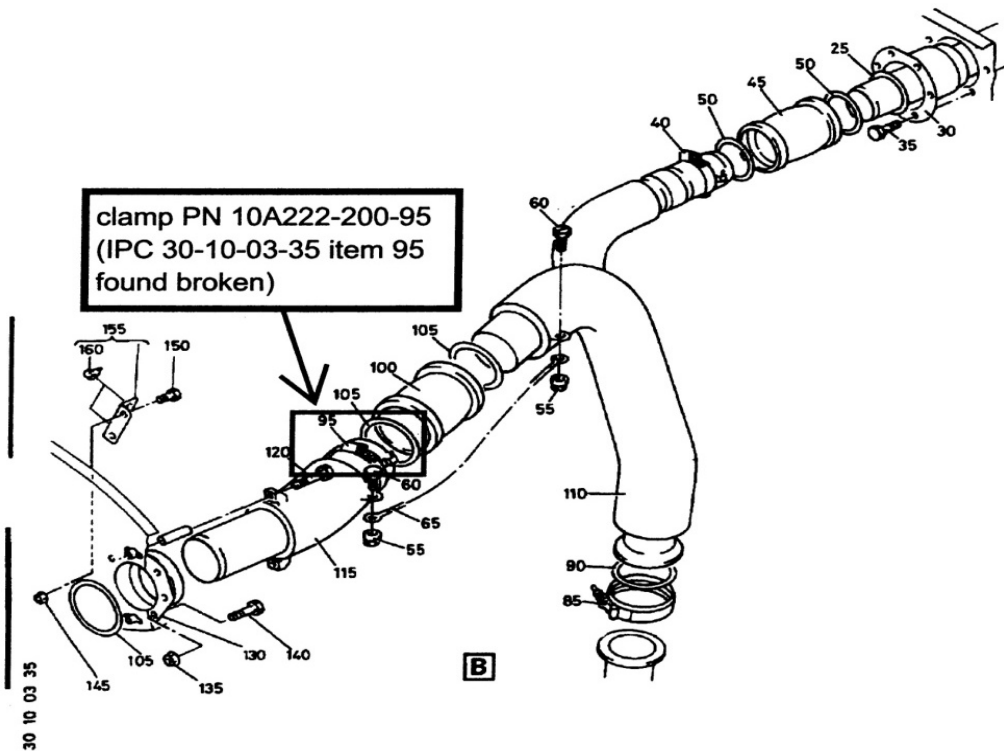
Annex 10: Leaking bleed air duct in the vicinity of engine no. 4

In the present case a leak occurred in the right air supply, more specifically at the transition from the engine 4 pylon to the wing (cf. Annex 10).

In the present case a leak occurred in the right aircraft zone, more specifically at the transition from the engine 4 pylon to the wing.

The broken clamp P/N 10A222-200-95 was replaced and a duct leak check was carried out.

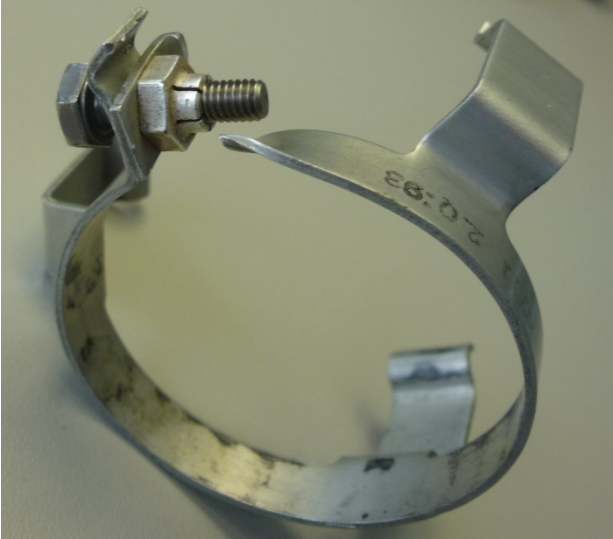
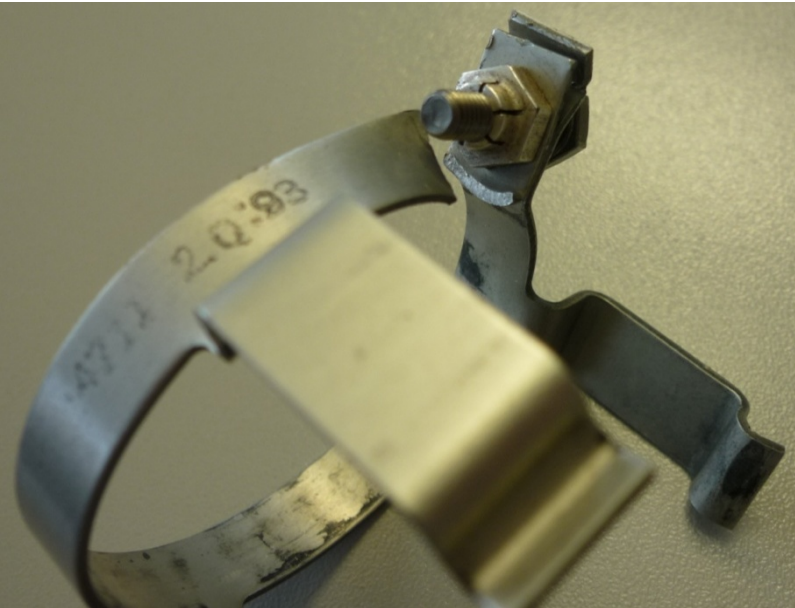
Annex 11: Broken clamp P/N 10A222-200-95

A broken clamp, part number P/N 10A222-200-95, was responsible for the leak (cf. Annexes 10 and 11).

Since a virtually identical failure occurred on 2 July 2012 to the bleed air system, it cannot be ruled out that over torquing of a fastener occurred during these works. This might have caused failure of the de-icing duct clamp.
