Final Report No. 2200 of the Swiss Accident Investigation Board SAIB

concerning the serious incident (AIRPROX)
involving a PA 34 – 200T aircraft, HB-LMM
and a Beechcraft A23-24 aircraft, HB-ENV
on 22 February 2012
in the Sion TMA

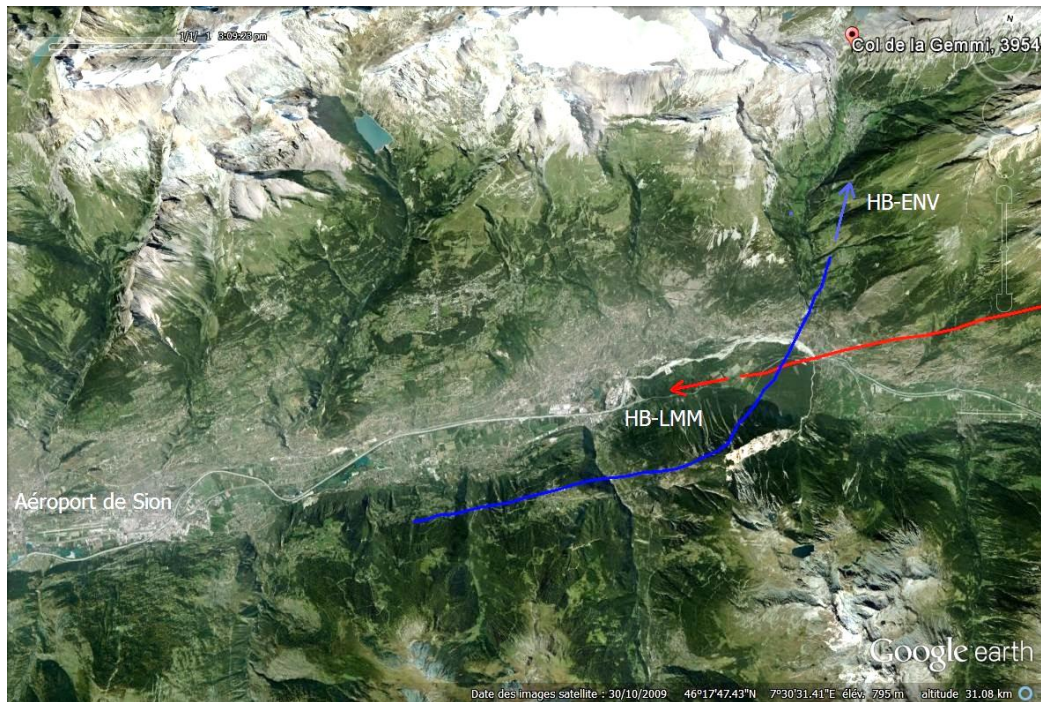
Figure 2: trajectories of HB-LMM and HB-ENV reconstituted on Google Earth

The radar data shows that the distances between HB-ENV and HB-LMM were at their minimum at 15:08:04 UTC; the aircraft passed each other with a horizontal separation of less than 0.2 NM and an altitude difference of 50 ft.

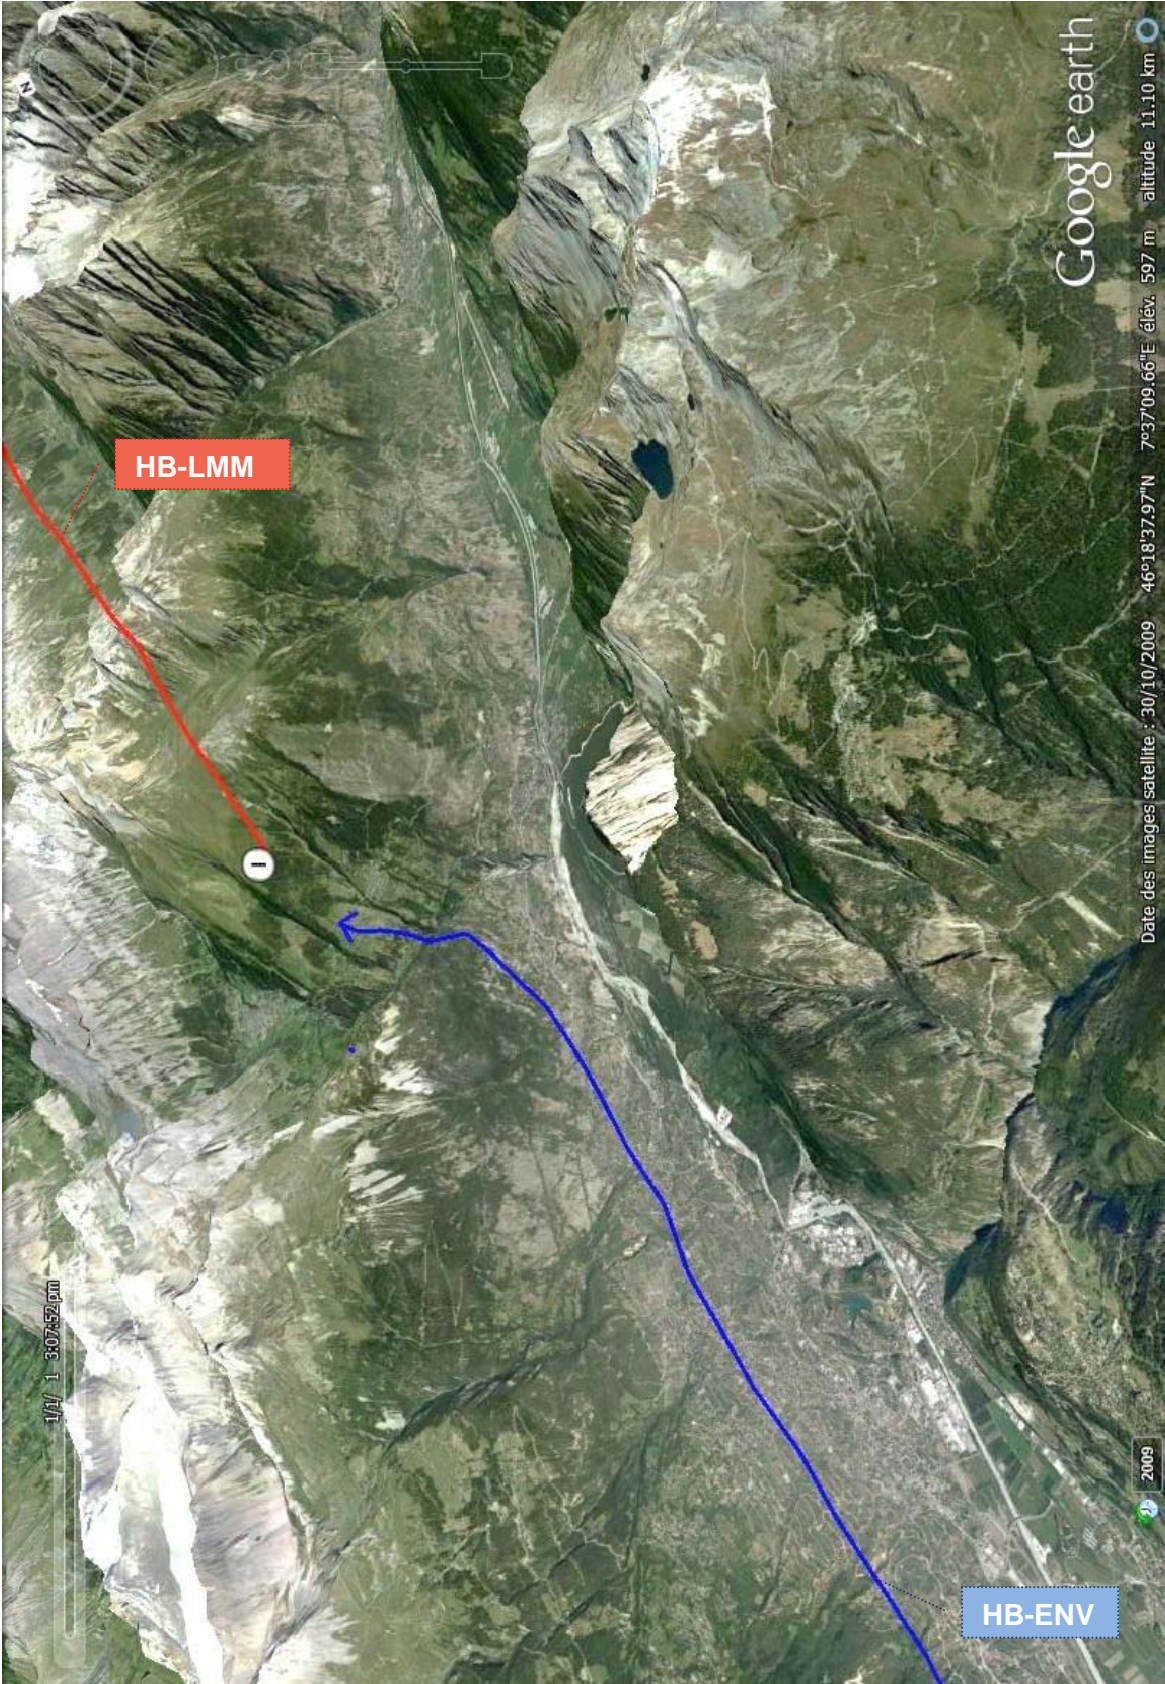
Annexe 2: Positions of the aircraft at the time of the traffic information to HB-LMM

I: time of the traffic information at 15:07:52 UTC
