Final Report No. 2202

Concerning the serious incident (near-collision)

involving the Dornier 328-100 aircraft,
operated by SkyWork Airlines AG
under flight number SRK 700

and the Robinson R44 II helicopter, HB-ZSA

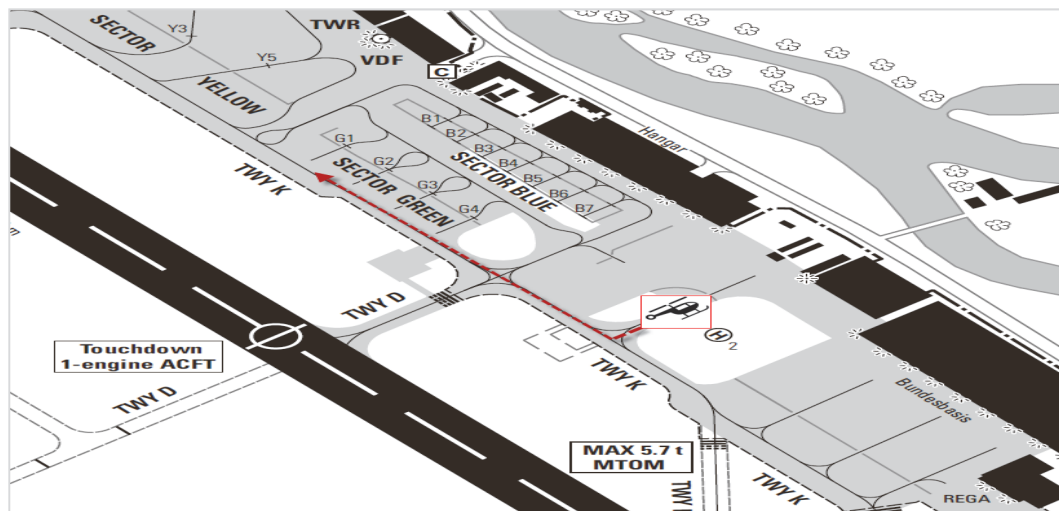
Figure 1: Take-off location (helipad 1) and approximate flight path of HB-ZSA according to statements

flight rules (VFR) with two interim landings in Uetendorf and Schallenberg. The helicopter was parked on helipad 1 facing the hangar (cf. Figure 1).

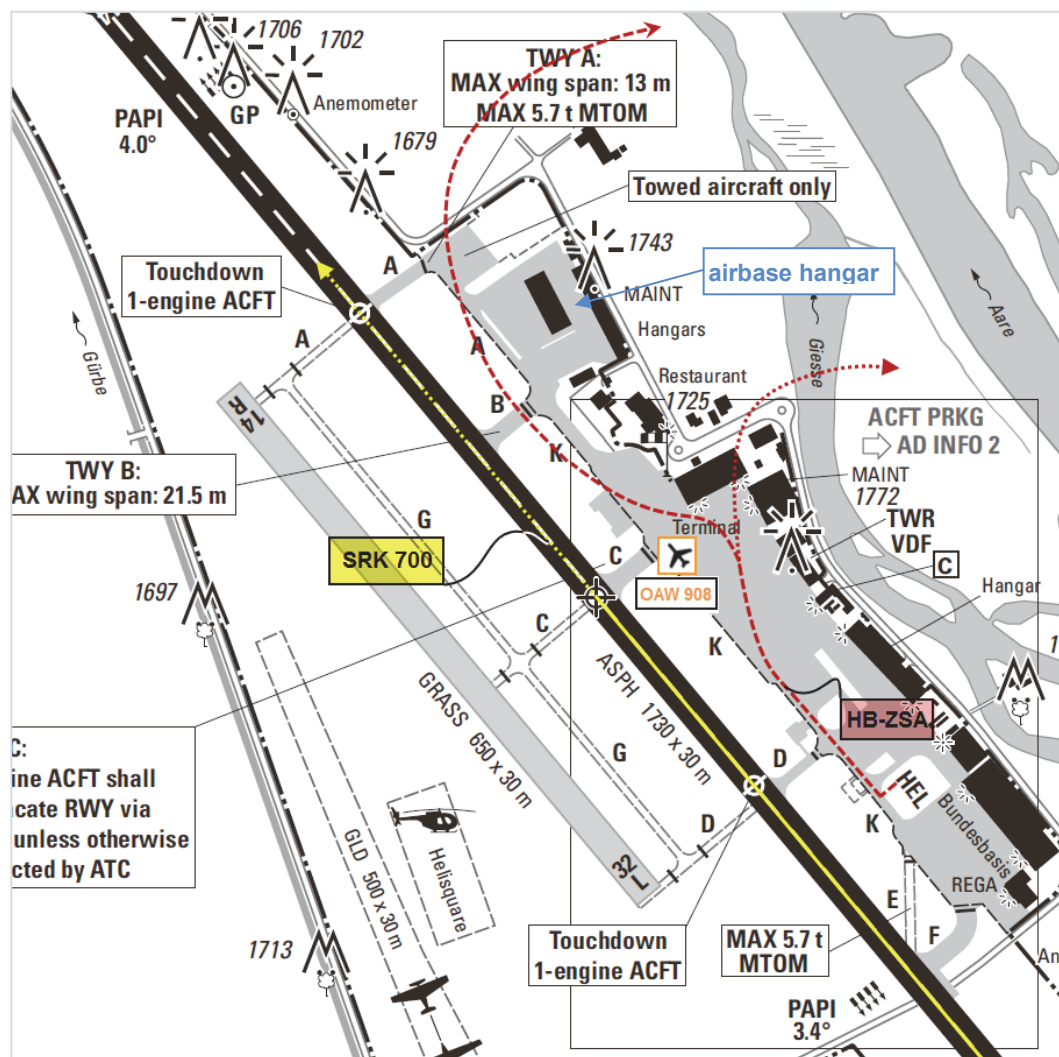
The pilot of the helicopter acknowledged the clearance at 10:22:22 UTC, and the ADC controller observed HB-ZSA lift off from helipad 1 and hover backwards towards TWY KILO, where it rotated left about its vertical axis and aligned itself parallel to the centre line of runway 32. HB-ZSA then accelerated near the ground along TWY KILO parallel to runway 32 in a north-westerly direction. In this acceleration phase, at an estimated speed of approximately 50 kt, the helicopter pilot decided to initiate a right turn around OAW 908 before the intersection of TWY CHARLIE to avoid passing over the waiting Fokker 100 (cf. Figure 2: dashed line).

The aerodrome controller also observed how the helicopter turned right and according to his statement expected a continuation of the right turn around the tower towards departure point HOTEL (cf. Figure 2: dotted line), as he himself later stated. Then he looked to the left towards the DO328, losing the helicopter from his field of vision, and cleared the crew of SRK 700 at 10:23:26 UTC to take off as follows: *"Skyfox seven hundred, wind three four zero degrees three knots, runway three two cleared for take-off."*

Abeam of the Fokker 100 waiting on TWY KILO near the CHARLIE intersection, HB-ZSA turned left in the direction of TWY KILO (cf. Figure 2: dashed line) on a trajectory converging on the centre line of runway 32.

Figure 2: Approximate flight path of HB-ZSA (dashed, red) and SRK 700 (yellow); the red dotted representation of the flight path corresponds to the expectations of the ADC air traffic controller

The lateral distance between the two aircraft at the time of the closest point of approach at approximately the same altitude was determined with the help of estimates to be approximately 80 to 100 metres.
