Final Report No. 2203

concerning the serious incident (near collision)

involving the Saab 2000 aircraft, registration HB-IZG
operated by Darwin Airline SA
under flight number DWT 124

and the Sportcruiser aircraft, registration HB-WYC

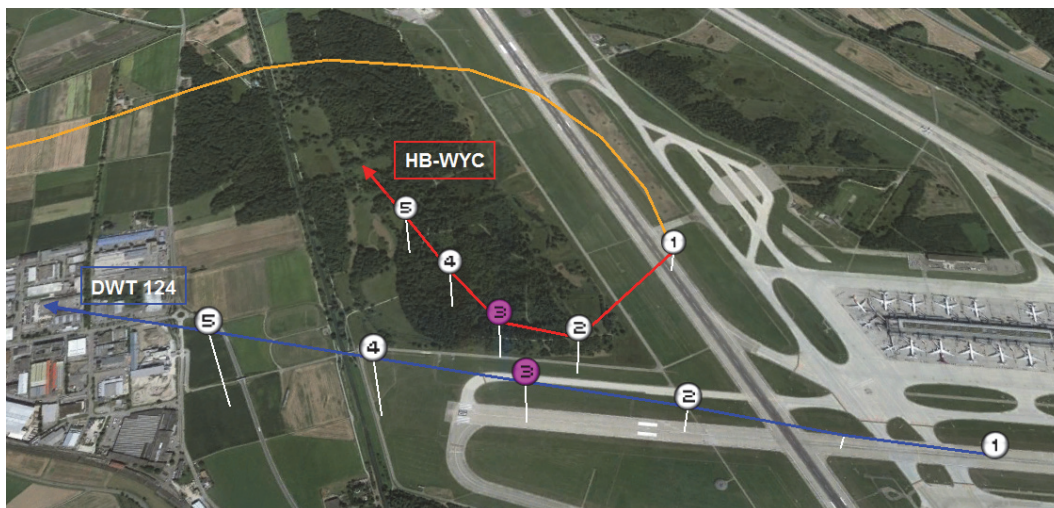
Figure 1: Flight paths of the two aircraft visualised in Google Earth using Mode-S data: Data point 3 corresponds to the time of the closest point of approach at 14:15:52 UTC.

In the meantime, the Saab 2000 had lifted off from runway 28 (see blue flight path in Figure 1) and maintained the direction of the runway 28 centreline. Shortly after take-off, at 14:15:37 UTC the on-board TCAS on DWT 124 generated a traffic advisory (TA) *"traffic, traffic"*, depicted on the commander's primary flight display (PFD). At the same time, the position of HB-WYC was depicted as a yellow icon on the copilot's TCAS screen. On the basis of this alert, both DWT 124 crew members were able to establish visual contact with HB-WYC, and the PF increased the rate of climb of the Saab 2000. The airspeed did not fall below the minimum airspeed for a safe initial climb (minimum take-off safety speed - V_2). After initiating the tight right-hand turn, the crew of HB-WYC lost visual contact with the Saab 2000 which was taking off. They subsequently stated that the tight right-hand turn was flown with flaps extended.

At the time of the closest point of approach of the two aircraft, at 14:15:52 UTC, HB-WYC was in a tight right turn just north of runway 28 at an altitude of 1835 ft QNH, whilst DWT 124 was just west of the 16/28 runway intersection, in a climb at an altitude of 1910 ft QNH. The two aircraft converged to a lateral distance of 205 m and an altitude difference of 75 ft.

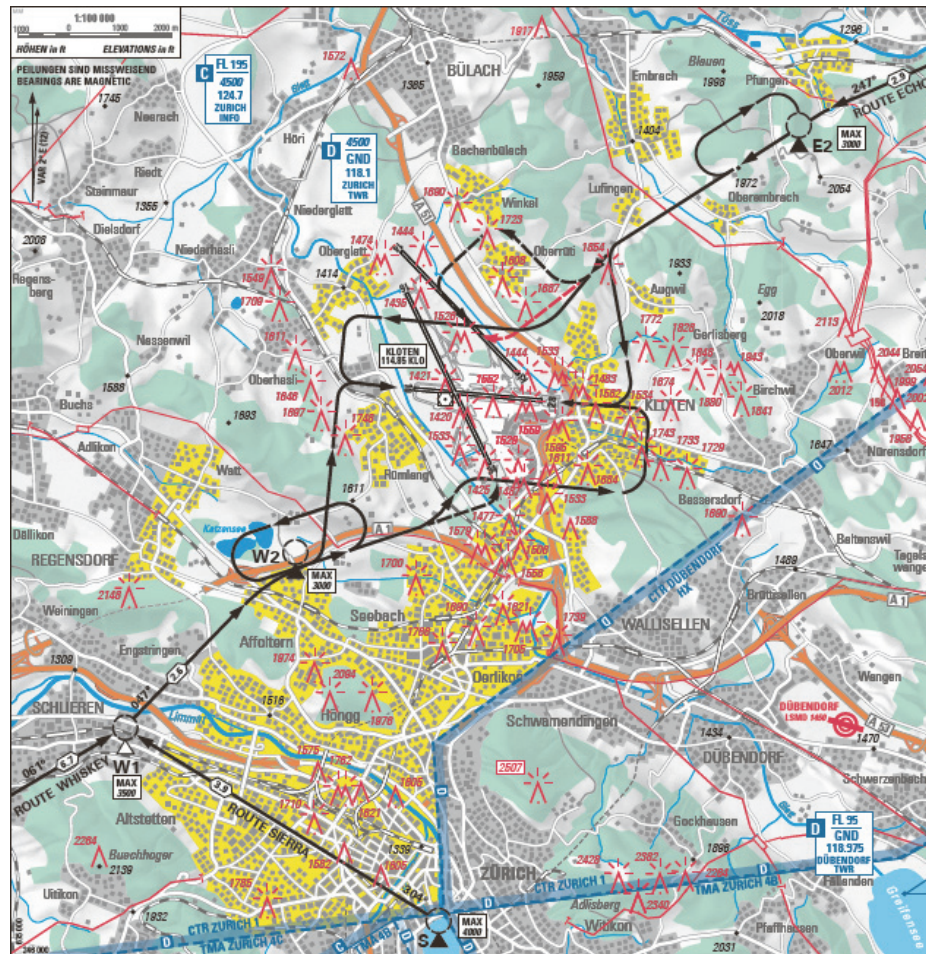
The following visual approaches were published for Zurich airport in the aeronautical manual (VFR Manual) for Switzerland: runways 10, 14, 28, 32 and 34. A visual approach procedure on runway 16 was not published.

Figure 3: Visual approach chart (VAC) with specified flight paths on runways 10, 14, 28, 32 and 34.

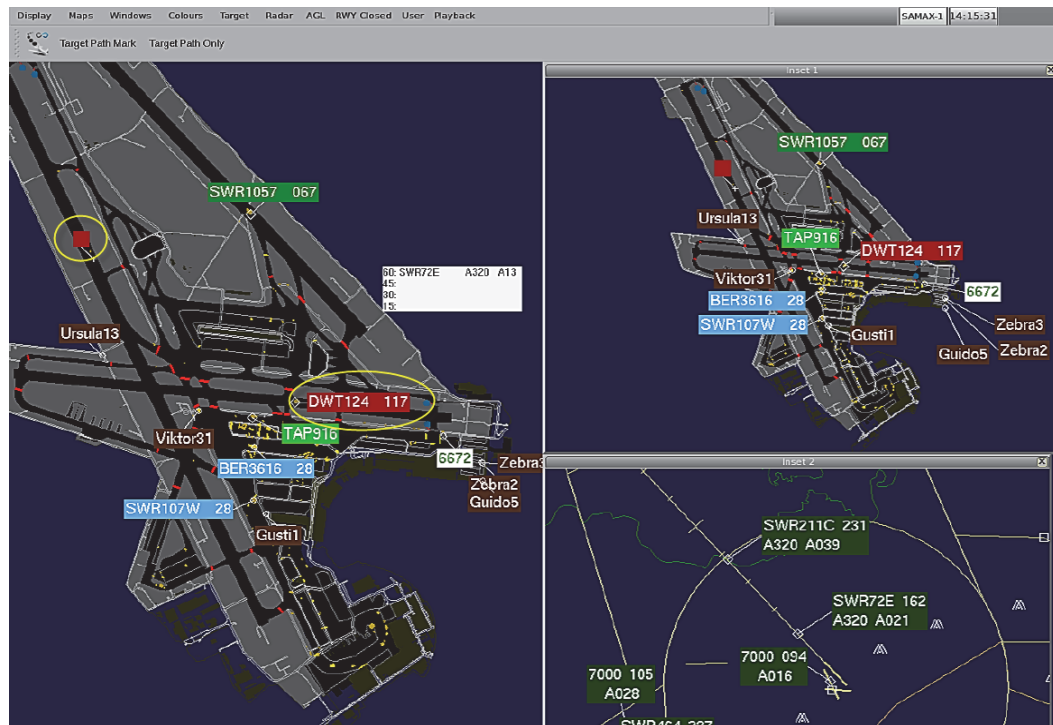
Figure 4: SAMAX image 14:15:31 UTC with the two aircraft circled in yellow, at the moment the RIMCAS alarm was triggered

In the serious incident under investigation, the ground radar detected HB-WYC in a position approximately 1000 m before the intersection of runways 16 and 28. At this point, DWT 124 was also approximately 1000 m from the 16/28 intersection, on its take-off roll. Some four seconds later, at 14:15:31 UTC, the RIMCAS system generated a stage 2 alert; the tags of the two aircraft on the screen changed to red and an aural alarm ("*RIMCAS*") was triggered.

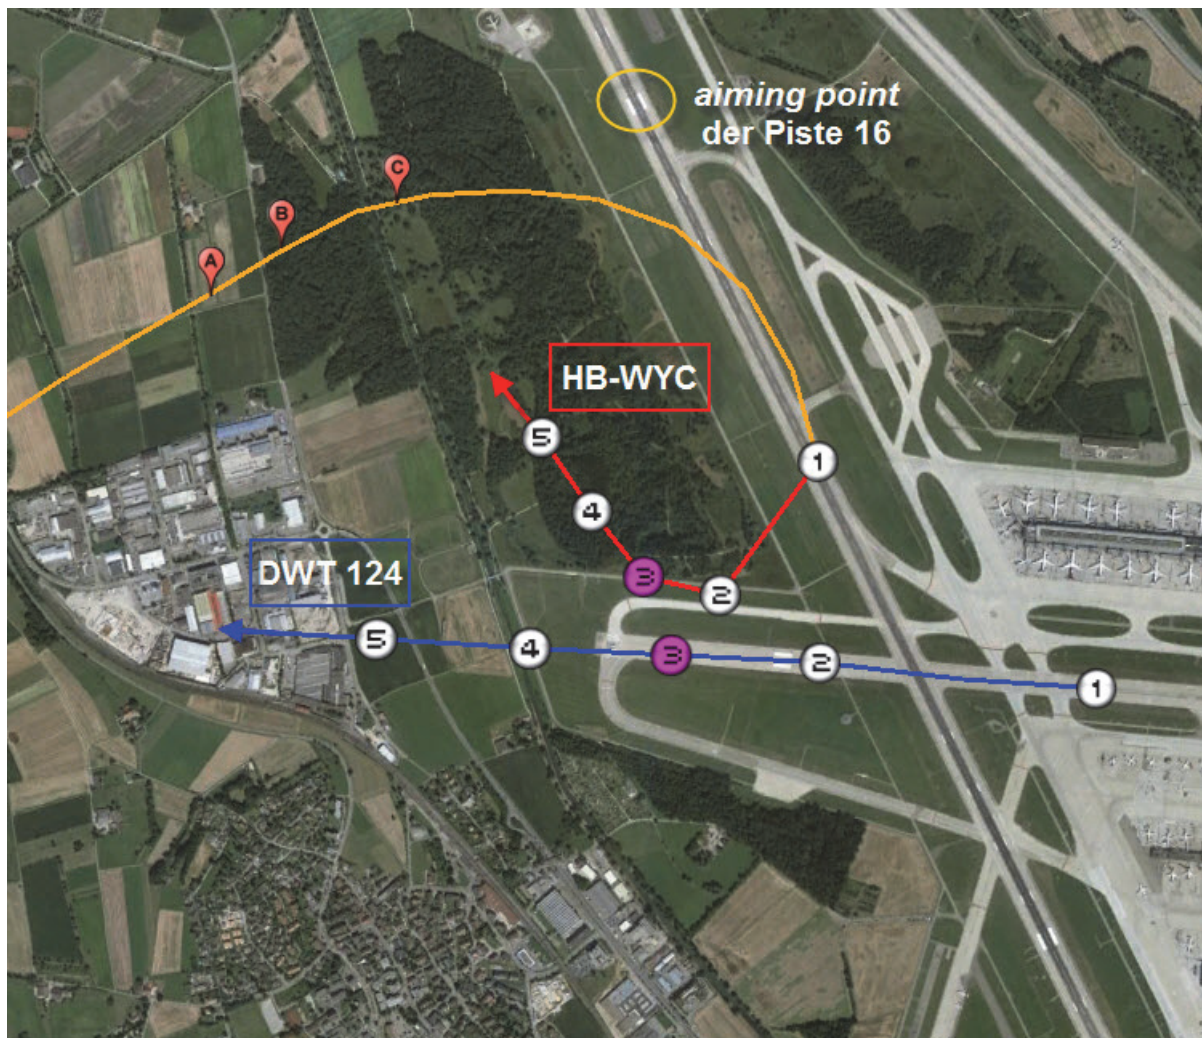
Annex 1: Recording of the two flight paths using Mode-S data

- Blue line** Flight path of the Saab 2000 (DWT 124).
- Orange line** Flight path of HB-WYC before take-off of the Saab 2000 from runway 28.
- Red line** Flight path of HB-WYC after take-off of the Saab 2000 from runway 28.
- 1 – 5 Positions of the two aircraft at the same time from 14:15:37 UTC to 14:16:02 UTC.
- 3 Position of the two aircraft at the time of the closest point of approach (14:15:52 UTC)
- A HB-WYC: "Right-hand base, runway one six, Hotel Yankee Charlie."
- B ADC: "Darwin one two four, wind three three zero degrees, seven knots, runway two eight, cleared for take off."
- C ADC: "Hotel Yankee Charlie, after touch and go then, join a left-hand downwind for runway two eight."
