# **Final Report No. 2208** **by the Swiss Accident** **Investigation Board SAIB**

concerning the serious incident (near collision)

involving the Airbus A340-313 aircraft, registration HB-JMN, under flight plan call sign SWR 39

and the ASW 20 glider, registration HB-1519

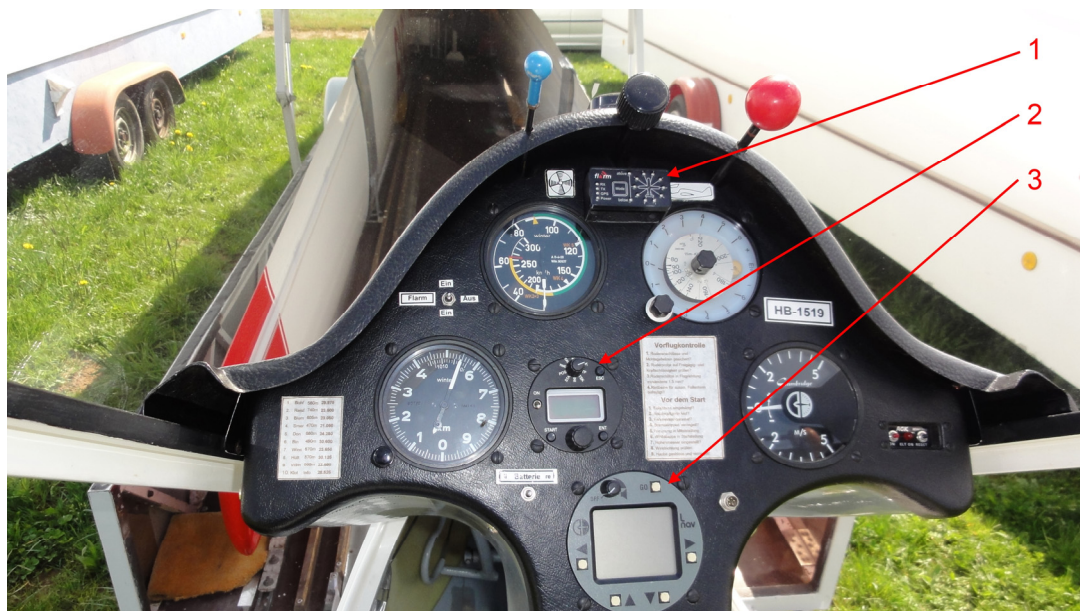
**Figure 1:** HB-1519 instrument panel with:  
① FLARM collision warning system  
② L-NAV navigation computer  
③ GPS navigation system

The glider was equipped, among other things, with a FLARM collision warning system (Hardware Version 6, Firmware Version 4.07), an L-NAV navigation computer (Version 5.8) and an LX 400 GPS navigation system (Version 4.0). There was no transponder fitted.

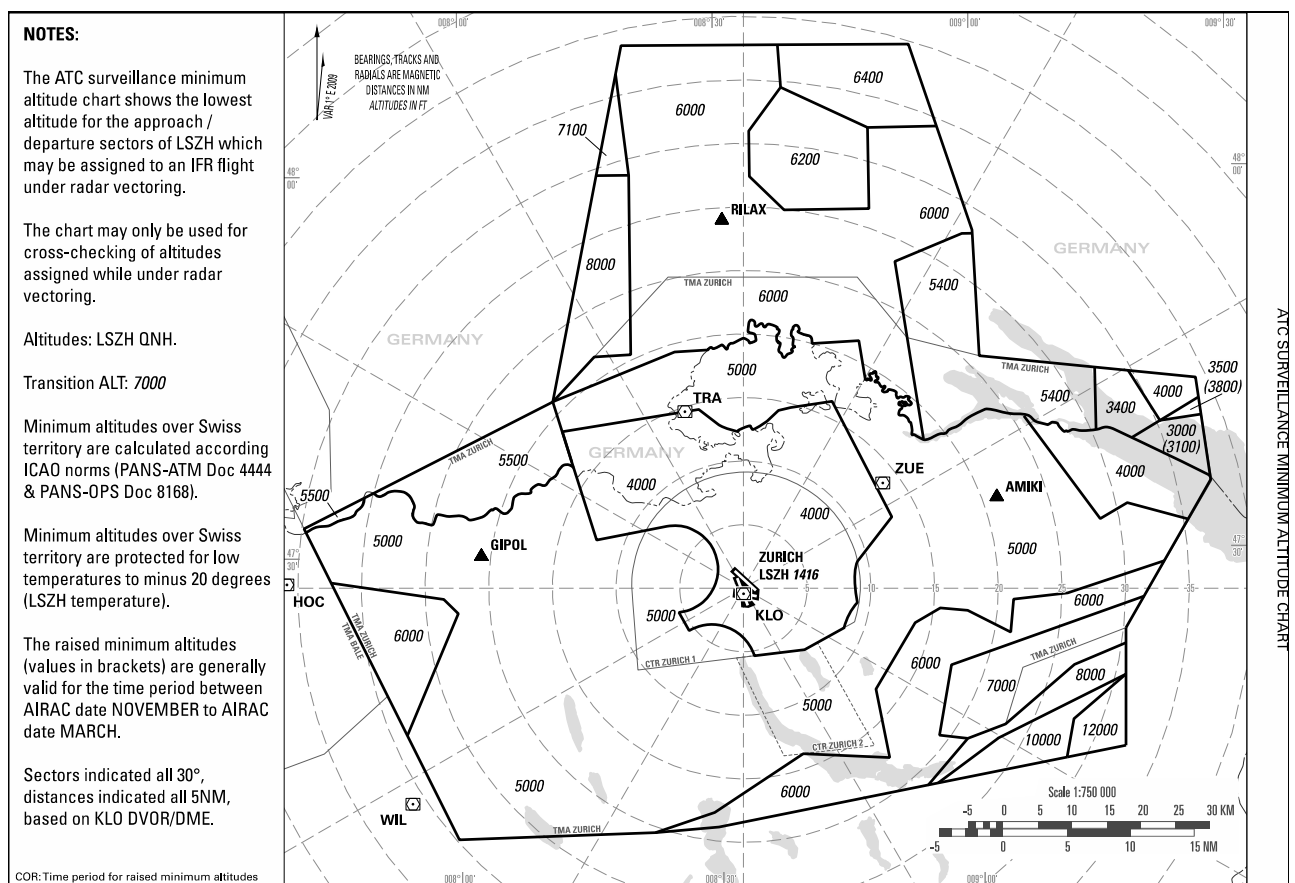
Figure 4: ATC surveillance minimum altitude chart

As TMA LSZH 2 has a lower limit of 4500 ft AMSL (i.e. over 3000 ft AMSL), IFR flights, which are normally only given altitude clearance in thousands of feet, can receive clearance from ATCOs to 5000 ft in TMA LSZH 2, which results in a minimum separation of 500 ft.

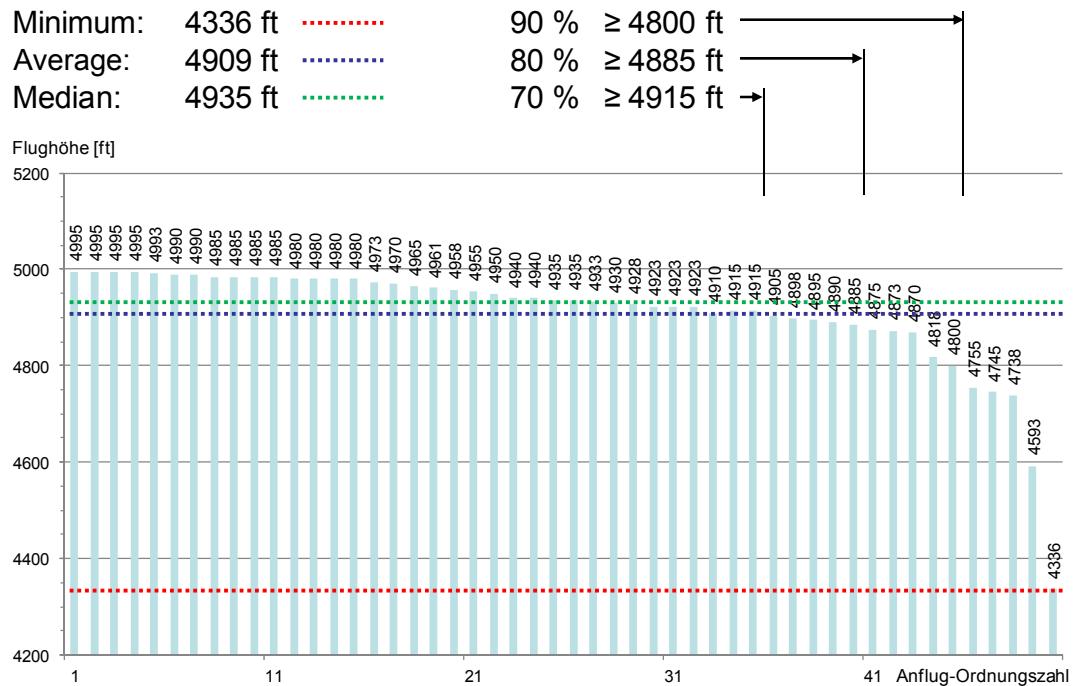
For the 47 approaches which first reached 5000 ft QNH within TMA LSZH 2, the altitude when passing over the boundary between TMA LSZH 1 and TMA LSZH 2 was calculated.

**Figure 9:** Representation of the analysis of altitudes when passing the boundary between TMA LSZH 2 and TMA LSZH 1 for the 47 approaches which passed below 5000 ft QNH within TMA LSZH 2.

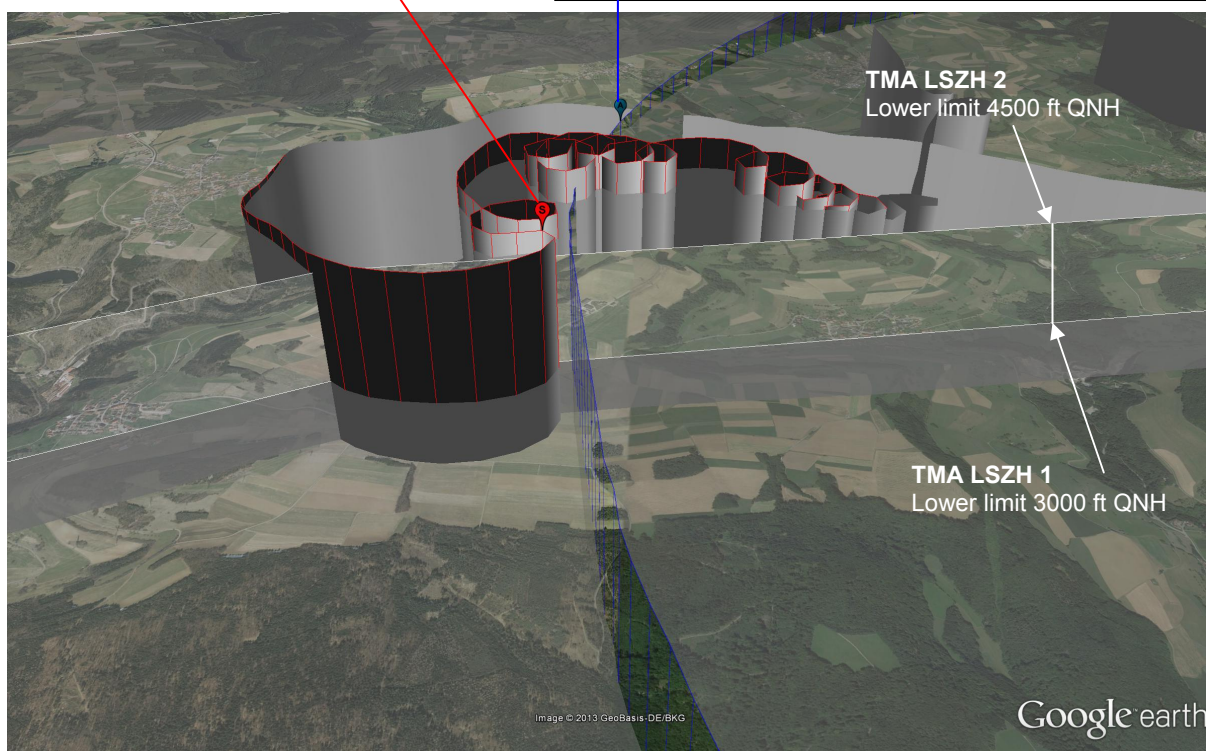
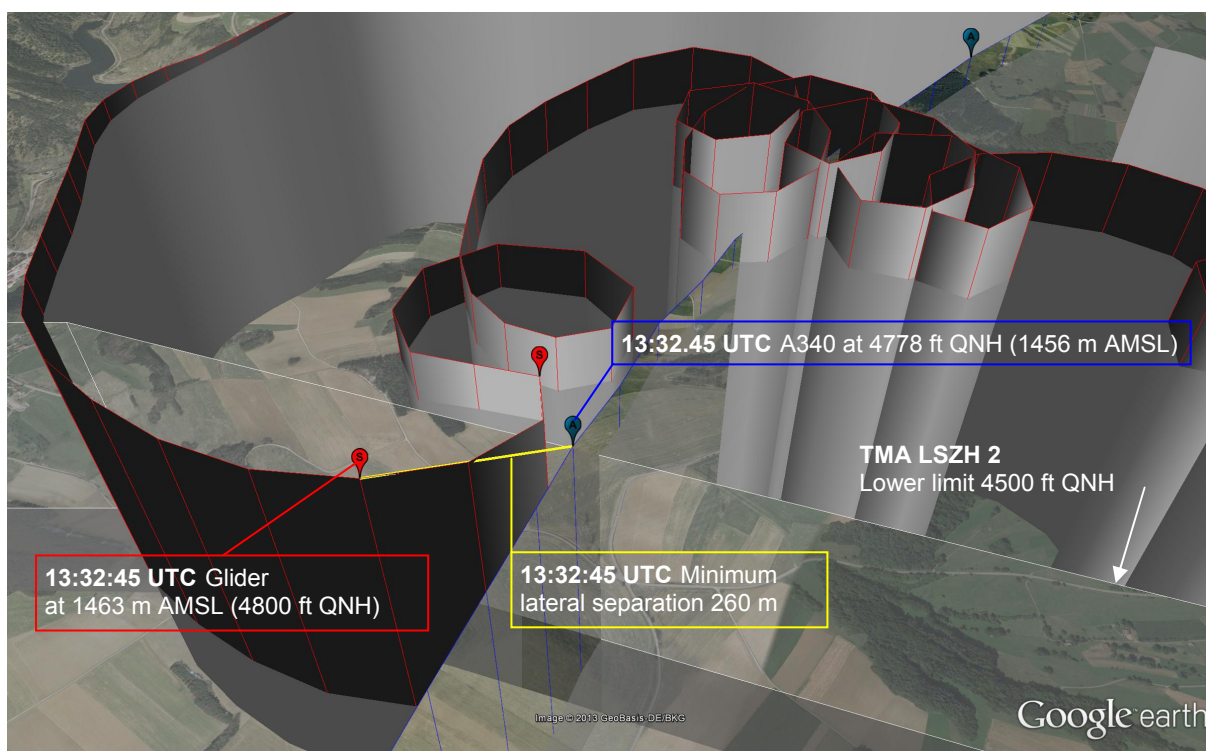
## Annex 4: Dangerous Convergence

13:32:32 UTC Glider pilot initiates avoidance manoeuvre

13:32:35 UTC Crew of A340 initiates avoidance manoeuvre

- Flight path of the HB-1519 glider
- Flight path of the A340-313, registration HB-JMN
- Violation of TMA lower limit

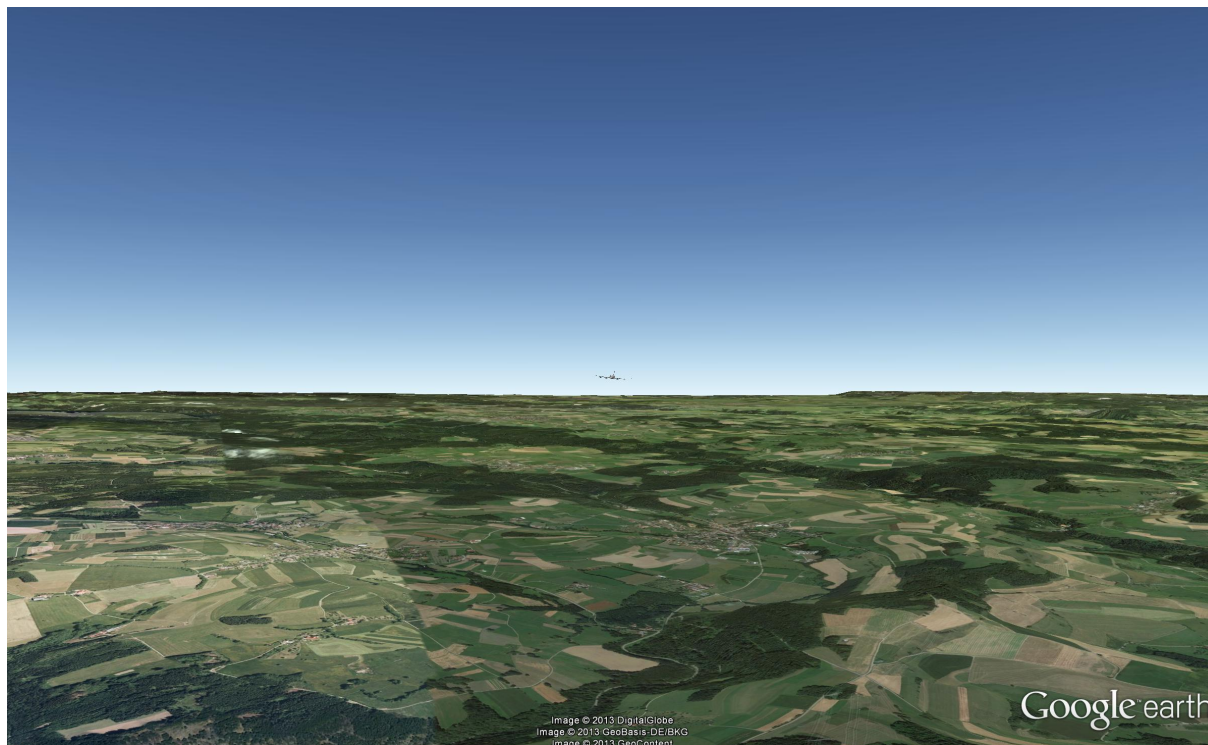
**Figure 10:** Probable view of the Airbus A340-313 from the position of the glider at 13:32:32 UTC

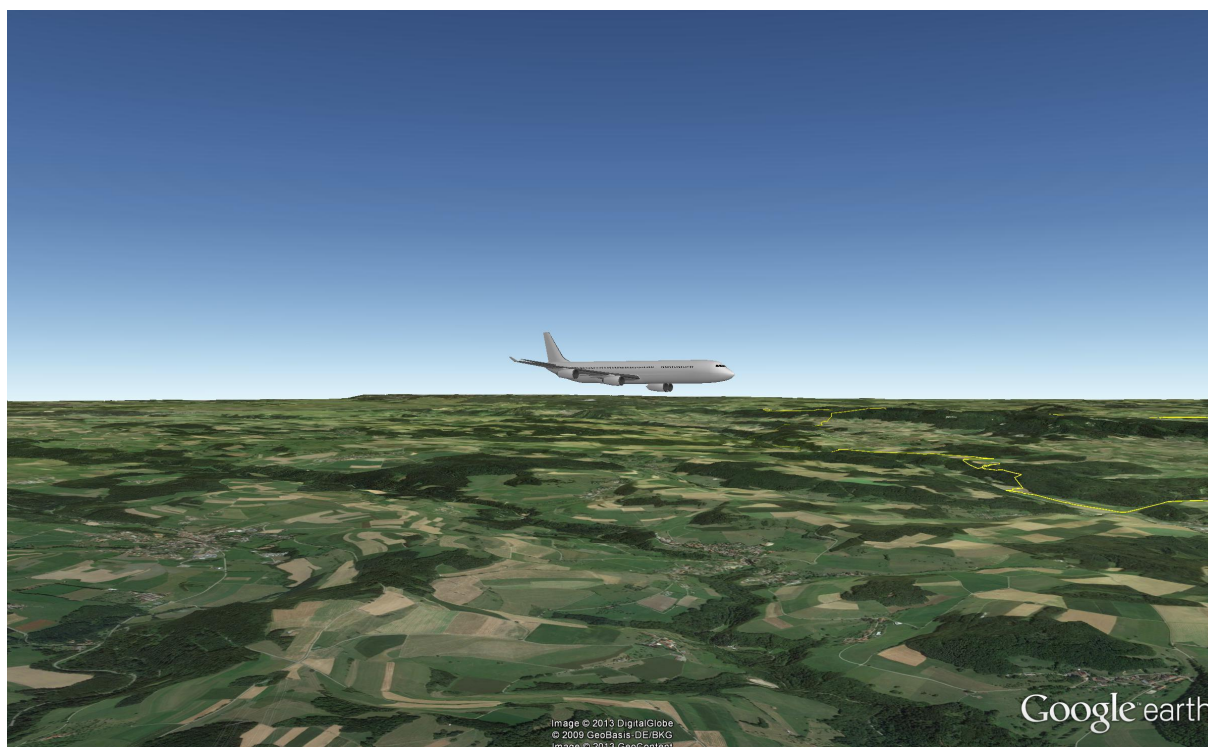
**Figure 11:** Probable view of the Airbus A340-313 from the position of the glider at 13:32:45 UTC

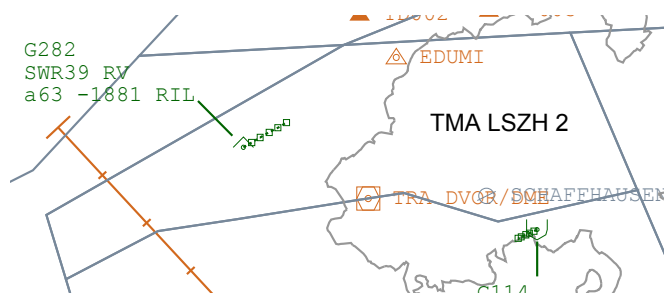
**Radar screen at 13:32:04 UTC**

SWR 39 receives a heading instruction and clearance to descend to 4000 ft from the ATCO.

Groundspeed 282 kt  
6300 ft QNH  
1881 ft/min ROD

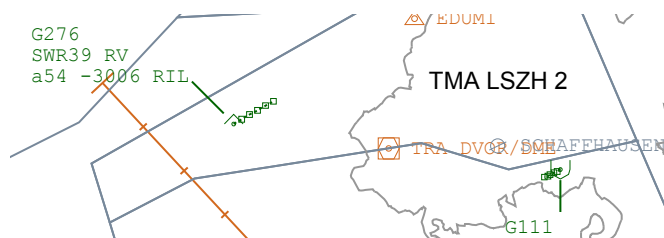
**Radar screen at 13:32:21 UTC**

SWR 39 receives the instruction to reduce speed to "*minimum clean*" from the ATCO at 13:32:23 UTC.

Groundspeed 276 kt  
5400 ft QNH  
3006 ft/min ROD

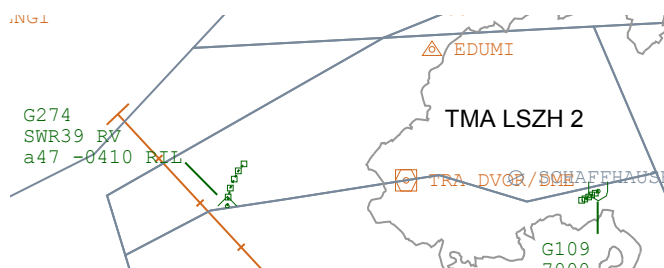
**Radar screen at 13:32:45 UTC**

SWR 39 reports the dangerous encounter to the ATCO after initiating an avoidance manoeuvre

Groundspeed 274 kt  
4700 ft QNH  
410 ft/min ROD

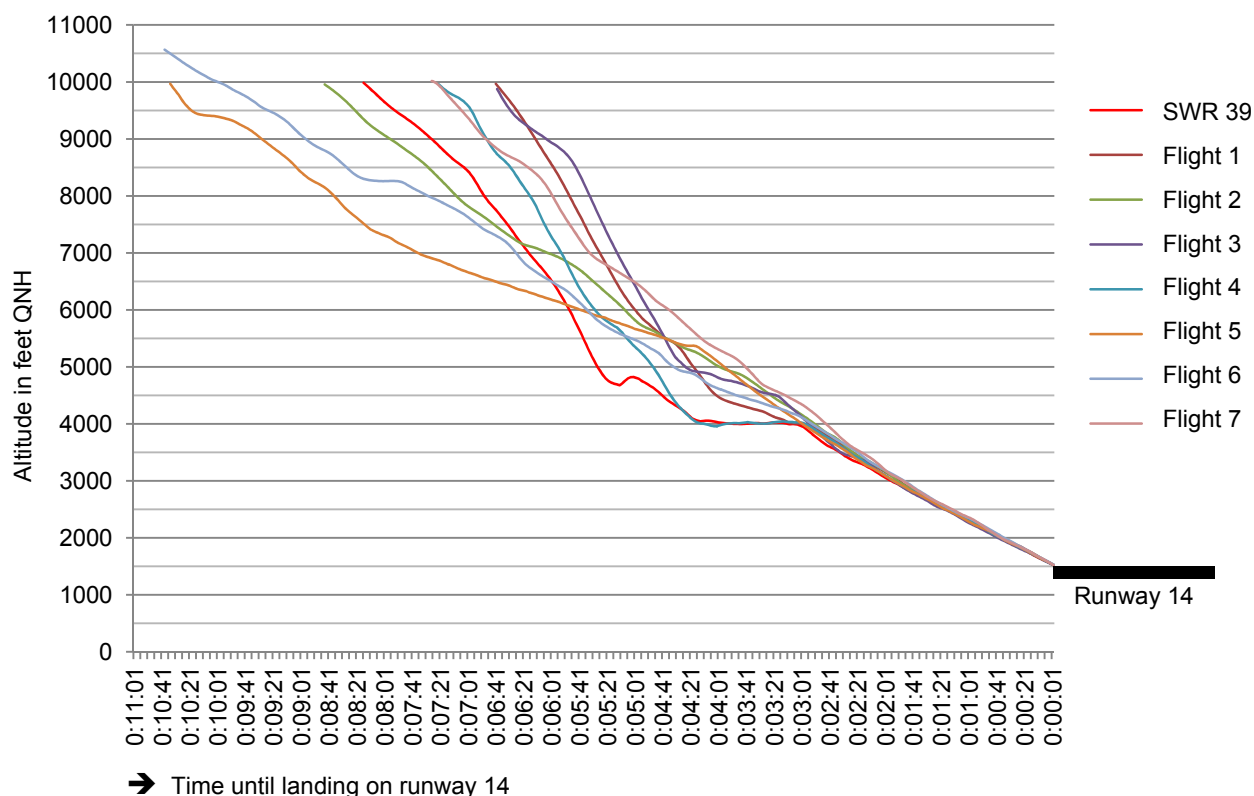
**Figure 13:** SWR 39 (red) and flights 1 to 7. Flights 2, 4 and 5 have a steeper rate of descent than flight SWR 39.

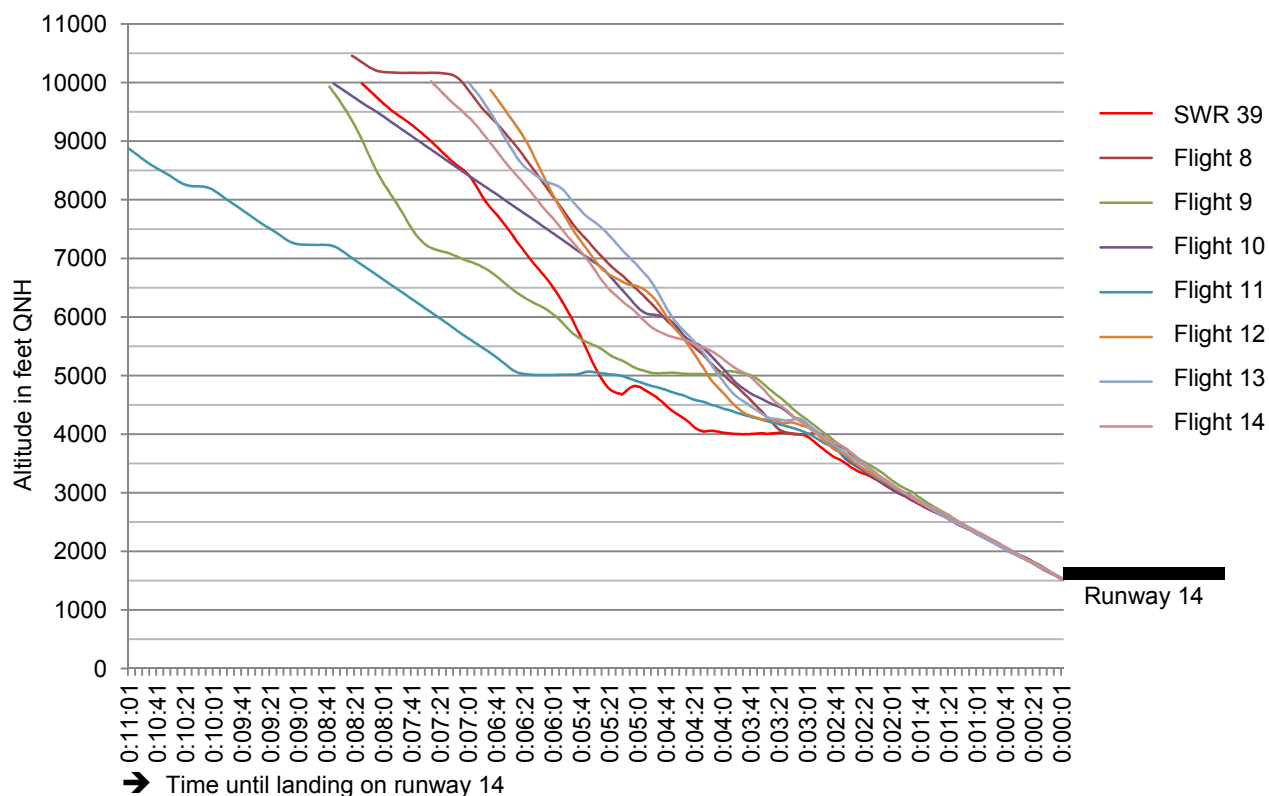
**Figure 14:** SWR 39 (red) and flights 8 to 14. Flights 9 and 11 only received clearance to 5000 ft QNH within TMA LSZH 2.

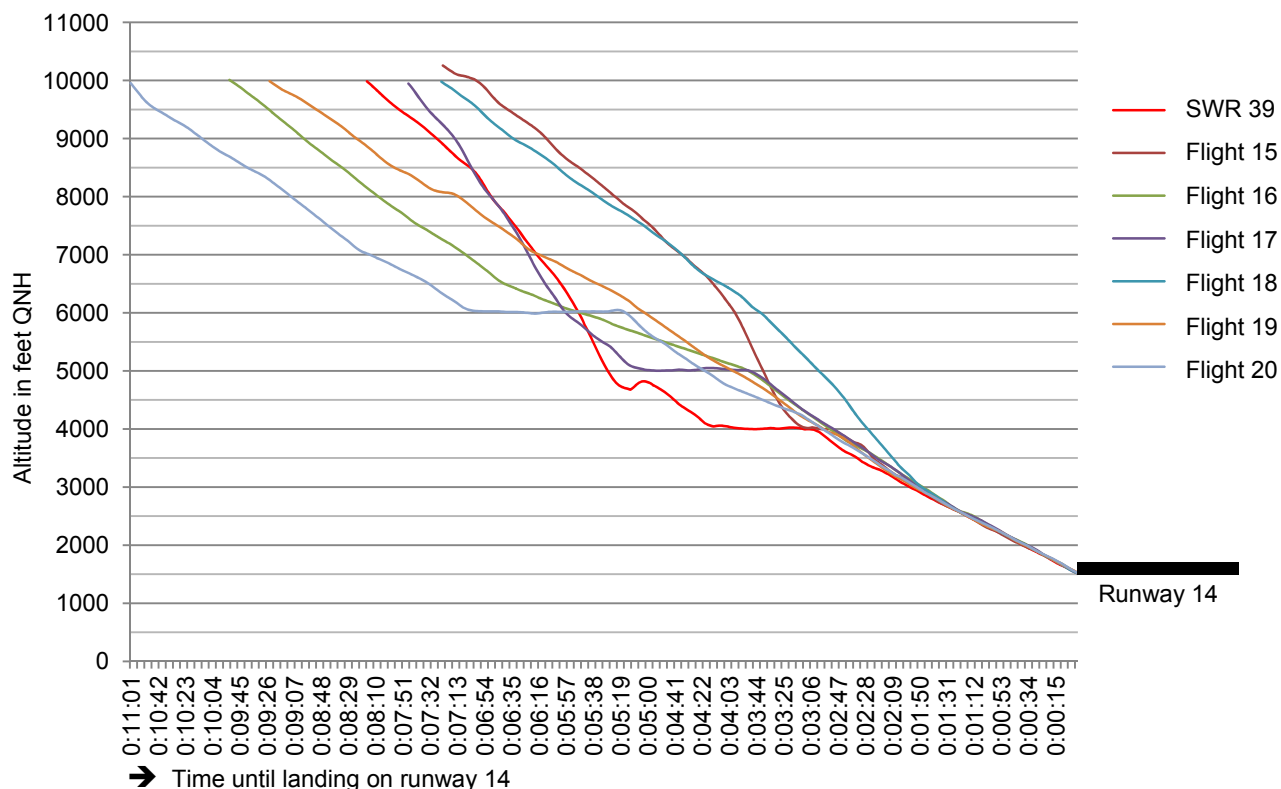
**Figure 15:** SWR 39 (red) and flights 15 to 20. Flight 20 had clearance to 4000 ft QNH, but remained in level flight at 6000 ft until the glide path of the instrument landing system (ILS) had been acquired.

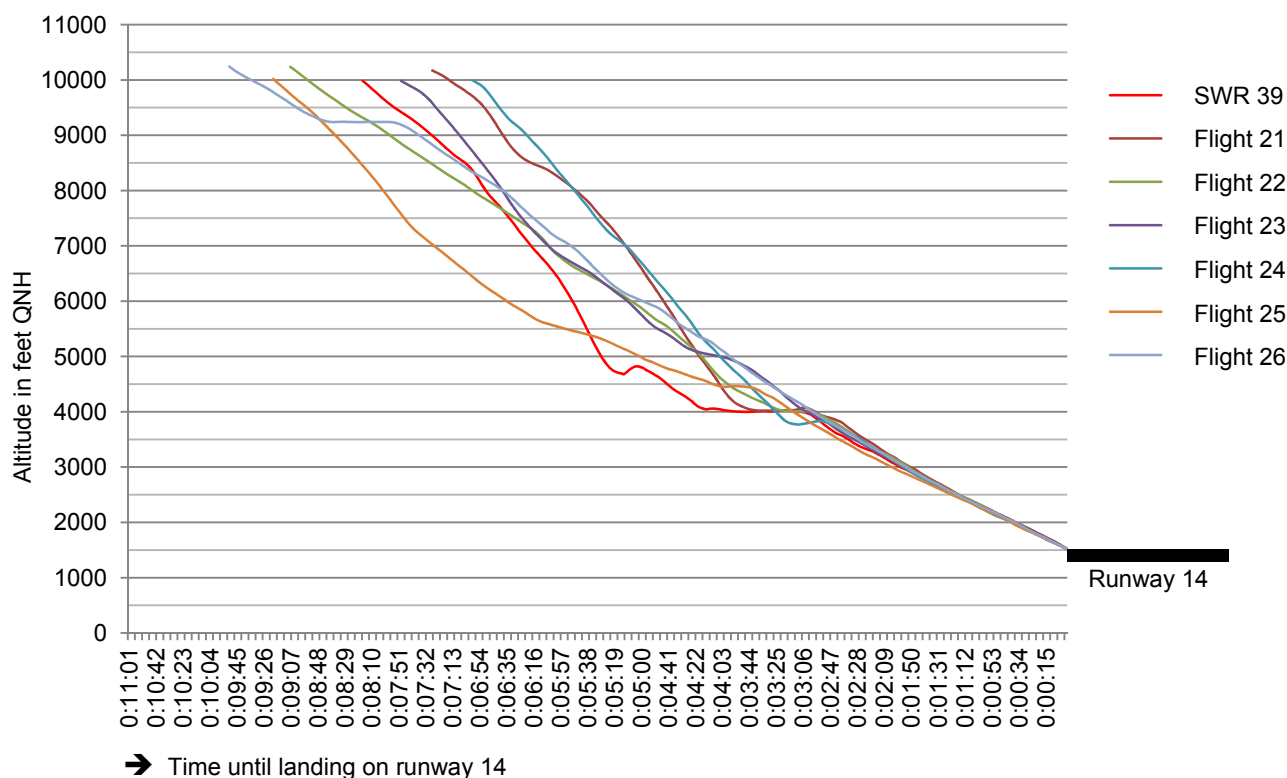
**Figure 16:** SWR 39 (red) and flights 21 to 26. Flight 21 has a virtually identical descent profile to SWR 39.
