Final Report No. 2215

by the Swiss Transportation Safety investigation Board STSB

concerning the serious incident involving
the B737-400 aircraft, registration TC-TLE

on 11 October 2013

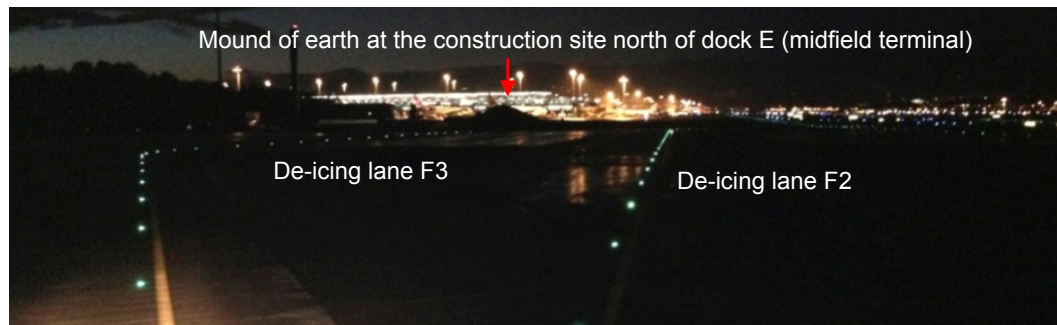
According to his statement, the commander saw the mound of earth south of de-icing pad (DIP) F at the same time as the aircraft passed the centre line lights for de-icing lane F2.

Figure 1: View from the cockpit when passing the green centre line lights for de-icing lane F2

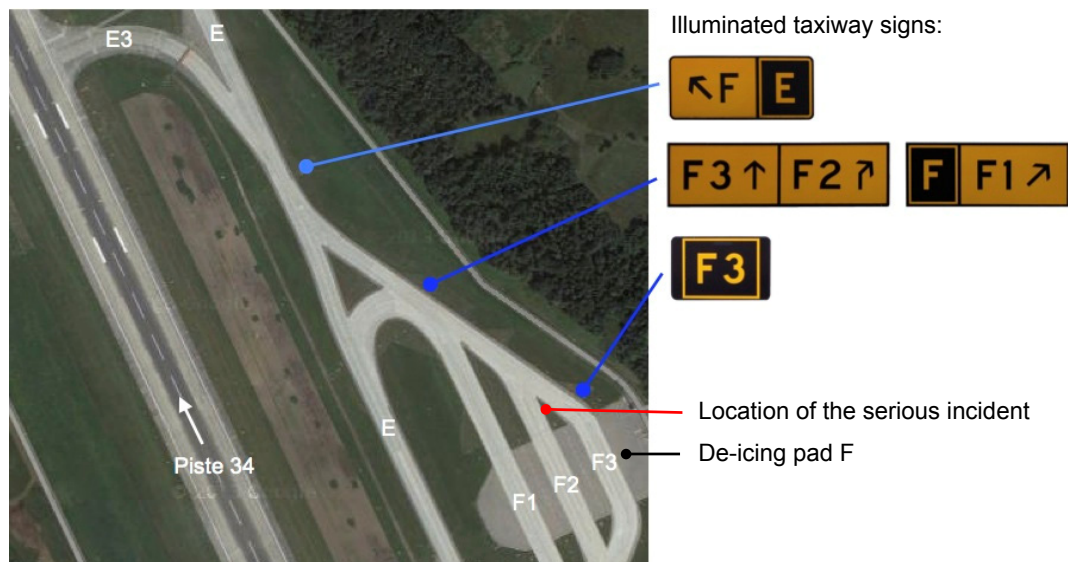
Figure 2: On de-icing pad F, north of dock E (midfield terminal), are three de-icing lanes (F1, F2 and F3).³

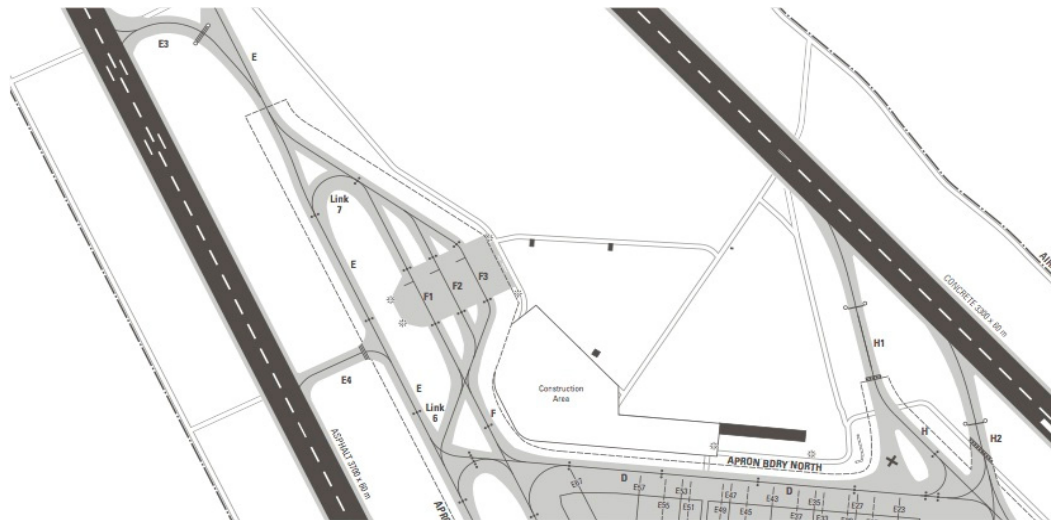
The ground chart published in the Aeronautical Information Publication (AIP) Switzerland is shown in Figure 6. The taxiway designation is not clear and the designation for TWY F north of DIP F is missing entirely.

Figure 6: Detail from the AIP Switzerland LSZH AD⁸ 2.24.3-3 dated 22 August 2013

It should be mentioned in this context that the publication of the Aeronautical Information Publication (AIP) Switzerland (LSZH AD 2.24.3-3, AIRAC of 22 August 2013 - cf. Figure 6) was also ambiguous in relation to taxiway designations. This meant that the designation for TWY F north of de-icing pad F was missing entirely and it was not clear how to proceed from TWY E to TWY F. For chart providers, such national aeronautical information publication guidelines are inadequate and represent room for ambiguity.

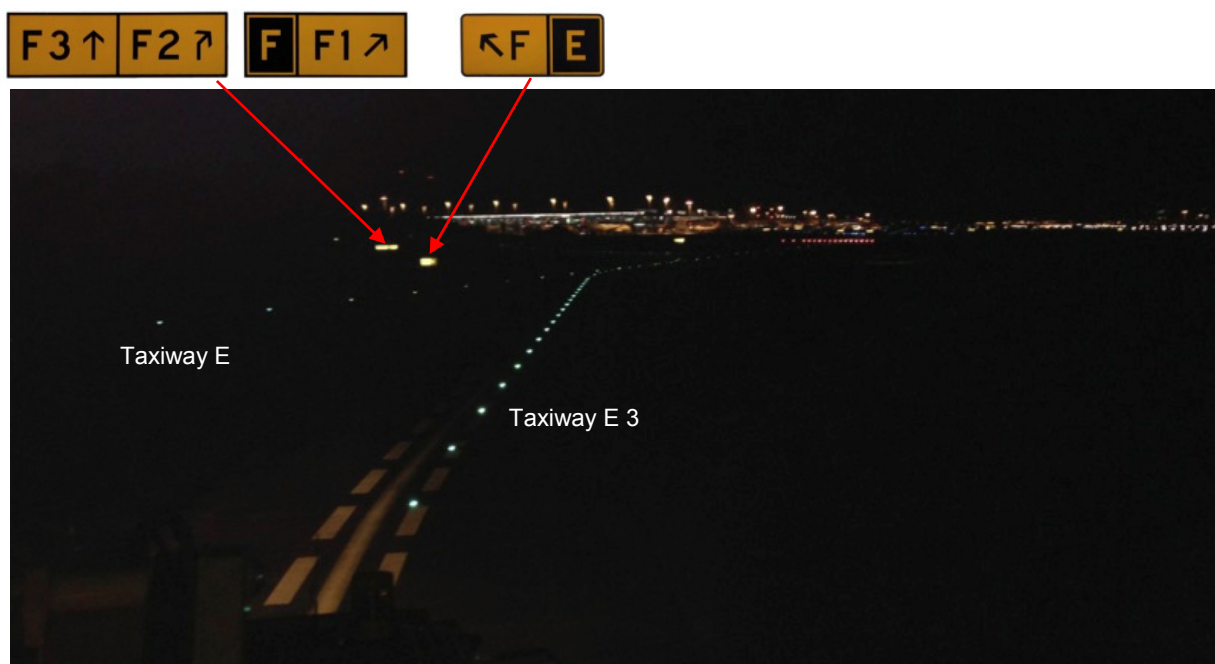
suddenly found themselves on de-icing lane F3, which was the continuation of taxiway F (cf. Annex 1, Figure 11 and Annex 2, Figures 13 and 14). The taxi clearance was therefore unclear and contributed to the occurrence of the serious incident which is the subject of the investigation.

Figure 11: View as from the cockpit (image from 16 October 2013 at 04:40 UTC)

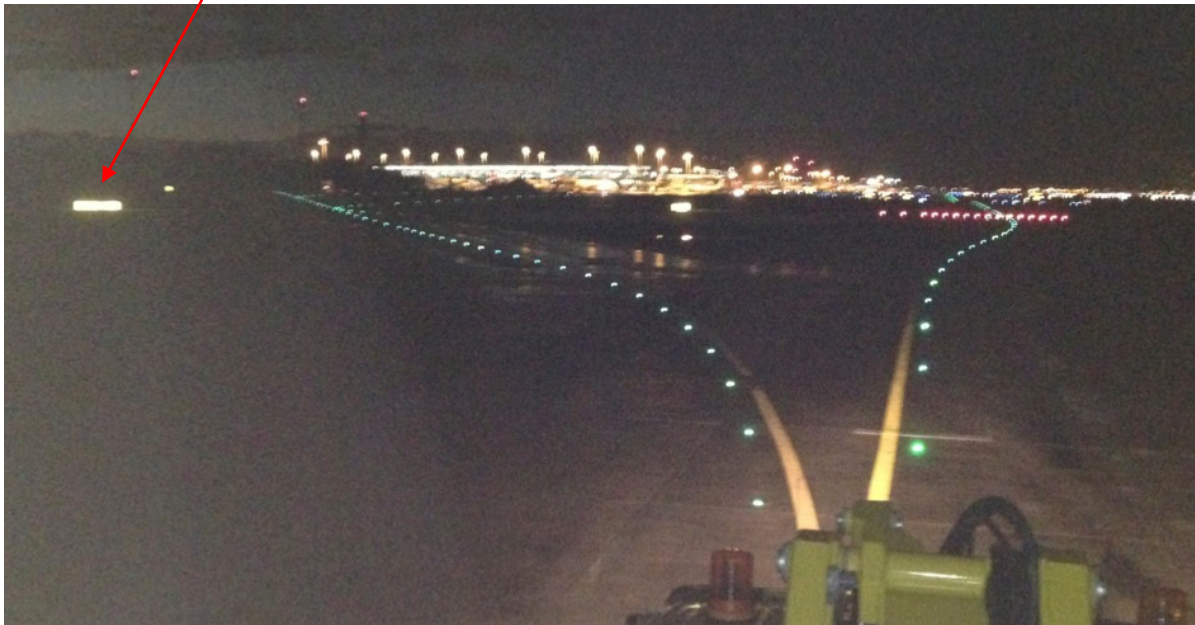
Figure 13: View as from the cockpit: left: taxiway F, straight ahead: taxiway E. (image from 16 October 2013 at 04:45 UTC (marked as closed with red crossbar on 16 October 2013))

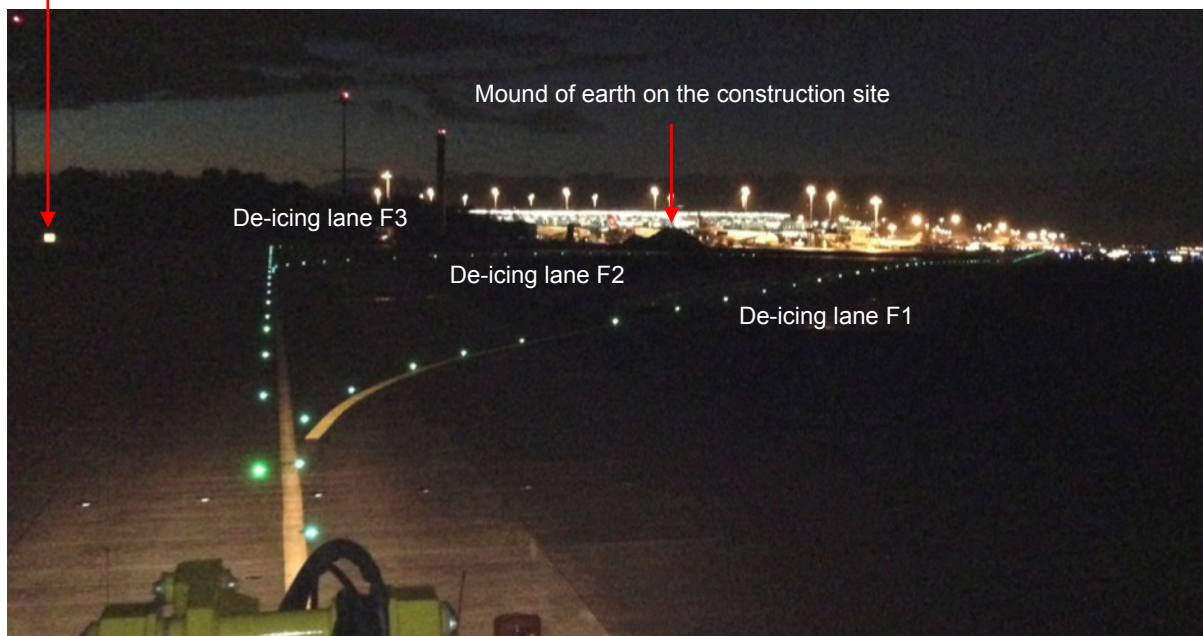
Figure 14: On taxiway F: right turn-off: de-icing lanes F1, F2 and F3 (image from 16 October 2013 at 04:50 UTC)

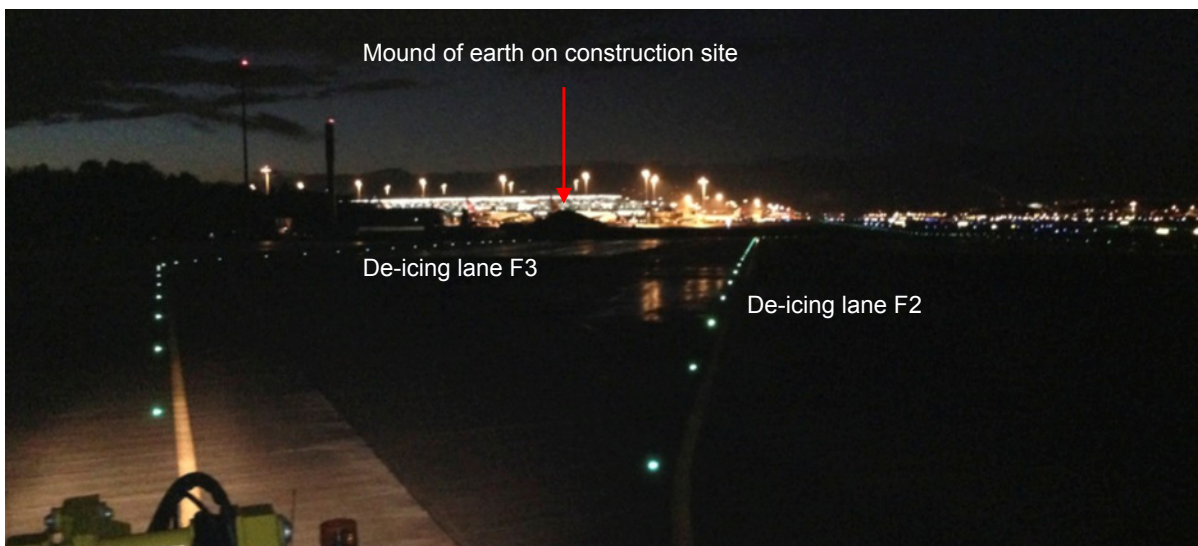
Figure 16: View as from the cockpit on taxiway F; right: de-icing lane F2, straight ahead and then to the right: de-icing lane F3, in the background: the mound of earth on the construction site (image from 16 October at 04:55 UTC).

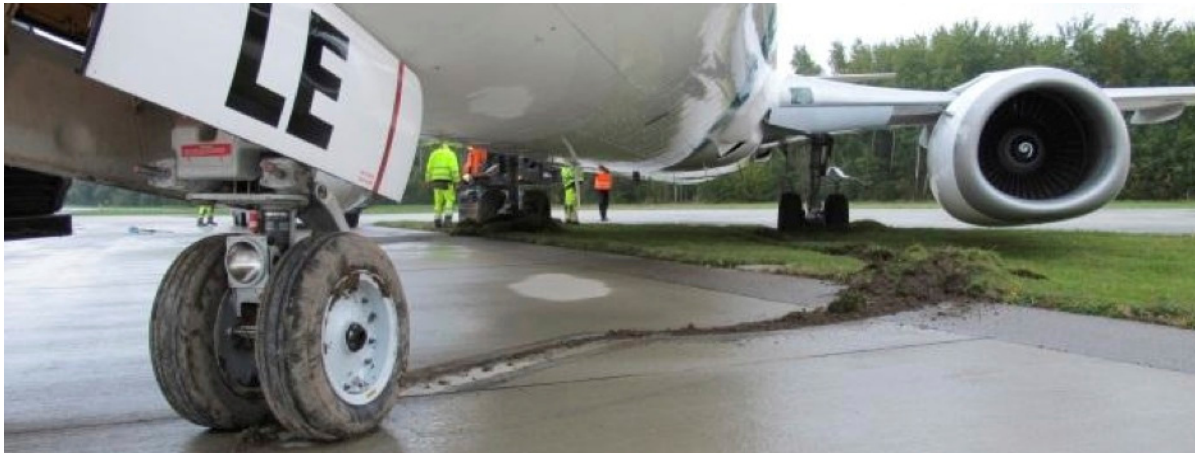
Figure 18: Looking north: nosewheel on de-icing lane F2

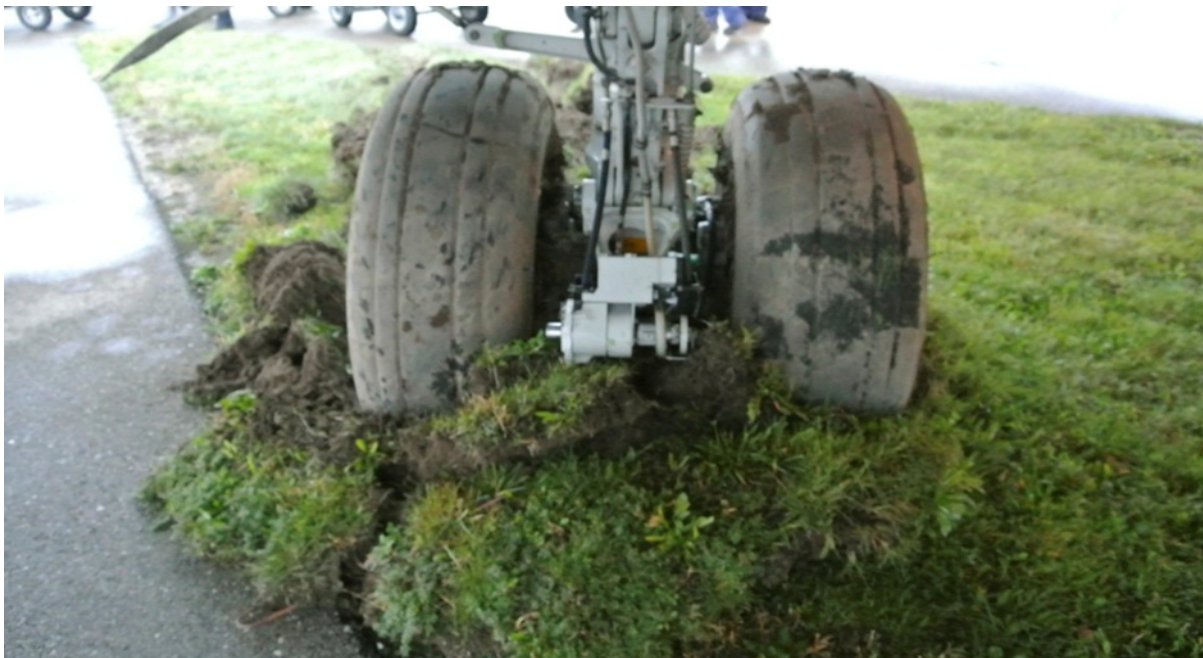
Figure 19: Looking north: right main landing gear, left: de-icing lane F2

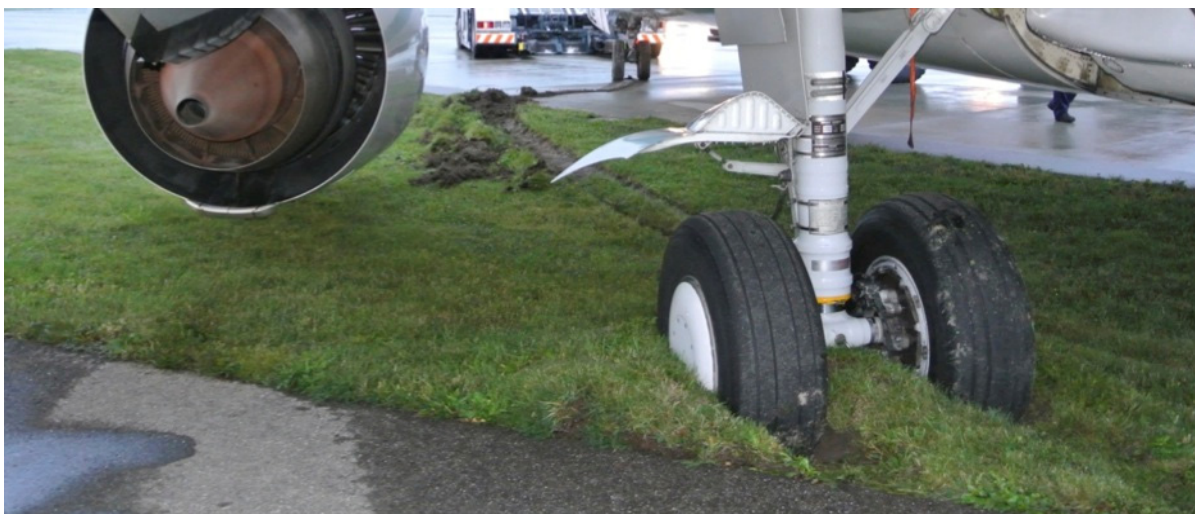
Figure 20: Looking towards the aircraft nose: left main landing gear, in the foreground: de-icing lane F2

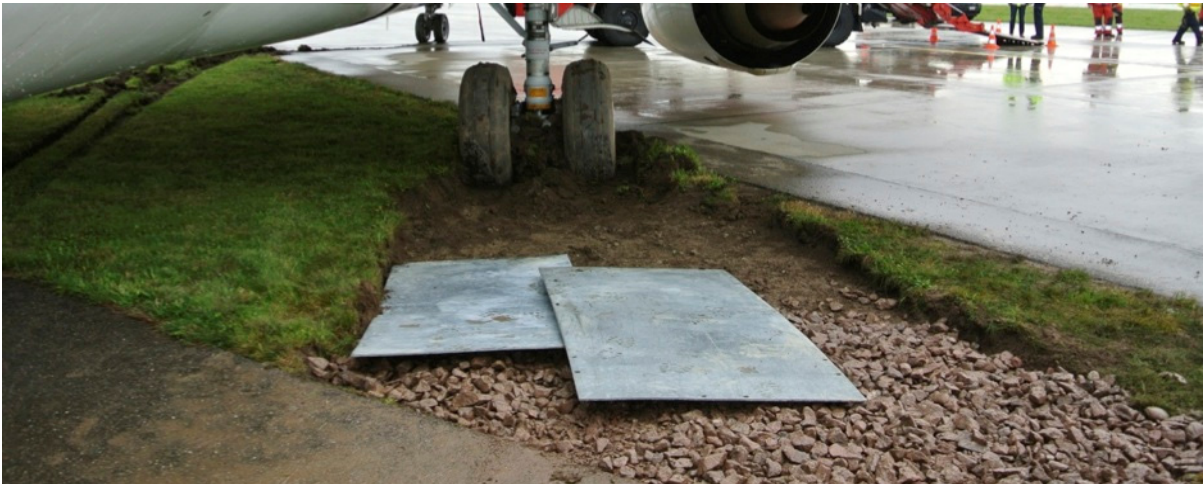
Figure 21: Removal of the earth behind the right main landing gear, creation of a weight-bearing base, right: de-icing lane F2

The aircraft was not damaged. During the course of the morning eight tons of fuel were defueled from aircraft TC-TLE and the recovery began at 11:10 UTC. In order to return the aircraft to the hard surface, the soil behind the main landing gear had to be removed. A hard surface was then created using gravel and sheet metal panels, which allowed the aircraft to be pushed back onto TWY F (cf. Annex 7) using a towbar.

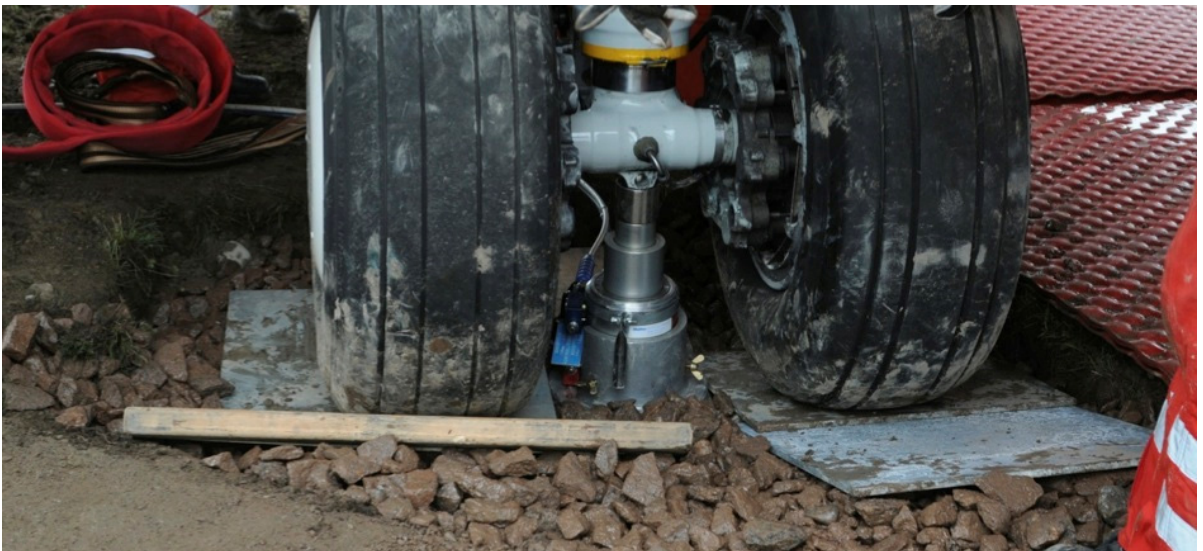
Figure 22: Right main landing gear. Jacking of the landing gear and insertion of a hard base

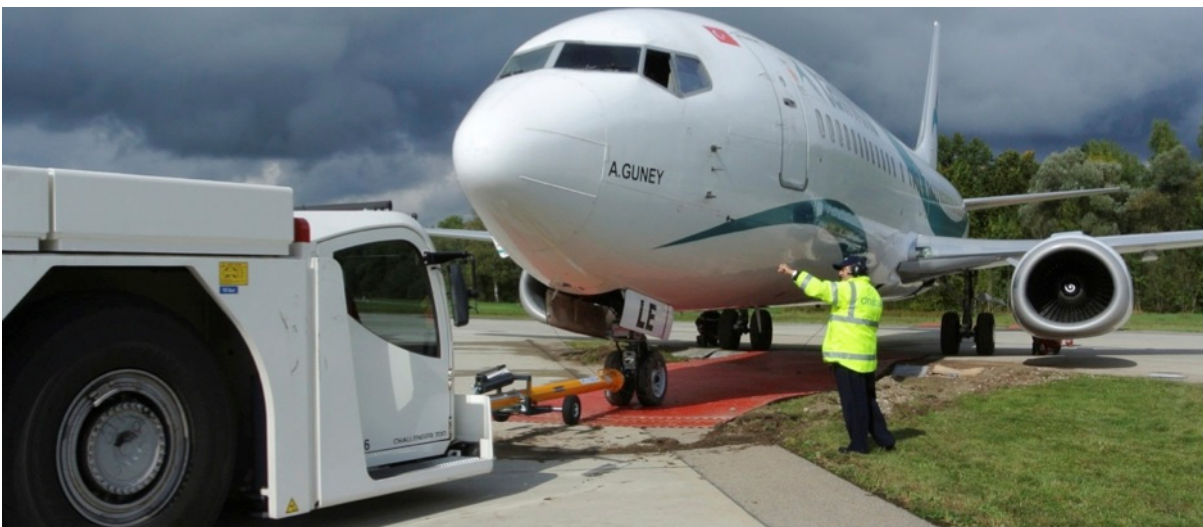
Figure 23: Looking north: pushing back the aircraft using a tractor and towbar, tractor on de-icing lane F2
