Final Report No. 2220

concerning the serious incident (Airprox)

involving a Fokker 100 aircraft, HB-JVH, operated by
Helvetic Airways
under flightplan call sign OAW 5311

and an EC 145 helicopter, HB-ZRC, operated by
Schweizerische Luft-Ambulanz AG under radio call sign
Rega Romeo Charlie

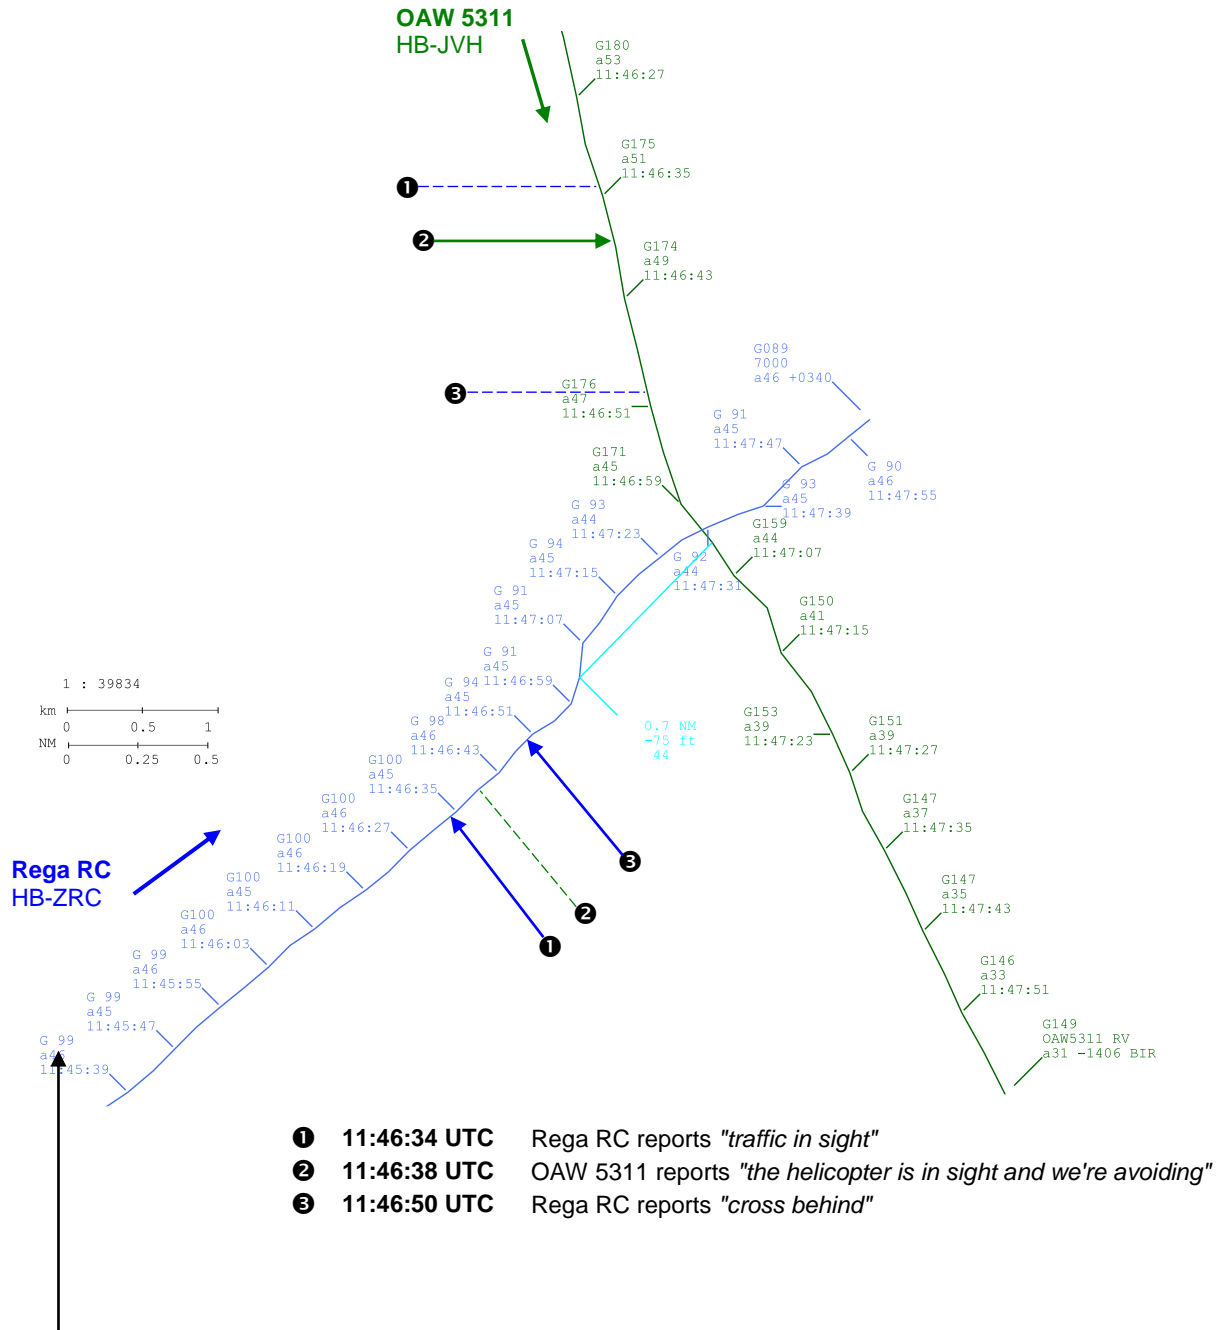
Annex 1: Flight path of the aircraft involved according to radar data

The two aircraft crossed at 11:47:03 UTC with a lateral distance of 0.7 NM and an altitude difference of 75 ft.

ing to his statement, the commander slightly reduced the rate of descent. A little later the TCAS generated the resolution advisory (RA) "*climb, climb*". According to the statement of the copilot of OAW 5311, at the time the RA was triggered the aircraft was descending and at approximately the same altitude as the helicopter. The crew reported that they had established visual contact at the 2-3 o'clock position. The commander decided not to comply with the resolution advisory and continued the approach while descending because the copilot had permanent visual contact with the helicopter and also observed it turning north. The copilot later stated that the commander had carried out a minor heading correction to the left. As a result of the continued descent, the TCAS generated the RA reversal "*descend, descend NOW!*" when the aircraft passed 4500 ft QNH (the flight altitude of the helicopter). This reversal did not cause the commander to alter the rate of descent, which was approximately 1200 ft/min. According to the data sent via the Mode S downlink, a resolution advisory was generated in the cockpit of OAW 5311 for 29 seconds. The copilot was in agreement with the decision not to comply with the resolution advisory and therefore did not report any RA to the ATCO. According to the recordings of the flight data recorder there was at this stage no change in the rate of descent (see Annex 3) and no marked change of course (see Annex 1).

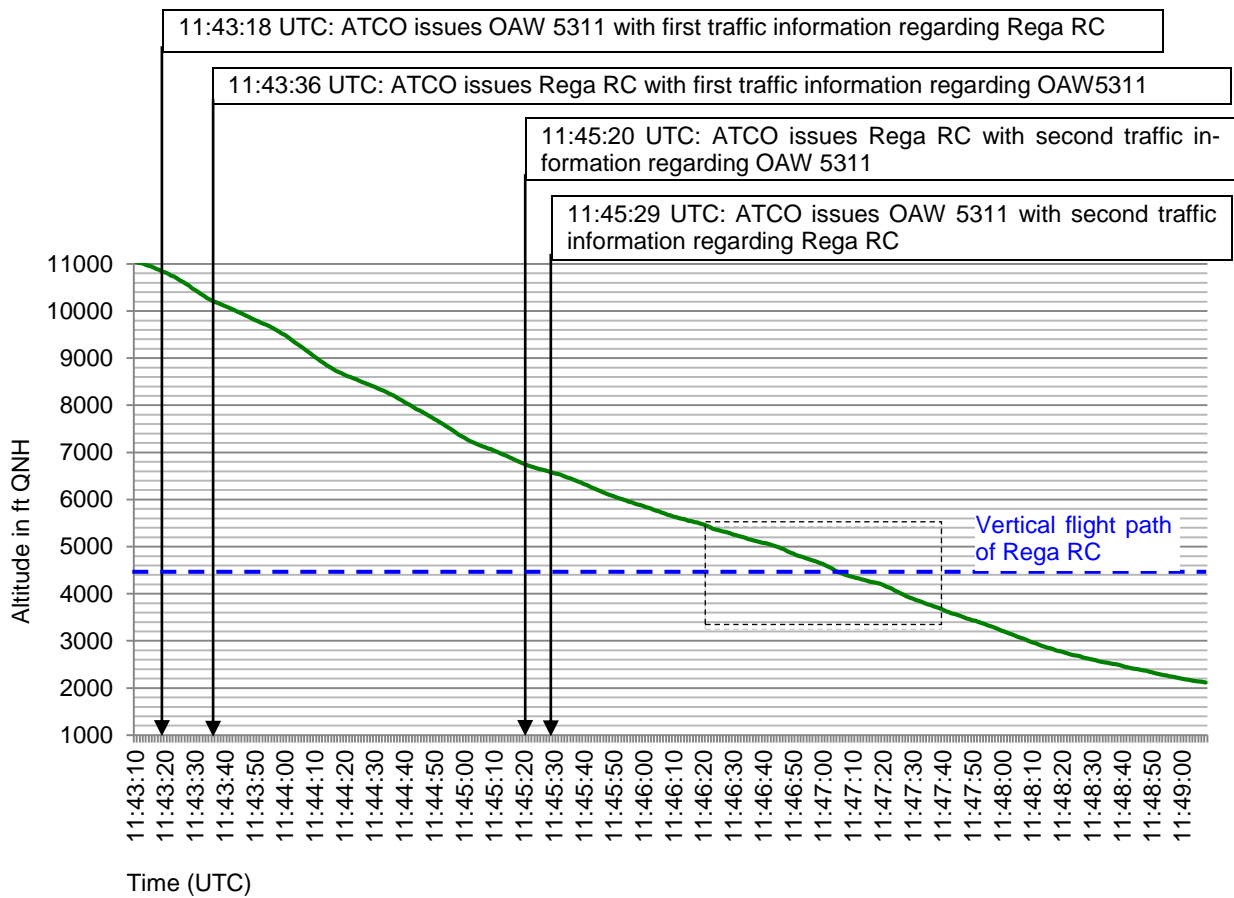
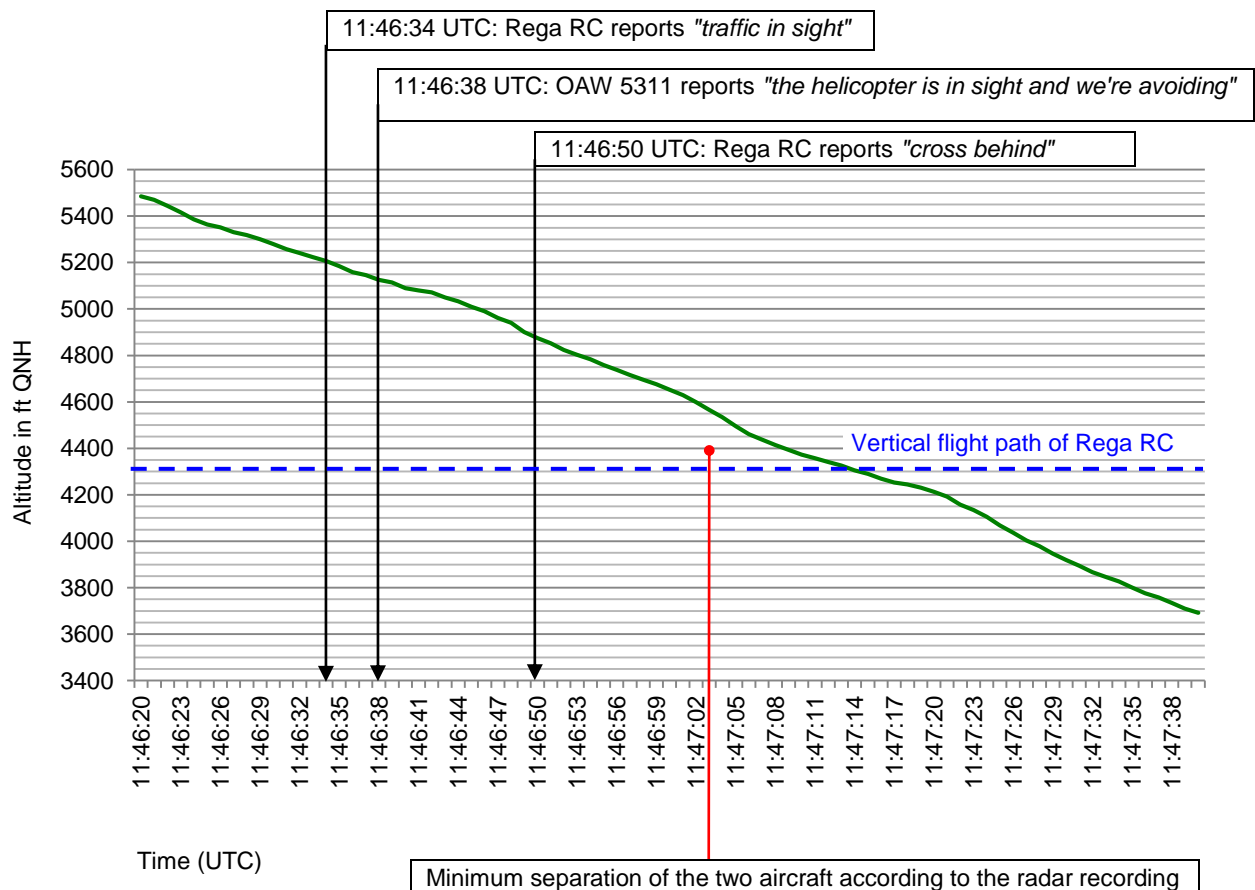
Annex 3: Vertical flight path of OAW 5311 according to FDR

Because the crew did not comply with the resolution advisory, the TCAS generated the RA reversal "*descend, descend NOW!*" as the aircraft descended and passed 4500 ft QNH, the helicopter's flight level. Such a reversal is only generated if the resolution advisory (RA) is triggered for at least nine seconds and in this time failure to comply or insufficient compliance with the RA means that the situation has not changed sufficiently that the original resolution advisory can achieve a predefined altitude difference. Such a change of circumstances took place in the present case because the RA was not complied with and it would no longer have been purposeful for OAW 5311 to have climbed after passing the helicopter's flight level during its descent.
