Final Report No. 2222

concerning the serious incident involving
the DO328-100 aircraft,
registration HB-AES

operated by SkyWork Airlines AG
under flight number SRK 600

on 14 March 2012

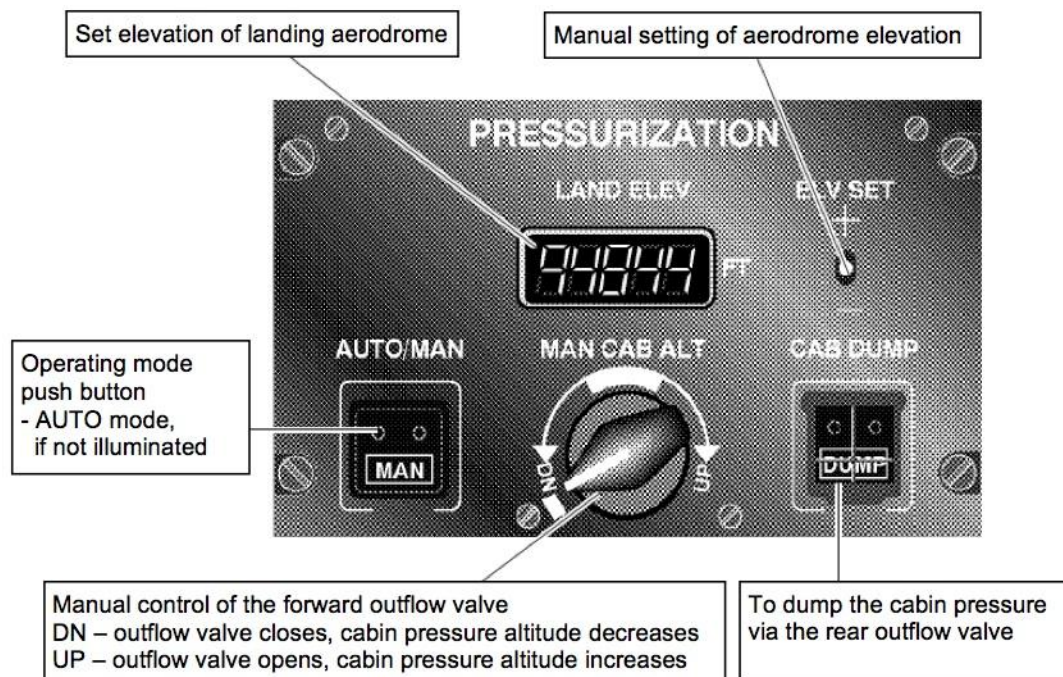
Figure 1: Pressurization control panel

The forward outflow valve is located in the forward bulkhead over the nosewheel. It can be opened and closed using the MAN CAB ALT control knob on the pressurization control panel and operates independently of the position of the AUTO/MAN push button. It is therefore important that the control knob is fully in the DN position (white mark) when in automatic mode.

It seems plausible for the following reason that the control knob, not being in the full left / DN position, was not noticed during cockpit preparation: In normal operation, this control knob is not used before, during, or after the flight. It is a commonly observed psychological phenomenon that the position of such a control element is often overlooked when working through a checklist, as it is unconsciously assumed that it is in the correct position. Tests in the operator's simulator also indicated that during cockpit preparation, many of the tested pilots did not notice that the MAN CAB ALT control knob had not been set to the full left / DN position and was therefore incorrect.

This situation arose because the crew failed to notice that the control knob for controlling the forward outflow valve was set in the incorrect position.

[The European Aviation Safety Agency (EASA) should, together with the aircraft manufacturer, take measures to ensure that an improperly closed forward outflow valve is better recognizable for the crew, particularly in automatic mode.]

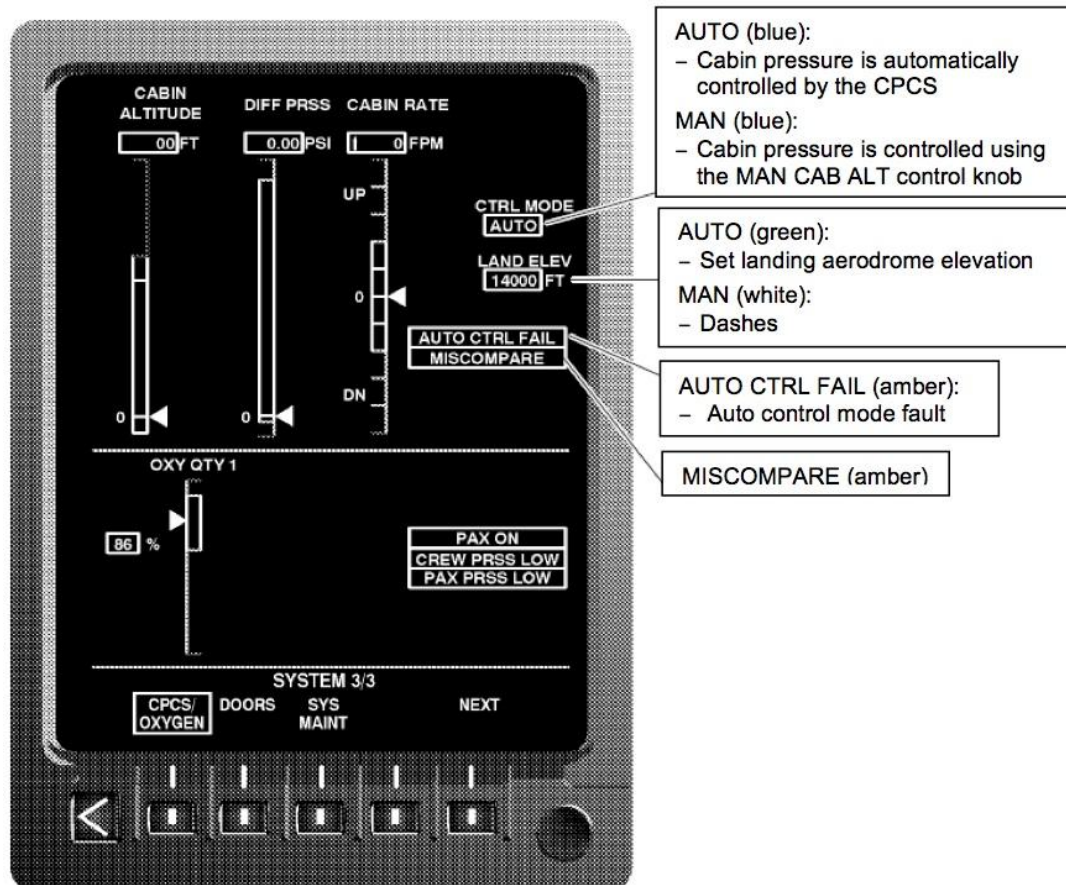
Figure 2: System page: CPCS / OXYGEN

The pneumatic valve is operated by engine bleed air and its position is therefore dependent on engine rpm. In the cockpit there is no explicit display for the position of the forward outflow valve. However, the parameters that are influenced, such as cabin altitude, differential pressure and cabin rate, are displayed as follows on the CPCS/OXY page:

- The position of the forward outflow valve (whether it is closed, open or partially open) is not explicitly displayed to the crew.
- The pilots and the flight attendant did not understand each other via the interphone.
- The weather conditions had no influence on the serious incident.

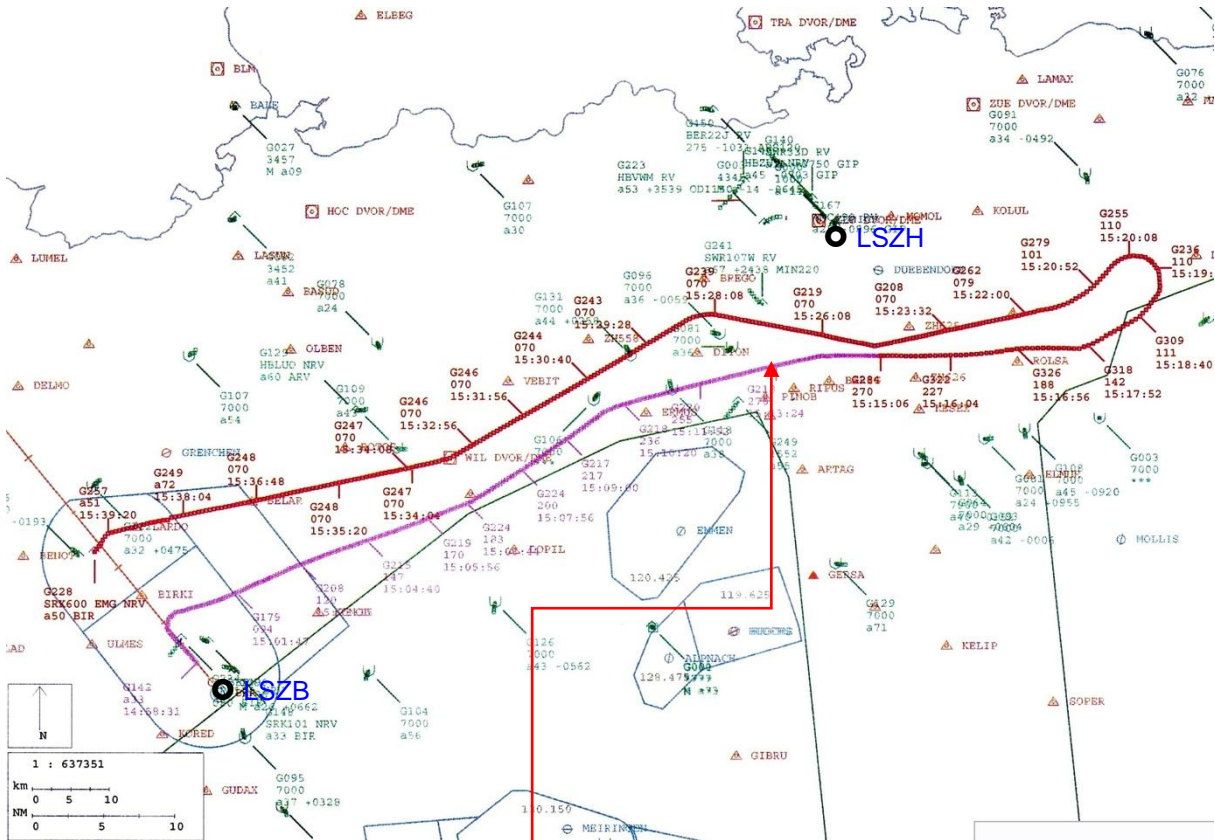
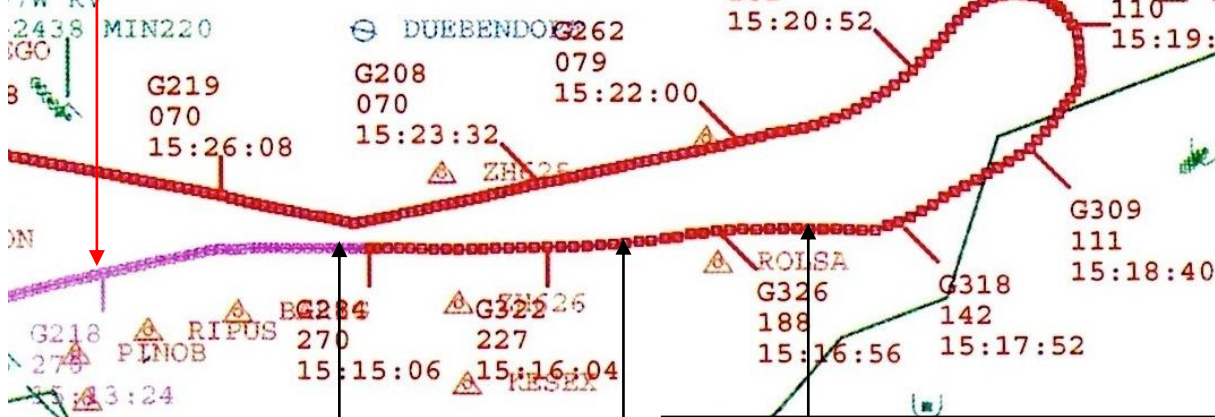
Annex 1: Radar recording of the flight path

15:13:22 UTC CAB ALT warning displayed

15:17:25 UTC crew receives heading instruction 060°

15:16:28 UTC crew receives clearance to descend to FL 110

15:14:55 UTC crew reports: "Mayday ... we request to descend"
