# **Final Report No. 2232**

## **by the Swiss Transportation Safety Investigation Board (STSB)**

concerning the serious incident involving  
the commercial aircraft A319-112,  
registration HB-IPX

on 11 December 2012

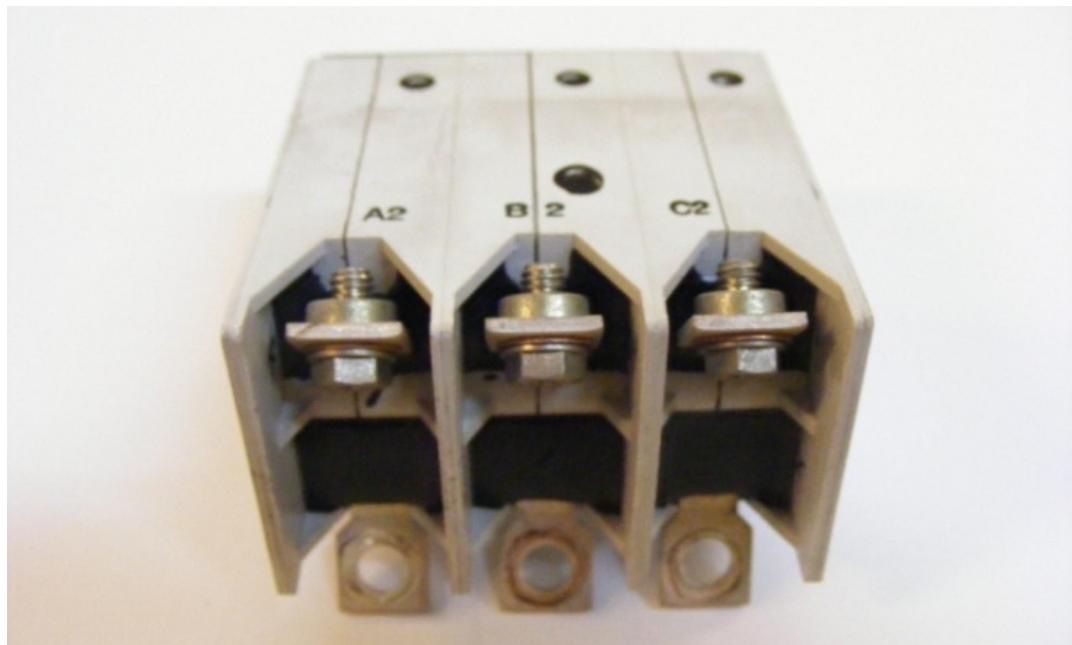
**Figure 5:** Circuit breaker 3XN1 before the test (source: Airbus)

On 25 June 2013 the circuit breaker 3XN1<sup>13</sup> (P/N E0459-501, S/N 4077) was tested by Airbus in Toulouse. The visual inspection of the device on arrival gave the following result: The release button of the circuit breaker (CB) was pushed in. There were no external signs of overheating, i.e. no discoloration. Nor was any mechanical damage detectable (cf. Figure 5).

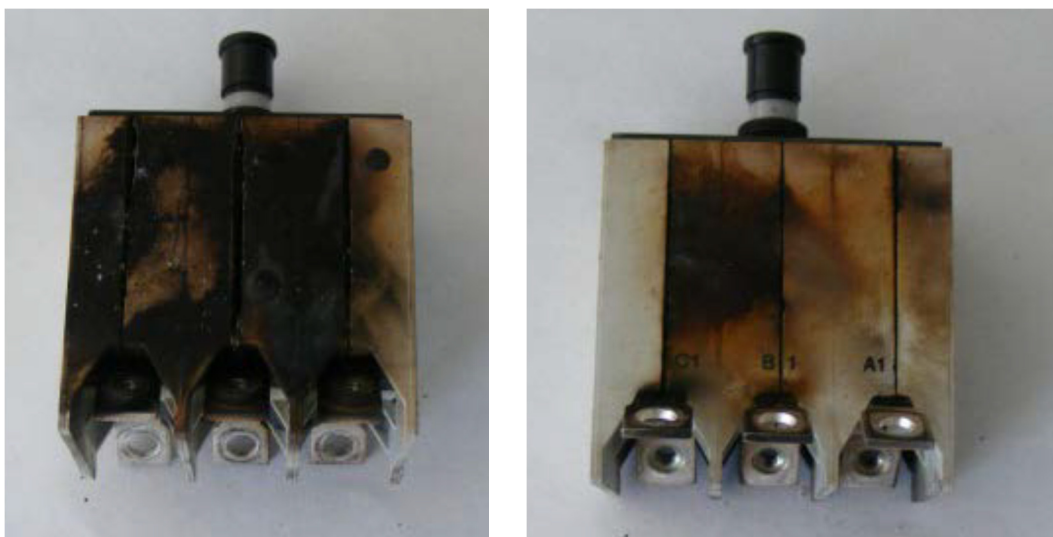
**Figure 6:** Front and rear of circuit breaker 3XN1 after the test (source: Airbus)

The release button of the CB was pushed in once again and then the power source was switched on again. This time, the CB made unusual noises and smoke appeared (cf. Figure 6). The power was disconnected immediately. The CB had tripped. The test was then aborted.

The intended test, with the aim of determining the tripping current of the 50 A circuit breaker, could not be carried out in these circumstances. It is believed that internal arcing occurred in the CB between the fuse elements.

To clarify the precise facts of the case, circuit breaker 3XN1 was x-rayed from different sides on 6 November 2013 by the manufacturer. A new CB was x-rayed under the same conditions for comparison. The comparison showed that on the CB from the HB-IPX, several parts were missing or had melted.

On the basis of the insights gained during testing on the manufacturer's premises (cf. chapter 1.16.3) it is likely that the CB heated up as a result of internal electrical arcing between two phases and therefore tripped. However, the cross-current between phases caused by the arcing was not sufficient to cause the internal monitoring in GCU 1 to respond and disconnect AC BUS 1 from the generator<sup>16</sup>. The recurring start-up current of a fuel pump in the left tank caused by the fault in the DC 1 network may have favoured the tripping of circuit breaker AB 11. It cannot therefore be excluded that the above-mentioned arcing in the CB was also present and latent on previous flights but did not cause it to trip.

On 14 December 2012 circuit breaker 3MC "AFT GALLEY FEED" (ex 3XN1) was replaced (WO 6199655-1).

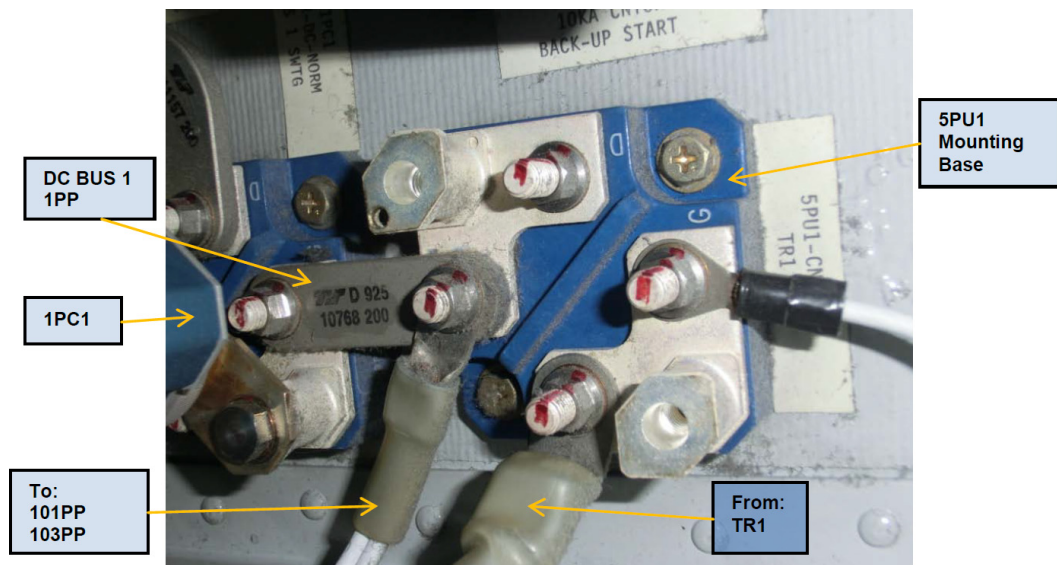
**Figure 7:** Mounting base after disassembly of contactor 5PU1

On 18 February 2013, contactor 5PU1 was replaced and at the same time a general visual inspection of connection point 5PU1/103PP/101PP was carried out in the area of DC BUS 1 (1PP) (cf. Figure 7). No irregularities, and in particular no burning marks were found.

Contactor 5PU1 was removed from the aircraft on 18 February 2013 and examined in detail by the manufacturer. No abnormal behaviour was found. On the same day, a visual inspection was carried out at connection point 5PU1/103PP/101PP. No fault could be found in this check either. The fact that up to 18 February, i.e. for approximately two months since the serious incident, the aircraft had been deployed in flight operations without any further failure in the electrical system supports these findings. The exact cause of this fault could not be established, even with the assistance of the aircraft manufacturer. However, it has not occurred again in operation to date.

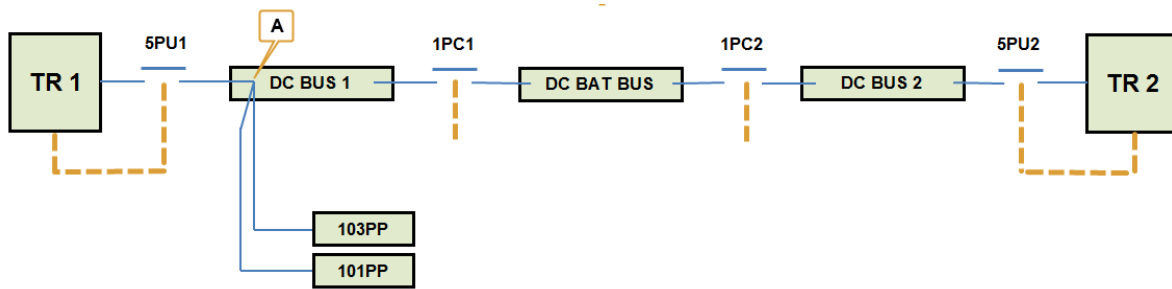
## Annex 6: Simplified representation of the BAT BUS switching logic

Since the power supply via TR1 was not affected<sup>14</sup> and contactor 5PU1 remained closed, there are two plausible explanations for the opening of contactor 4PC and therefore for the switchover to the ESS TR: a contact resistance inside contactor 5PU1 or a loose contact at connection point 5PU1/103PP/101PP (point A in Annex 6).

There are two plausible explanations for the multiple brief voltage lowering events at DC BUS 1: a contact resistance inside contactor 5PU1 or a loose contact at the connection point 5PU1/103PP/101PP (point A of annex 6).

Point at which a loose contact was suspected. A detailed visual inspection of the corresponding connections on the aircraft was carried out. Result: no irregularities were detected.

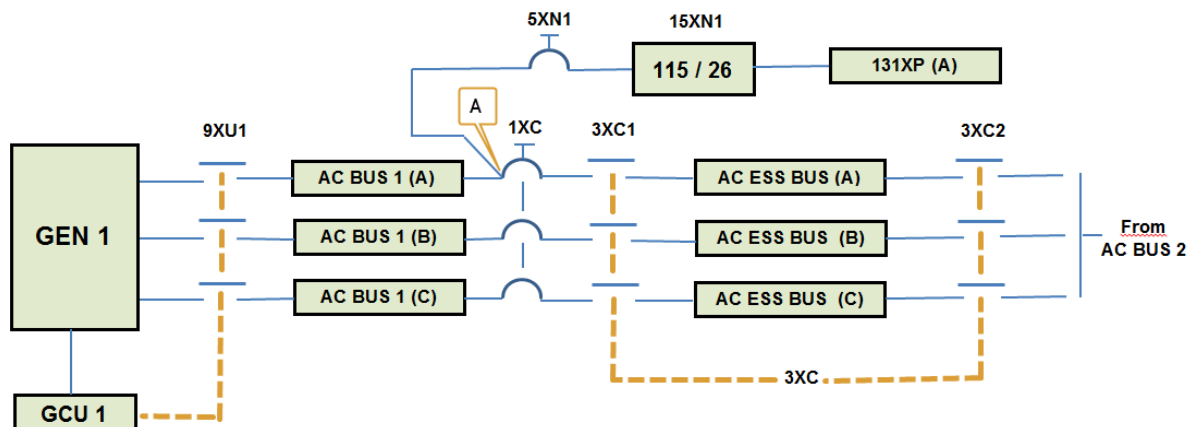
## Annex 7: Simplified representation of the AC ESS BUS switching logic

Point "A" in Annex 7 designates the point at which a loose contact was assumed. A detailed visual inspection of the corresponding connections was carried out on the aircraft. Circuit breaker 1XC was tested. No discrepancies could be detected. To date no further faults have occurred in this area. The reason for this malfunction could not be determined.

Point at which a loose contact was suspected. A detailed visual inspection of the corresponding connections on the aircraft was carried out. Result: no irregularities were detected.
