Final Report No. 2233

concerning the serious incident (near collision)

between the Eurocopter EC 120B helicopter,
registration HB-ZBB, operated by BB Heli AG, and

the AgustaWestland AW109SP helicopter,
registration HB-ZRY, operated by
Schweizerische Luft-Ambulanz AG

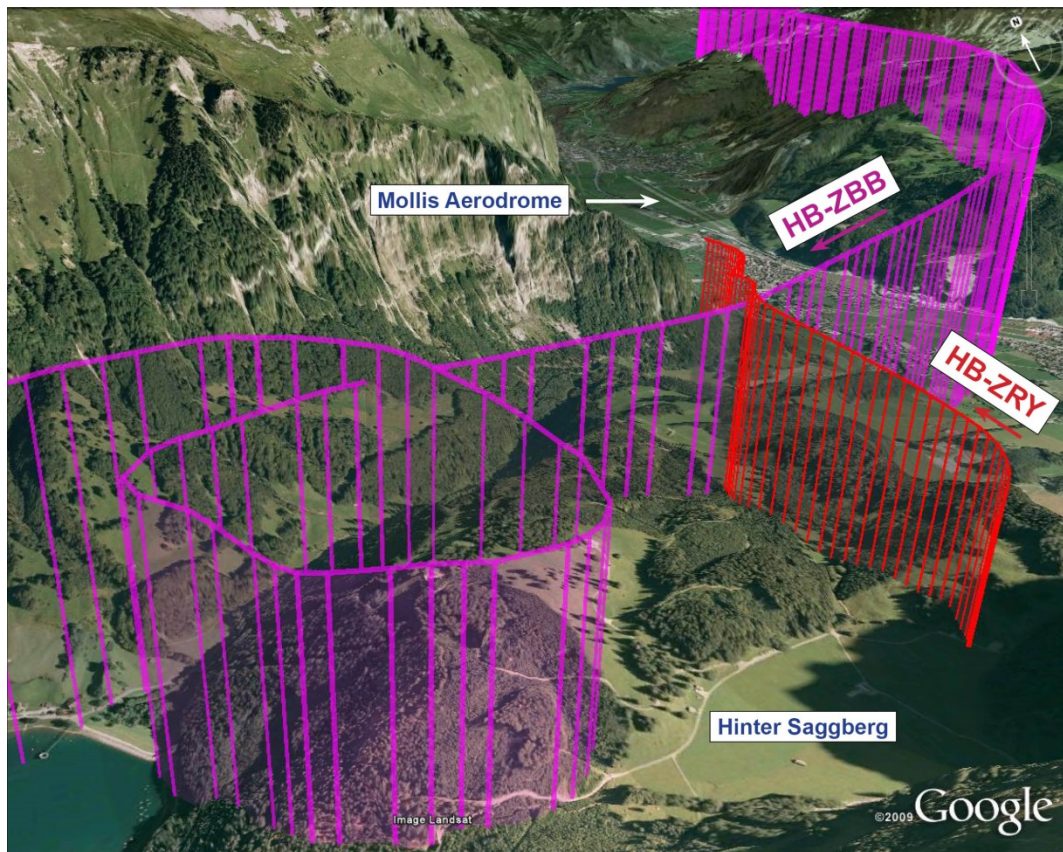
Figure 3: The history of flight HB-ZRY according to the recording of the FLOICE is displayed in red; the history of flight HB-ZBB according to the recording of the tablet computer on board HB-ZBB is displayed in purple (on Google Earth). The altitudes displayed are uncorrected GPS altitudes, i.e. the altitudes are approximately 48 m above the respective altitudes above sea level. Cf. Annex 1 for temporal relations.

According to the recording of the FLOICE, the two helicopters crossed at an altitude of approximately 1400 m AMSL at approximately 08:11:54 UTC (cf. Annex 1). The distance registered at this time was approximately 40 m horizontally and 20 m vertically. The fact that the recording has only discrete time steps and is subject to a certain amount of data inaccuracy mean that the real minimum distances may have been slightly lower or slightly higher.

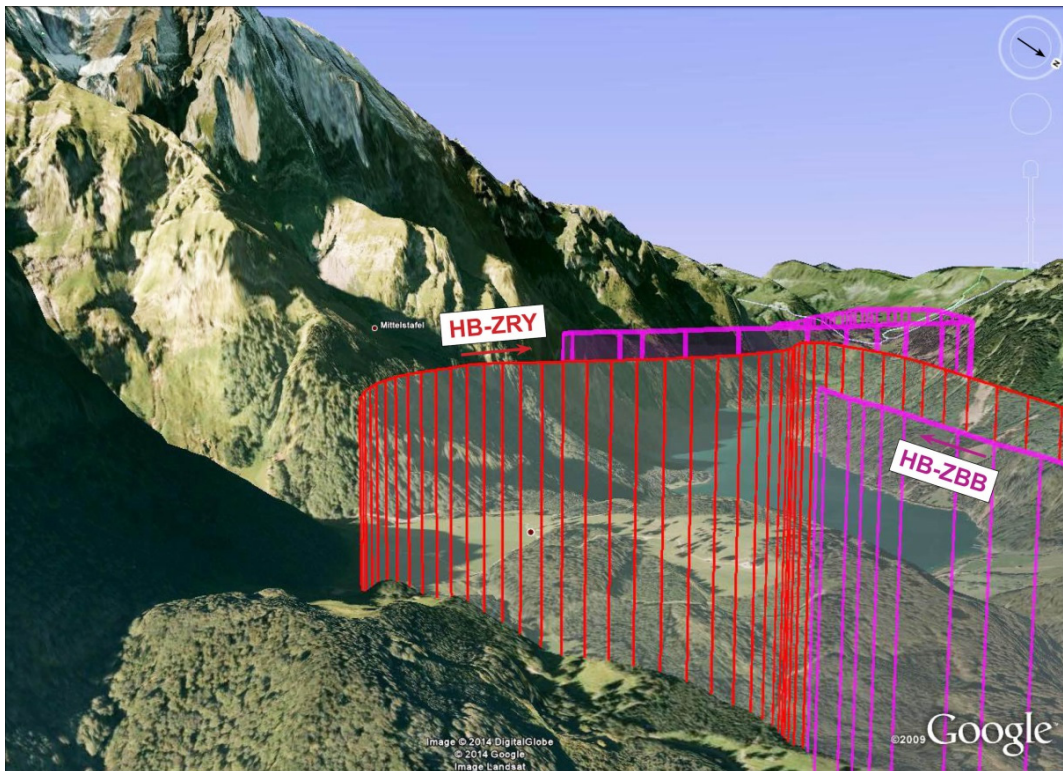
The crew of HB-ZRY observed HB-ZBB first approach directly towards them at the same altitude from the one or two o'clock position and then initiate a pronounced avoidance manoeuvre to the right while descending slightly. According to the estimation of the crew, the two aircraft crossed approximately two seconds after the pilot of HB-ZRY had made visual contact with HB-ZBB and at a lateral separation of 10 to 20 m and an altitude difference of approximately 5 m. At this time, HB-ZRY was almost hovering.

Figure 4: Representation of the crossing on Google Earth (cf. Figure 3, with different perspective).

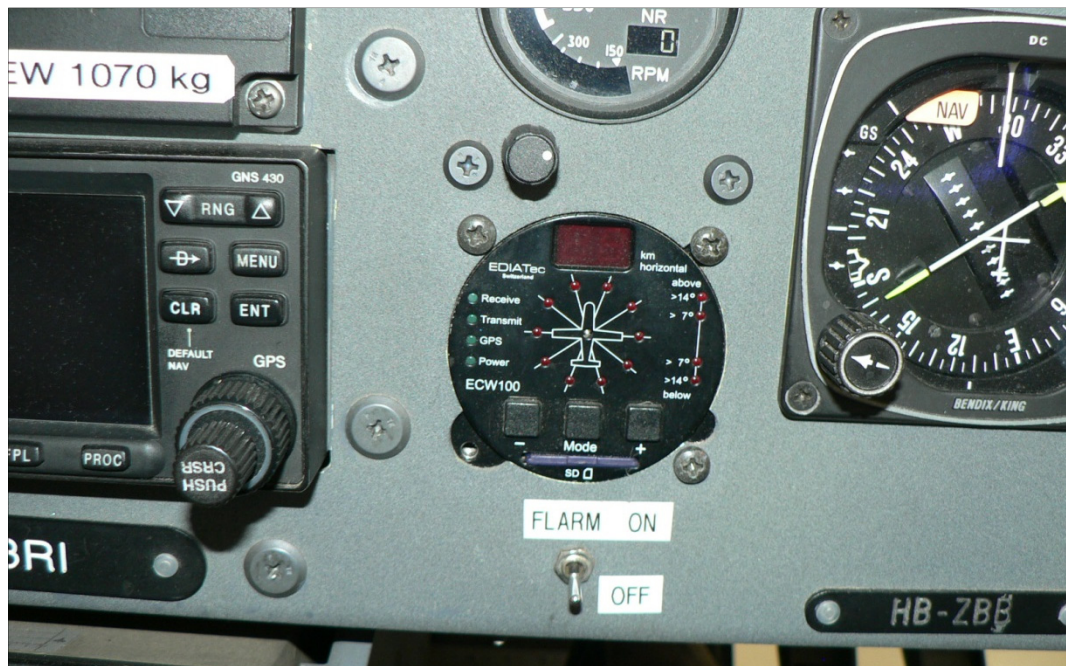
Figure 6: Ediatec ECW100 FLARM on the instrument panel of HB-ZBB. The relative position of other aircraft is displayed in the horizontal plane by the circle of LEDs in the middle of the display; in the vertical plane it is displayed by the LEDs on the right edge. The upper digital display gives the horizontal distance in 100 m increments (e.g. 0.1 km).

When the FLARM was able to receive the FLOICE, the distance between the two helicopters was in the range of approximately 100 m – this was observed on the display by the flight instructor. The approach speed of HB-ZBB was 120 to 130 kt (approx. 60 m/s), which meant that the time interval before collision or crossing was approximately two seconds. This corresponds to the highest warning level, which is why the device correctly issued the appropriate alert, whereupon the crew were able to see HB-ZRY. In this respect the FLARM ultimately fulfilled its purpose, since the warning made the crew aware of HB-ZRY and allowed a collision to be avoided by an abrupt avoidance manoeuvre. However, the warning provided by the device was very late due to the reduced reception range and it therefore did not function as intended.

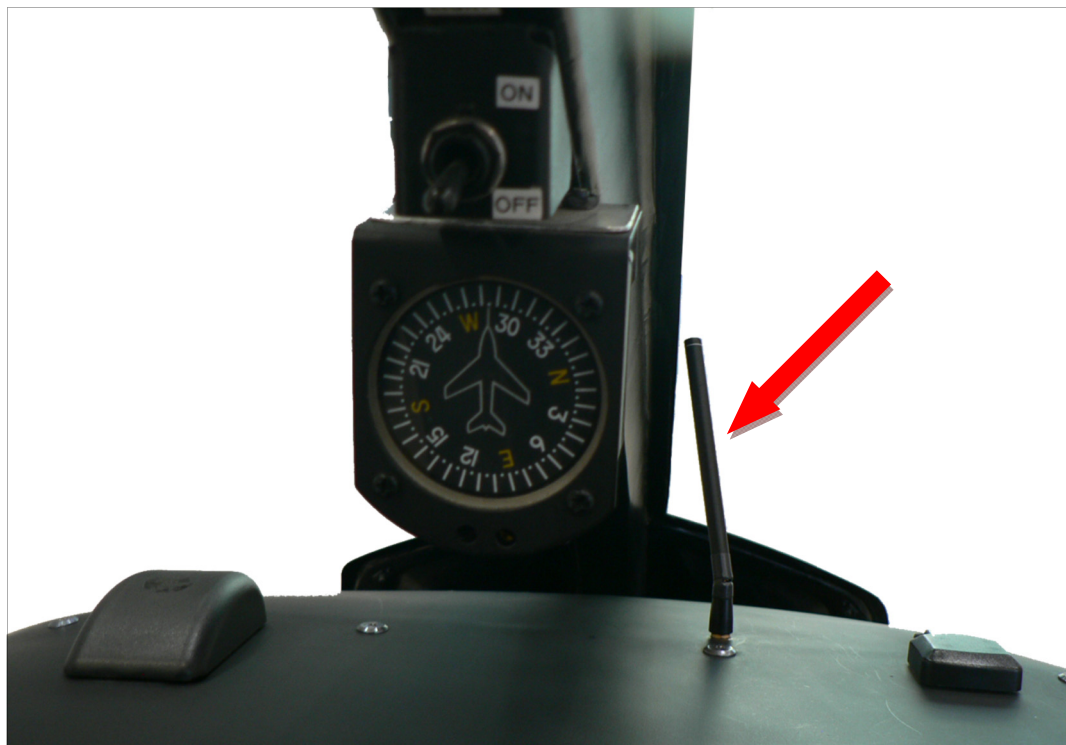
Figure 7: FLARM antenna on the cover of the instrument panel of HB-ZBB.

The installation of the FLARM device and the antennas on HB-ZBB was investigated in cooperation with the manufacturer of the device. It was possible to determine that the positioning of the FLARM antenna (cf. Figure 7) was essentially appropriate and should be able to achieve a good range at least in the forward direction. The FLARM antenna itself was checked and showed parameters in the normal range. Furthermore, it was found that the connecting cable between the device and the FLARM antenna was very long and was therefore wound several times during the installation. This can have a negative influence on transmission and reception efficiency.

During these investigations the flight instructor mentioned that the FLARM antenna was regularly unscrewed and screwed back again in order to put a cloth over the cover of the instrument panel to protect it against solar radiation during the ground time of the helicopter. This procedure holds the risk of damage or excessive wear of the contact points of the antenna. Furthermore the antenna can be forgotten or screwed incorrectly.

Apart from the very limited reception range there is no evidence of a FLARM malfunction. Since the device met the transmission and reception specifications, the reason for the limited reception range should probably be sought in relation to the installation conditions and FLARM antenna. The respective analysis revealed some factors which were not in favor of an optimal range. Nevertheless, the exact cause of the limited reception range could not be determined in detail.

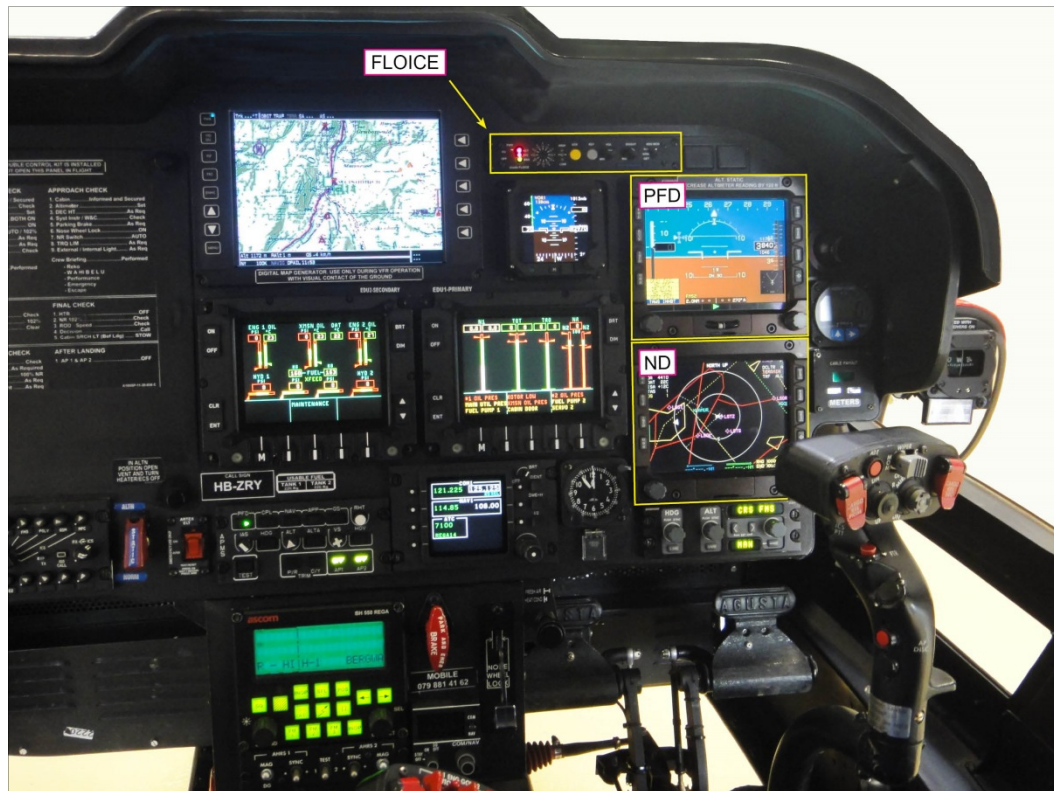
Figure 9: HB-ZRY instrument panel (Photo: Rega). The PFD and ND are on the right. The FLOICE is to the left above the PFD.

The TAS therefore did not function as intended: this represents a fundamental safety hazard.

- There are no indications of any specific technical defects on the TAS.
- In the context of test flights with an AW109SP it was found that the functioning of the TAS had a certain directional dependence, insofar as approaches from the right and rear right were sometimes not recognised by the TAS.

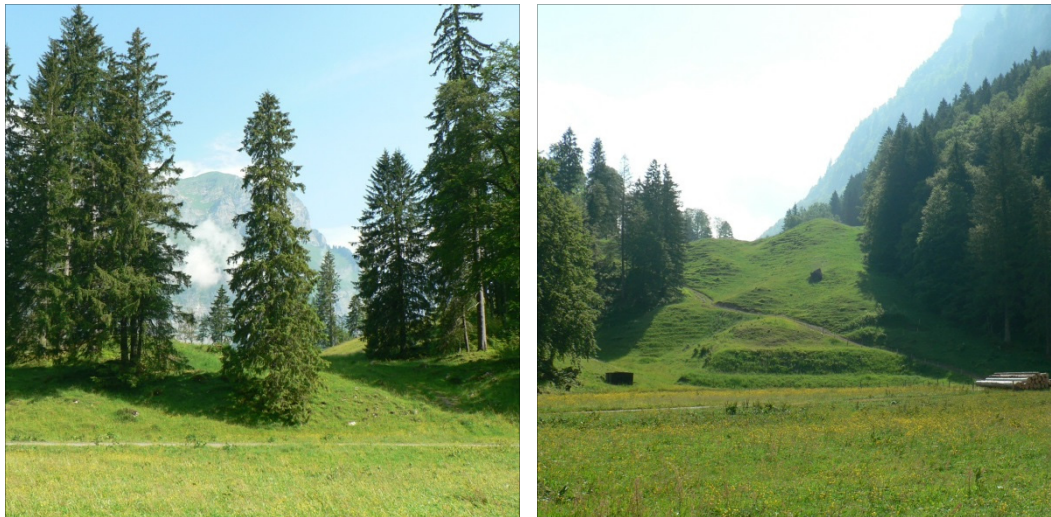
Towards the Glarner Haupttal valley, however, the visibility is severely restricted due to rising terrain and trees. Visibility is also restricted in the direction of Unter Stafel (cf. Figure 10).

Figure 10: Take-off and landing site Hinter Saggberg. Left: Looking towards Unter Stafel. Right: Looking towards Glarner Haupttal valley (Photos: June 2014).
