Final Report No. 2236

by the Swiss Transportation Safety Investigation Board (STSB)

concerning the serious incident involving
the Hawker Beechcraft Beechjet 400A
aircraft, registration N400AJ, converted to
Nextant 400XT,

on 12 June 2012

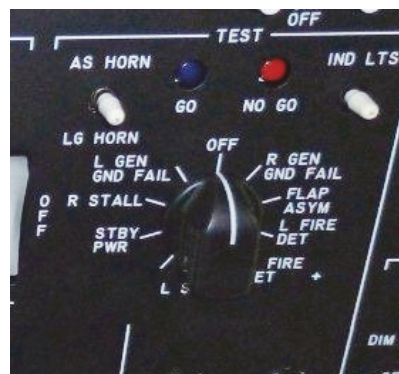
Figure 1: Master test switch

The SIC again referred to the CAE SimuFlite checklist and independently performed several checks that she had not yet performed in order to conserve the battery before starting the engines. One of these was the master test, in which various systems were tested for GO or NO GO by means of a rotary switch on the overhead panel. Turning this switch from the "OFF" position to either of the first positions causes both generators to go off-line (cf. Section 1.6.4), which is correspondingly indicated. This went unnoticed by the crew.

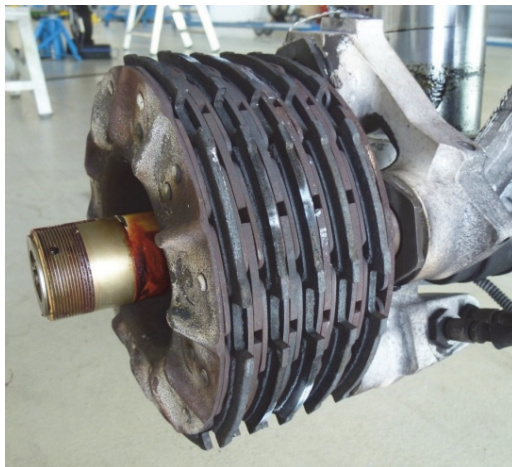
Figure 2: Left braking system

The main wheel thermal fuses vented air after a few minutes after landing due to overheating. The left and the right braking systems exhibited clear signs of overheating.

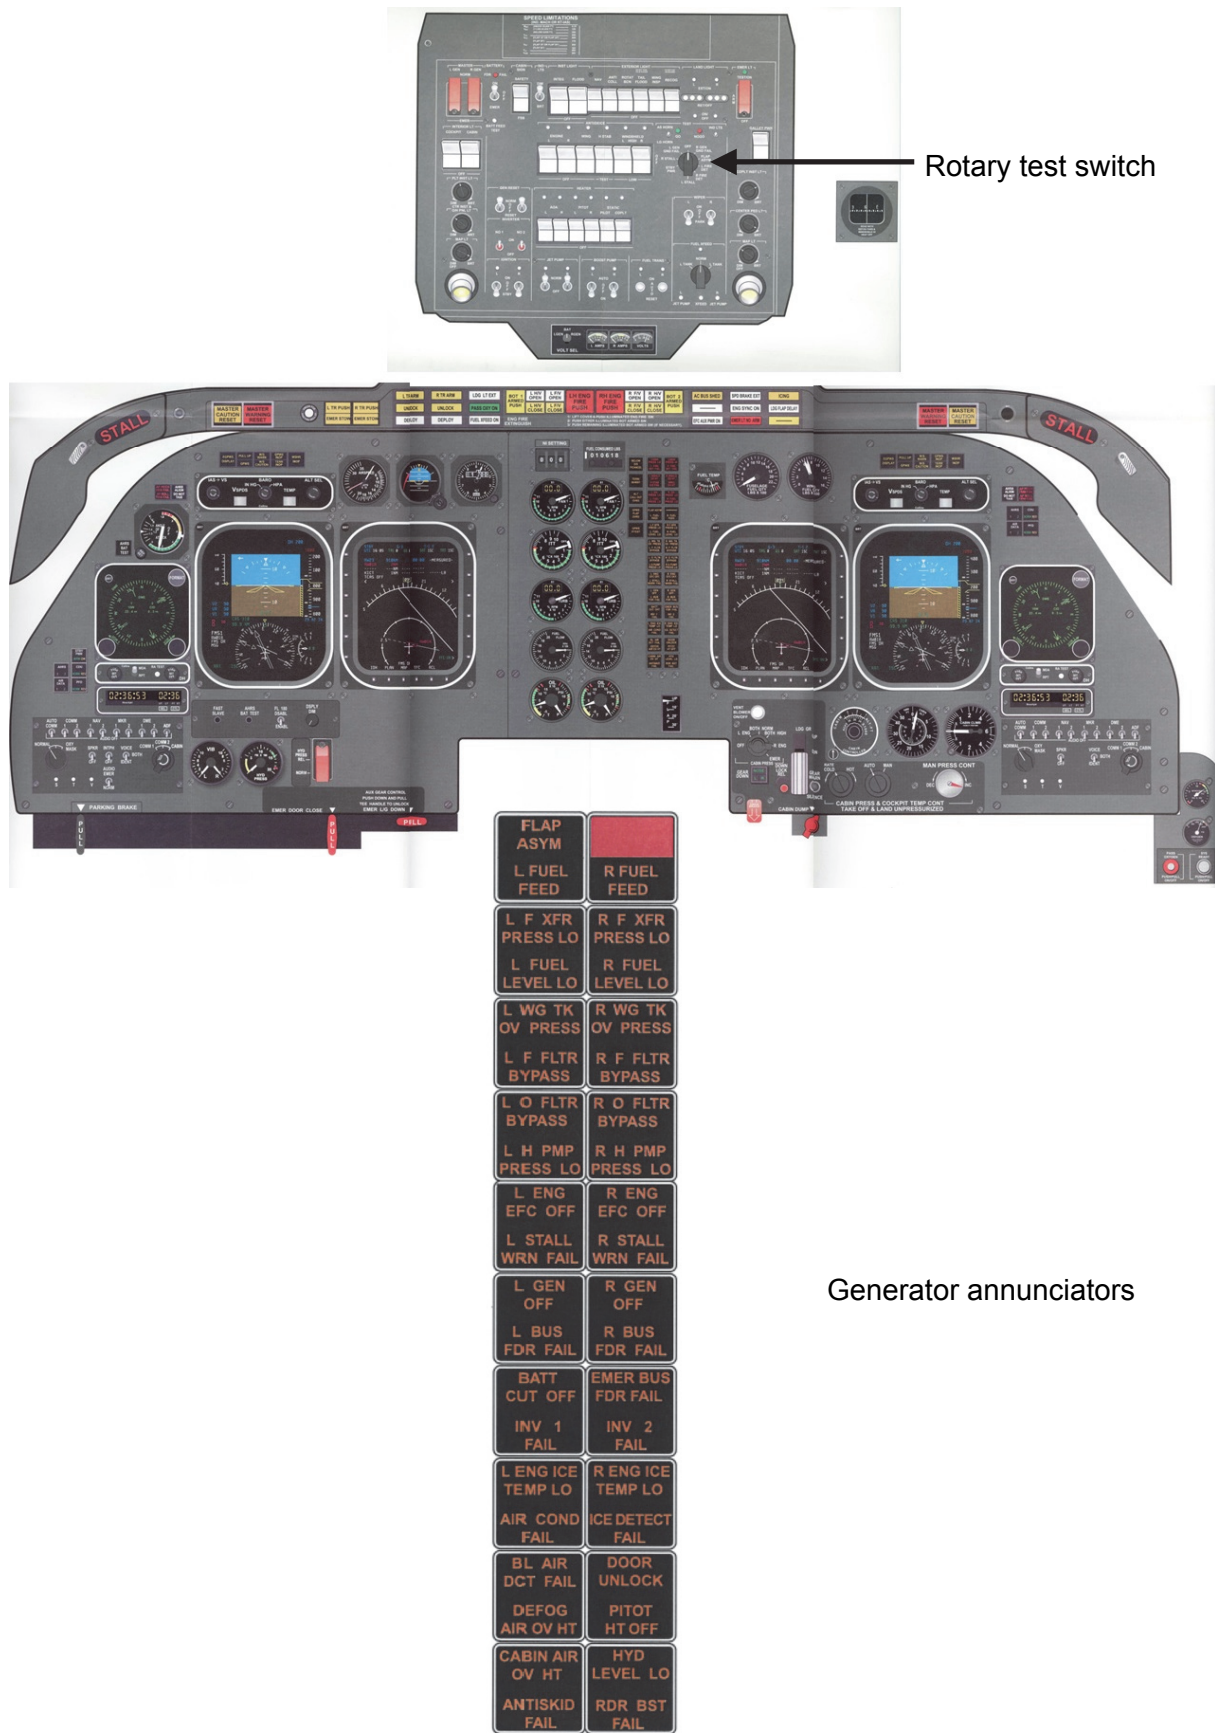
Annex 3: Original layout of the cockpit displays and controls (Type 400A)

In the original version of the aircraft (model 400A) the annunciators of the master warning/caution system (MWCS) were mounted in two vertical rows between the main display screens (see Annex 3). The top six displays were red warnings. Below these were 20 amber caution displays. Two annunciators could be displayed in each field. The two displays for off-line or failed generators were situated in the centre of the amber displays, which corresponded approximately to the horizontal centre line of the screens. This was the arrangement with which the crew was familiar on the basis of their experience.

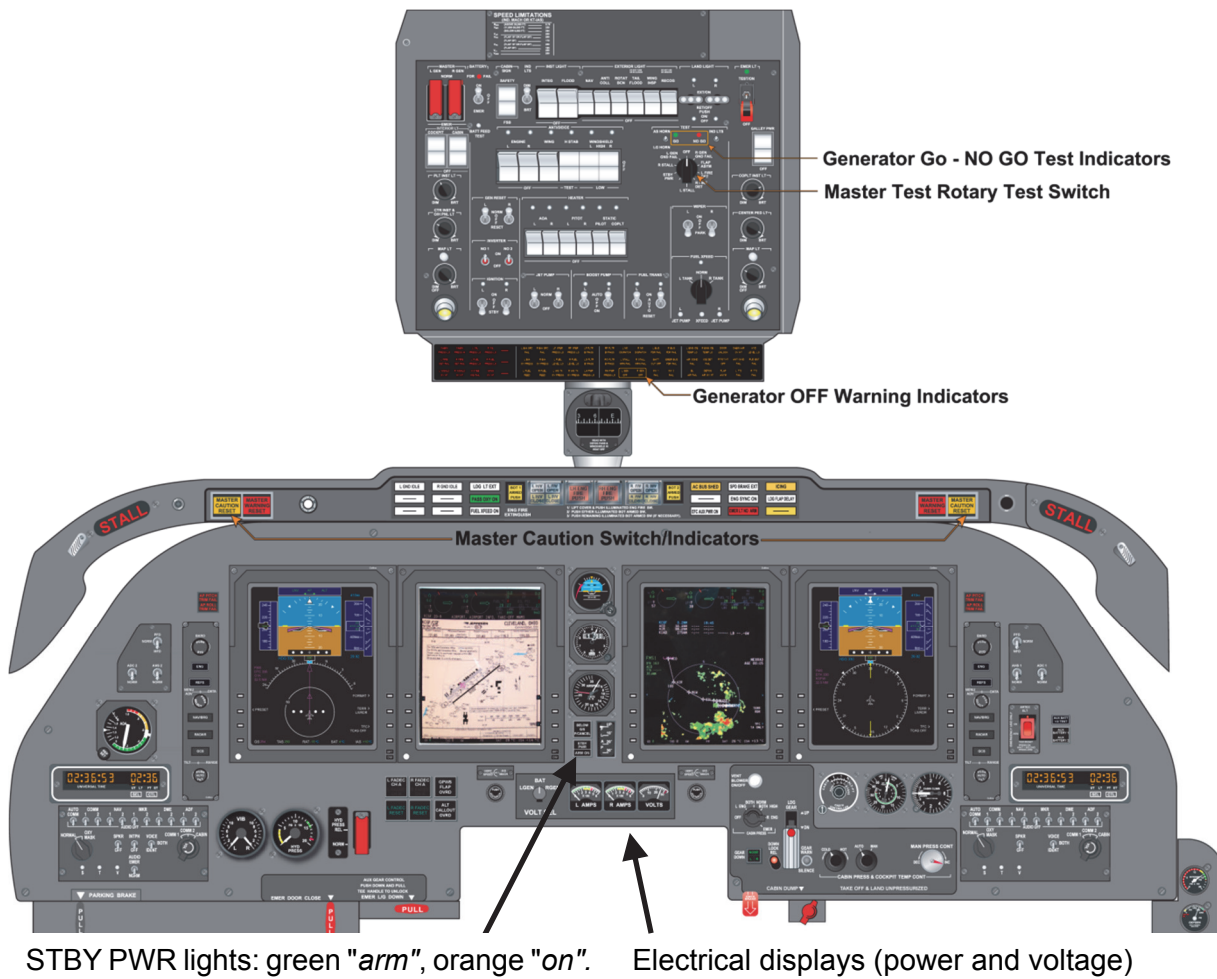
Annex 4: Modified layout of the cockpit displays and controls (Type 400XT)

The annunciators were arranged in 4 groups of 15. All red annunciators are located in the left group, closest to the central field of vision of the pilot in the left seat. The amber annunciators for deactivated or failed systems are to the right of these. In the middle of these three groups are the annunciators for the operating status of the two generators (see Annexes 4 and 5).

During the modification to type 400XT the Master Caution/Master Warning (MCMW) was moved from the instrument panel (see Annex 3) to the bottom of the overhead panel (see Annex 4 above).
