Final Report No. 2240

concerning the serious incident involving
the Fokker F28 Mk 100 aircraft,
registration HB-JVH

on 15 July 2013

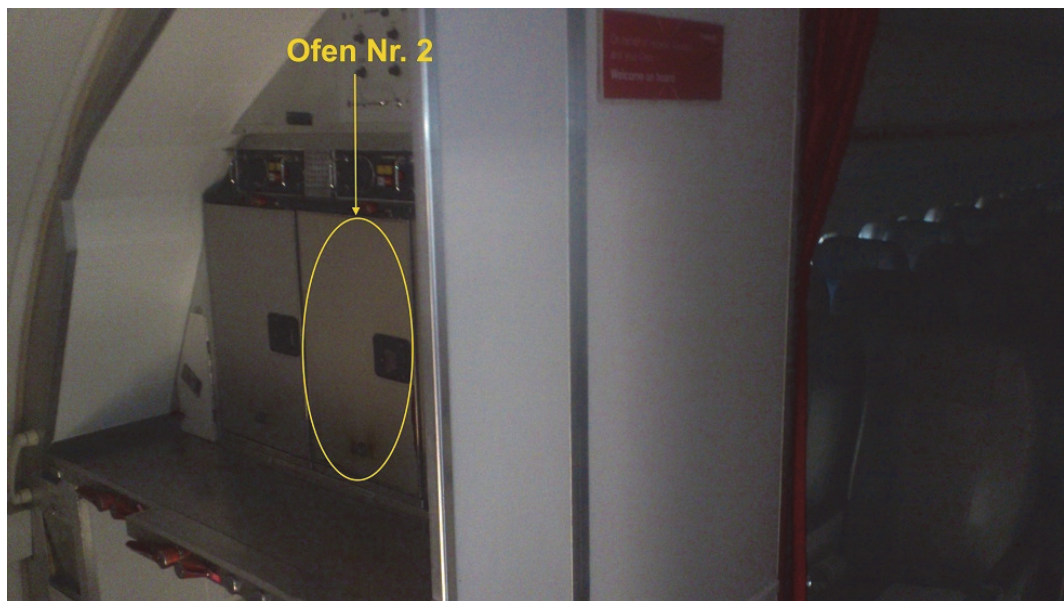
The affected oven², which was manufactured by Rumbold, was incorporated into the galley towards the front of the aircraft. The following figure illustrates the position from the left front entrance door.

Figure 1: Looking towards the cabin.

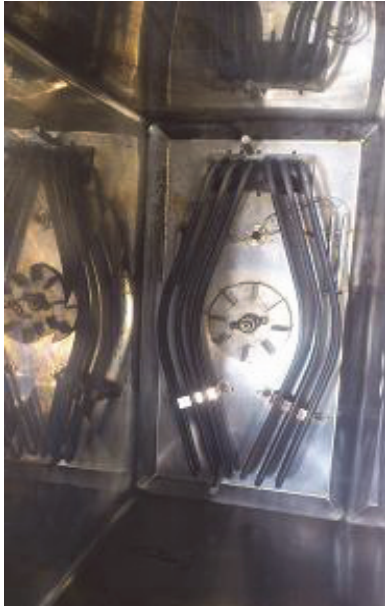
Two different types of oven are used in the galley on the Fokker F28 Mk 100 aircraft type operated by Helvetic Airways. One variant has a cover plate at the rear wall in front of the heating element. The other version does not feature such a cover plate; this construction therefore has an unprotected heating element facing the inside of the oven. The oven which generated smoke during the serious incident had an unprotected heating element (see. Figures 4 to 7).

Figure 4: Oven with unprotected heating element

The cabin crew stated that in their opinion the cover plate for the heating element of oven no. 2 on the HB-JVH aircraft had been missing for "a long time".

- In the present case, the oven had an exposed heating element and the appropriate tray rack was not used.
- The regulations of the aviation operator in relation to inspection of the oven are general in nature and no distinction is made between the two oven types.
- The weather conditions had no influence on the serious incident.

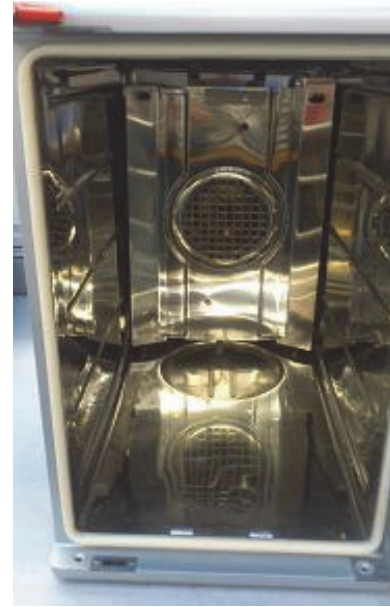
Figure 5: Oven with protected heating element

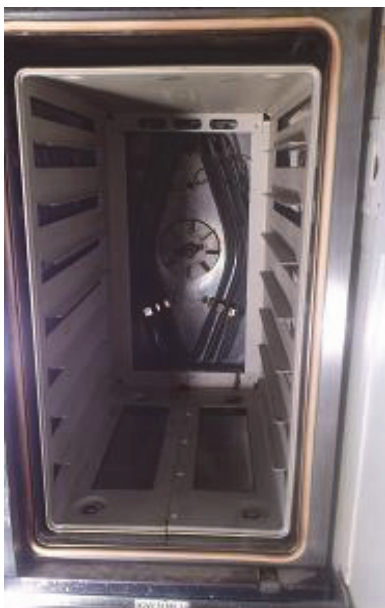
Figure 6: Tray rack without rear wall

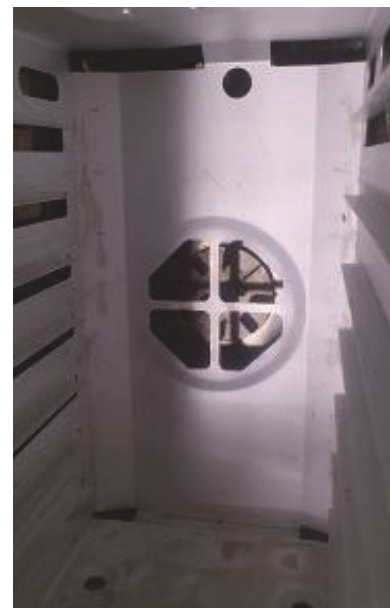
Figure 7: Tray rack with rear wall
