Final Report No. 2245

concerning the accident involving the
Bombardier DHC-8-402 aircraft, registra-
tion 9A-CQC,

on 27 September 2013

on runway 14 of Zurich Airport

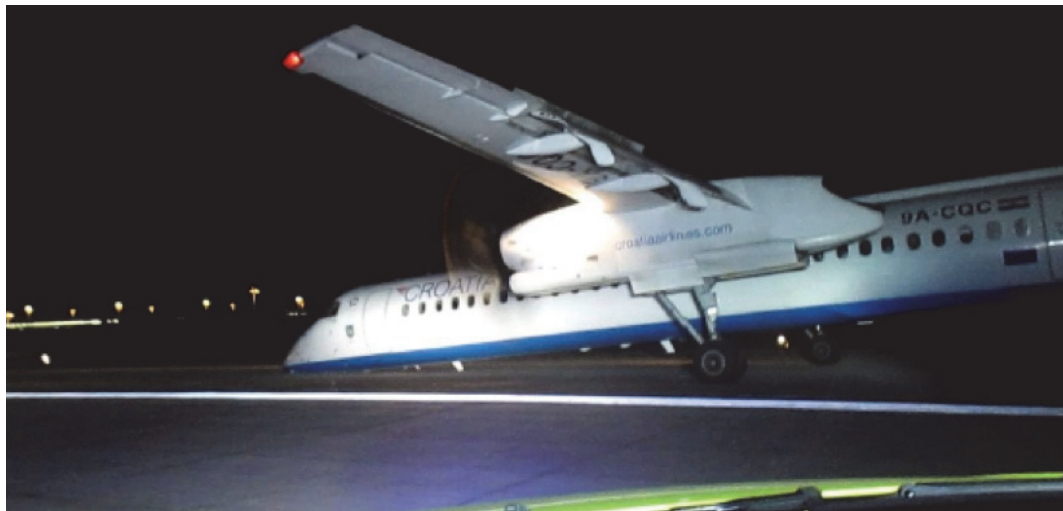
Approximately 1000 m after touchdown the nose of the aircraft made contact with the runway surface. After another 540 m, the aircraft came to a standstill approximately on the centerline of the runway (see Figure 1 and 5). The commander stated that he braked slightly and used no reverse thrust during the landing. Shortly after the aircraft came to a standstill the parking brake was set and both engines shut off. The commander commented that they had been ready to pull the fire handles. He stated that they had refrained from doing so because no fire warning was displayed and the fire brigade, which was at the aircraft's location only a few seconds after it came to a standstill, notified them via aerodrome control that no fire had broken out.

Figure 1: The aircraft immediately after coming to a standstill, photographed from the leading fire brigade engine. The propellers are still turning.

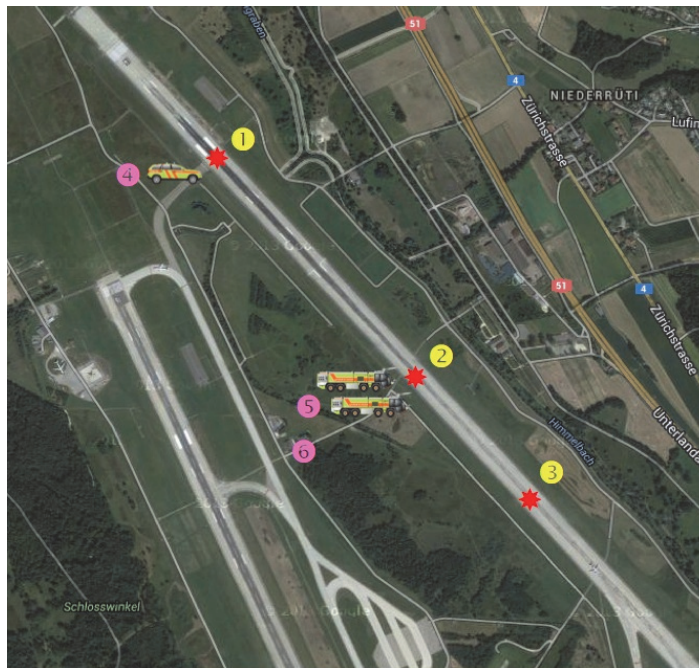
- ❶ Main landing gear touches down
- ❷ Nose makes contact with the runway surface
- ❸ Aircraft comes to a standstill
- ❹ „Florian 1” vehicle
- ❺ Airport fire engines
- ❻ Satellite road

Figure 5: Part of the fire brigade's deployed fleet according to the information by Schutz und Rettung Zürich.

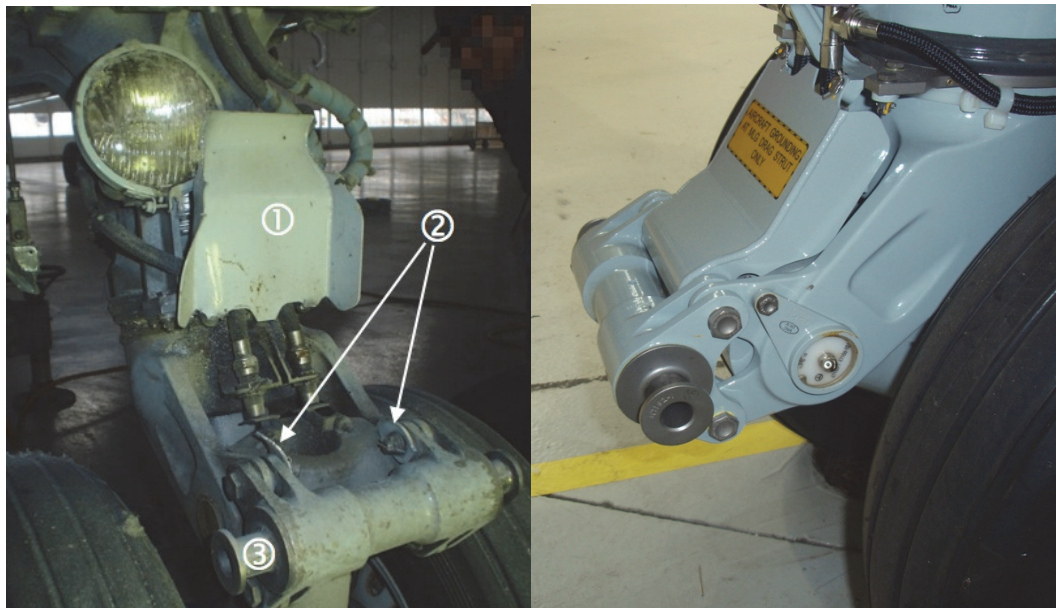
It was found that the cover plate which protects the two weight on wheels (WOW) sensors was broken on the lower left and right lugs. This weight on wheels proximity switch cover plate [hereinafter referred to as the WOW cover plate] was discovered bent upwards around the upper tab mounts (see Figure 6). Photographs taken at the site of the accident also revealed that the WOW cover plate was jammed in the nose landing gear mechanism (see Figure 7 and 8). It can be seen that it became trapped between the drag brace, the taxi light, the supporting lugs and possibly the respective bracket.

Figure 6: Left: WOW cover plate as it was discovered after the nose landing gear was extended
Right: WOW cover plate in its normal state.
1: WOW cover plate
2: lower lugs (broken)
3: tow fitting assembly

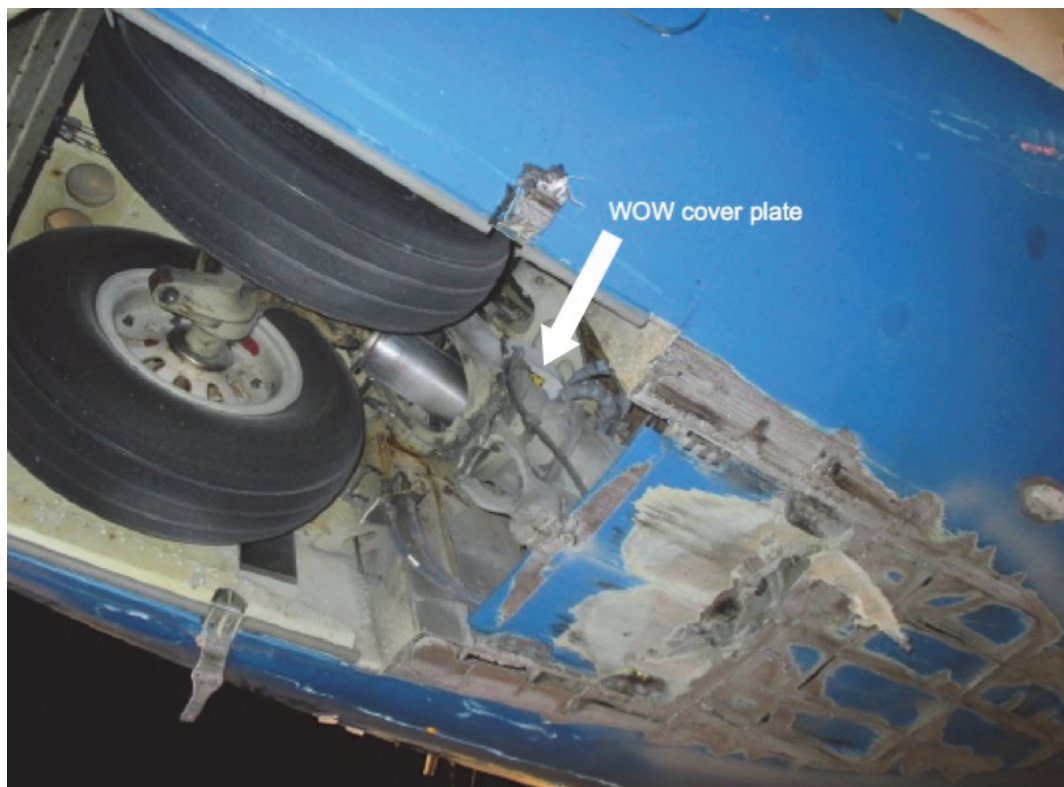
- The WOW cover plate on the nose landing gear was broken on both lower lugs so that it was bent upwards around the upper tab mounts and was trapped in the nose gear mechanism, which prevented the extension.

Figure 7: The nose landing gear WOW cover plate trapped between the upper and lower drag struts of the nose landing gear. This photo was taken at the scene of the accident.

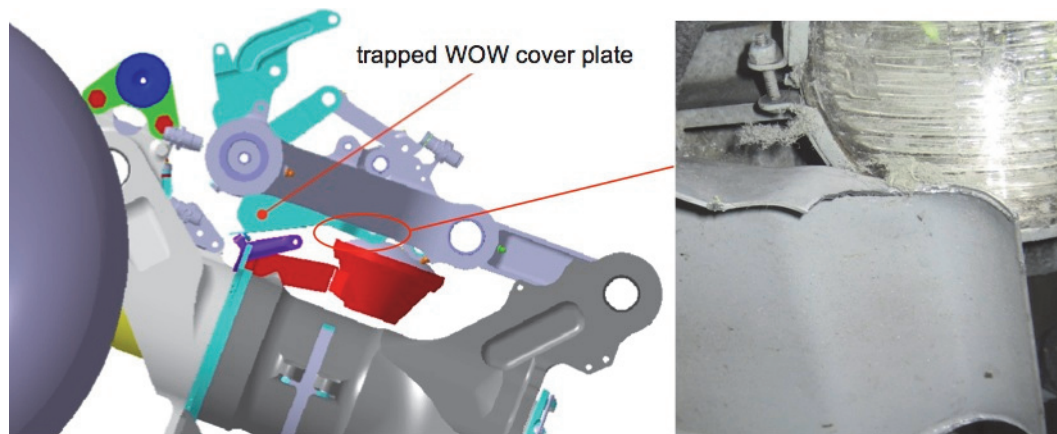
Figure 8: Left: The trapped nose landing gear WOW cover plate. Simulation picture created by the gear manufacturer.
Right: view from above, upwards bent WOW cover plate and taxi light.

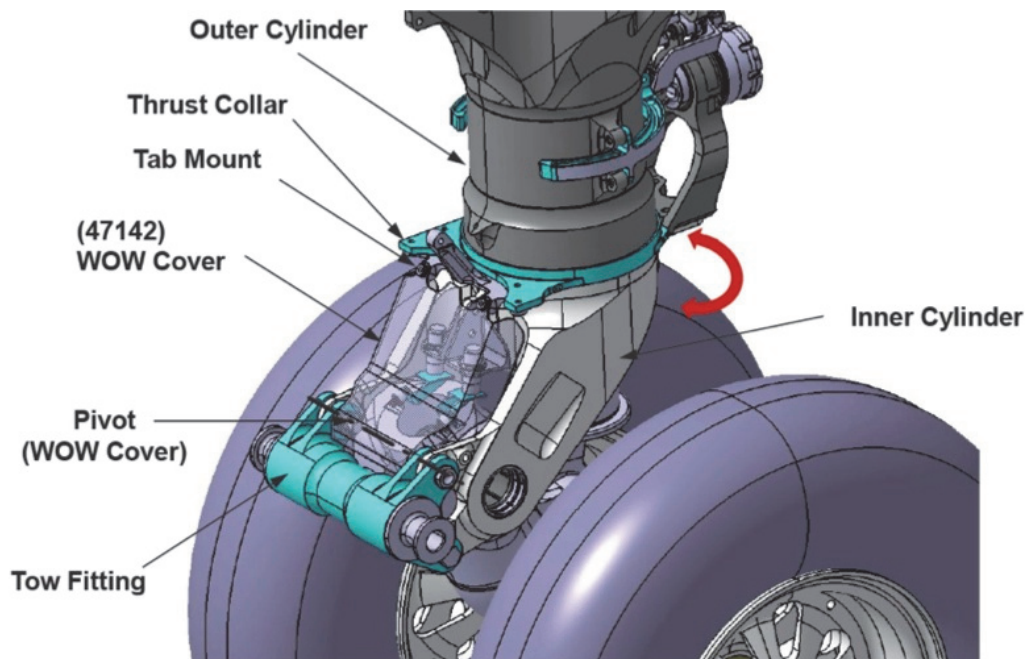
Per design, the WOW cover plate is not firmly connected with the inner cylinder via the lower lugs. A certain amount of lateral freedom is provided. However, the existing clearance is not large enough to absorb the residual rotation completely. This can cause the WOW cover plate to come into contact with adjacent parts of

the landing gear, which can lead to mechanical stress in the upper and lower lugs.

Figure 9: WOW cover plate mounting assembly
(Image from the gear manufacturer, adapted by the STSB)

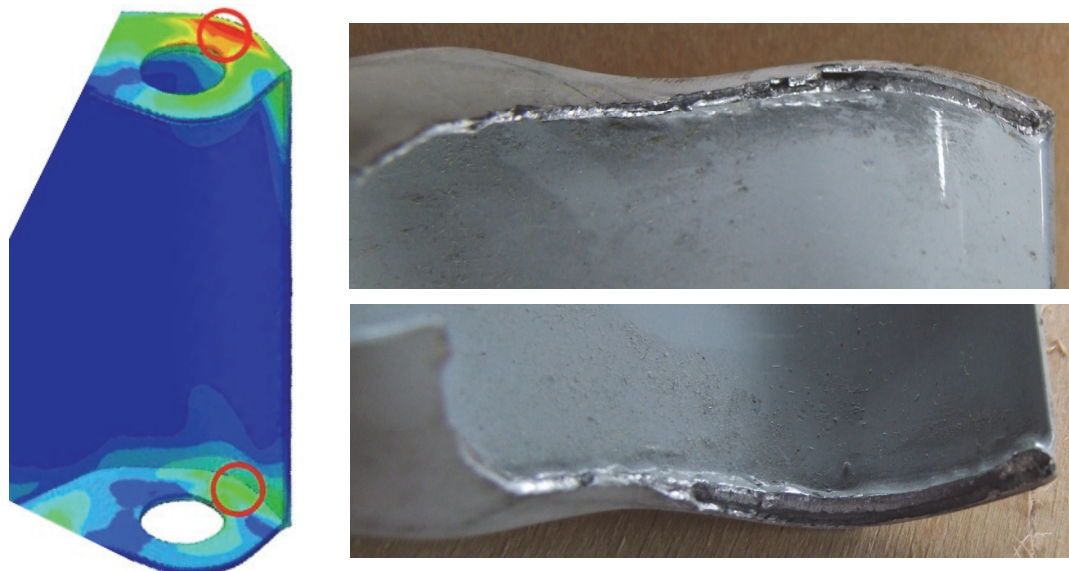
Using a computer simulation, it was also possible to prove that the resulting stress on the upper lugs is generally greater than that on the lower lugs. The main stress points in the area of the upper and lower lugs determined in this manner were also at the points where the WOW cover plates actually failed in operation. On the lower lugs this was in the area of the welding seams (see Figure 10).

Figure 10: Left: View from below onto the WOW cover plate in a simulation. The red circles show the simulated stress concentration in the area of the lower lugs (image from the gear manufacturer, adapted by the STSB).
Right: WOW cover plate from aircraft 9A-CQC after the accident. The lower lugs are broken at the welding seams.

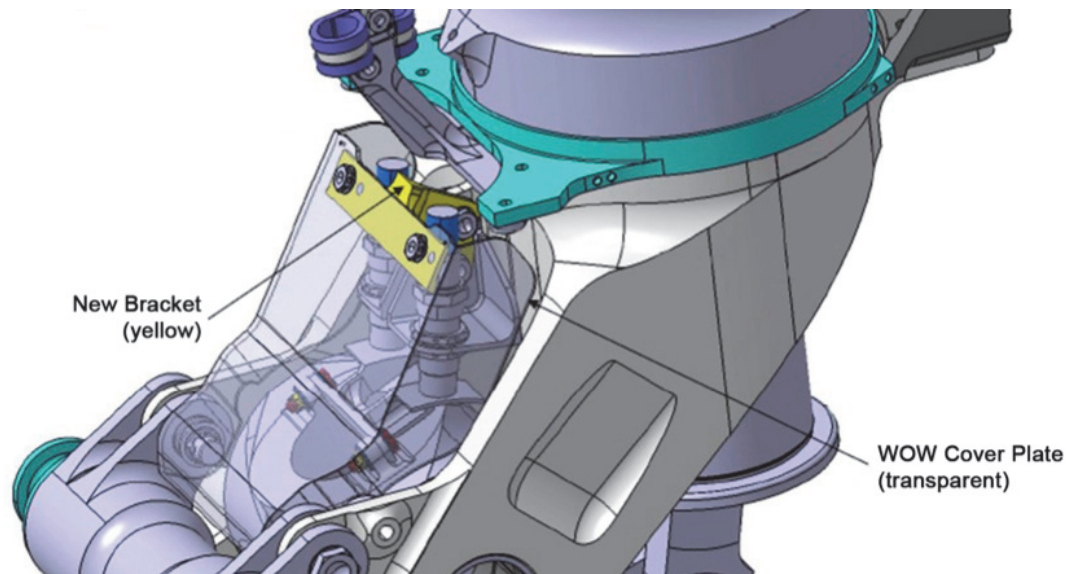
Figure 11: The plan is to no longer mount the WOW cover plate on the thrust collar; instead it will be mounted to the inner cylinder using a new bracket (Image from manufacturer's design study, adapted by the STSB).

The aircraft manufacturer announced after the completion of the joint investigation with the landing gear manufacturer (cf. chapter 1.18.3) that a new way of mounting the WOW cover plate is planned. A respective design study is available. The plan is to no longer mount the WOW cover plate directly on the thrust

collar; instead it will be mounted to the inner cylinder using a new type of tab bracket (see Figure 11). This is to prevent unwanted lateral forces being transferred to the WOW cover plate via the nose landing gear steering.
