# **Final Report No. 2246**

concerning the serious incident involving  
the Airbus A320-214 aircraft, registration  
HB-IOR,

on 1 October 2013

at Porto Airport, Portugal

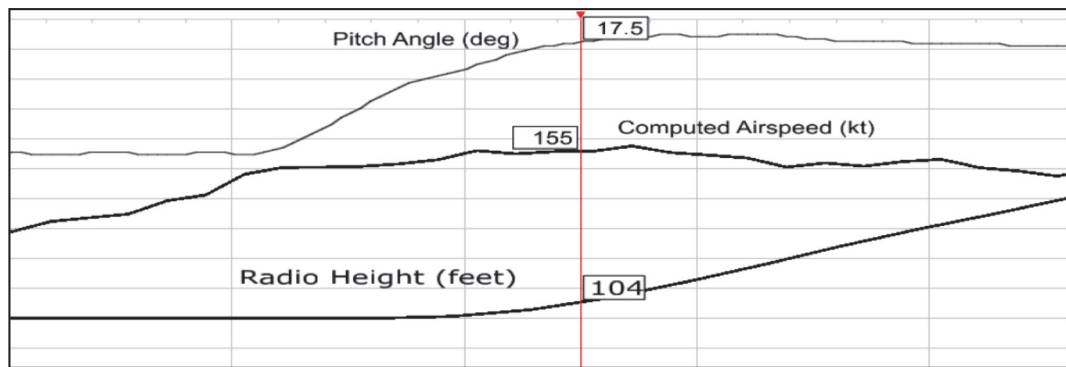
At 15:43 UTC, HB-IOR began its takeoff roll from intersection Foxtrot with 153 passengers on board and with an engine power which had been planned for a full-length takeoff. Although this reduced engine power was sufficient for a normal takeoff, however, according to the manufacturer's official performance calculations, it did not meet the following two requirements (cf. chapter 1.18.1):

The decision speed of 140 knots was achieved 700 m before the end of the runway, when level with the taxiway Delta intersection. The aircraft took off when level with the taxiway Charlie intersection, 350 m before the end of the runway. The radioaltimeter registered a height of 104 ft above the end of the runway (see Figure 1).

**Figure 1:** Pitch angle, computed airspeed and radio height at the time the aircraft passed the end of the runway (marked in red).

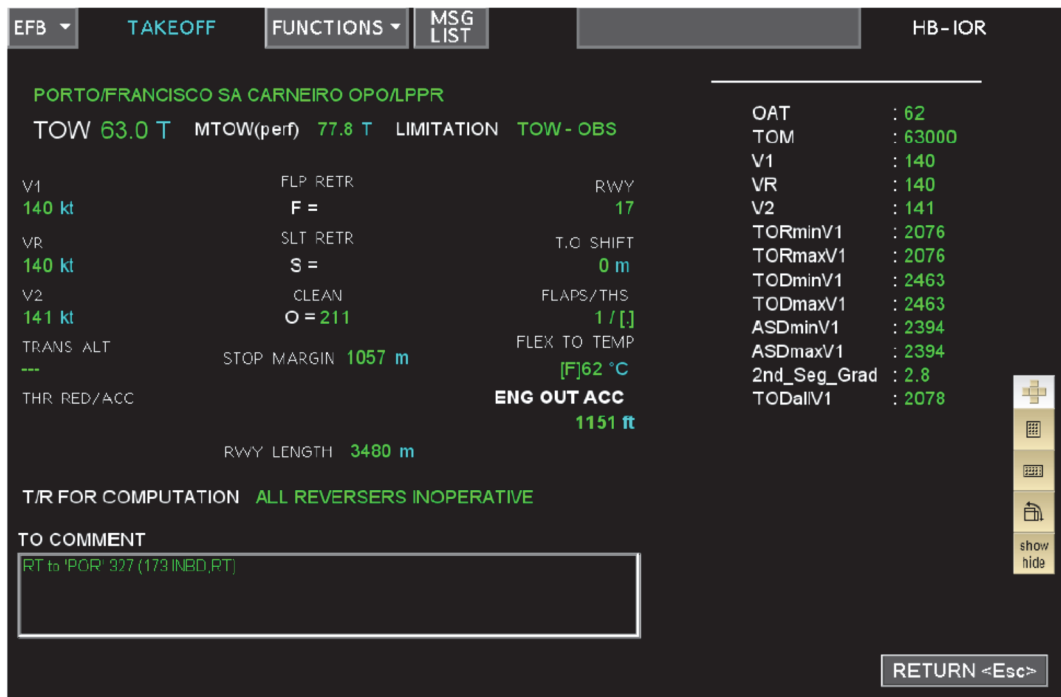
At 15:20 UTC the commander used the information provided by the loadsheet to recalculate the engine power for the entire available runway length of 3480 m (takeoff run available – TORA), which offered the maximum possible protection for the engines. In the event of an engine failure and continued takeoff a takeoff run (TOR) of 2076 m was thereby determined and a value of 2463 m (takeoff distance – TOD) for the corresponding takeoff run to a height of 35 ft. For the required runway length in case of a rejected takeoff (accelerate stop distance – ASD) a value of 2394 m was determined (see Figure 2). For a takeoff from intersection Foxtrot the TORA was 1900 m.

**Figure 2:** Results of the takeoff performance calculation on the screen of an EFB

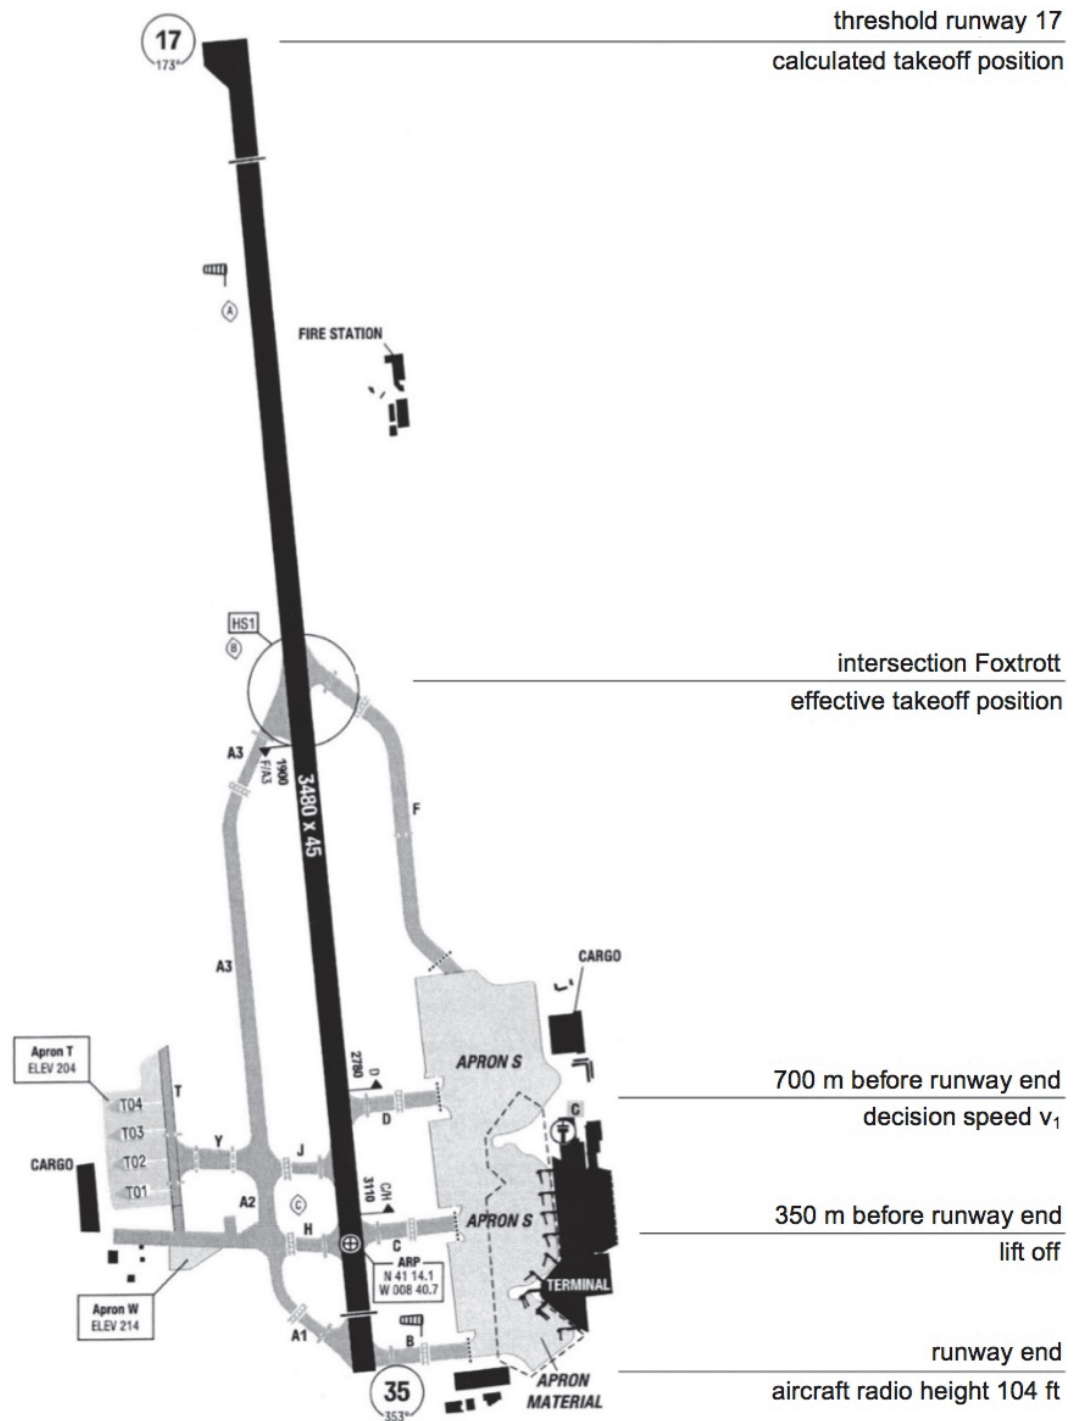
A runway length of 1900 m is available for takeoffs from runway 17 from the intersection Foxtrot. The area beyond the end of the runway cannot be used as a stopway in the event of a rejected takeoff.

**Figure 3:** Runway and taxiways at Porto Airport and takeoff sequence of HB-IOR
