# **Final Report No. 2249**

## **by the Swiss Transportation Safety Investigation Board STSB**

concerning the accident involving the  
EC 120B helicopter, registration HB-ZIX

on 26 September 2013

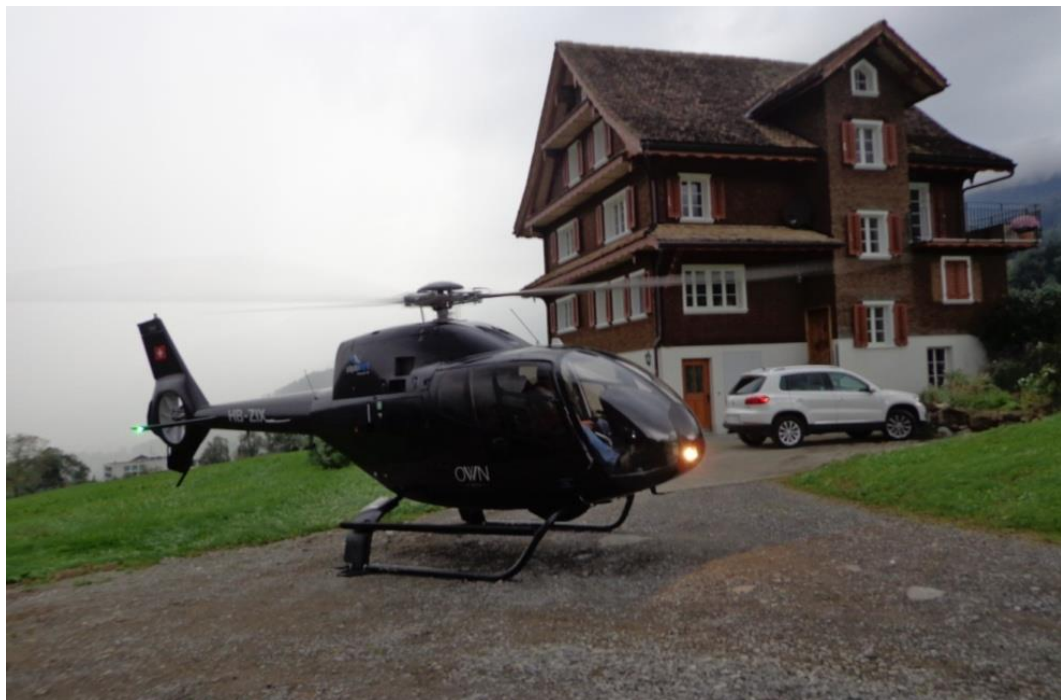
**Figure 1:** The HB-ZIX helicopter shortly before take-off. The recording was made by the passenger.

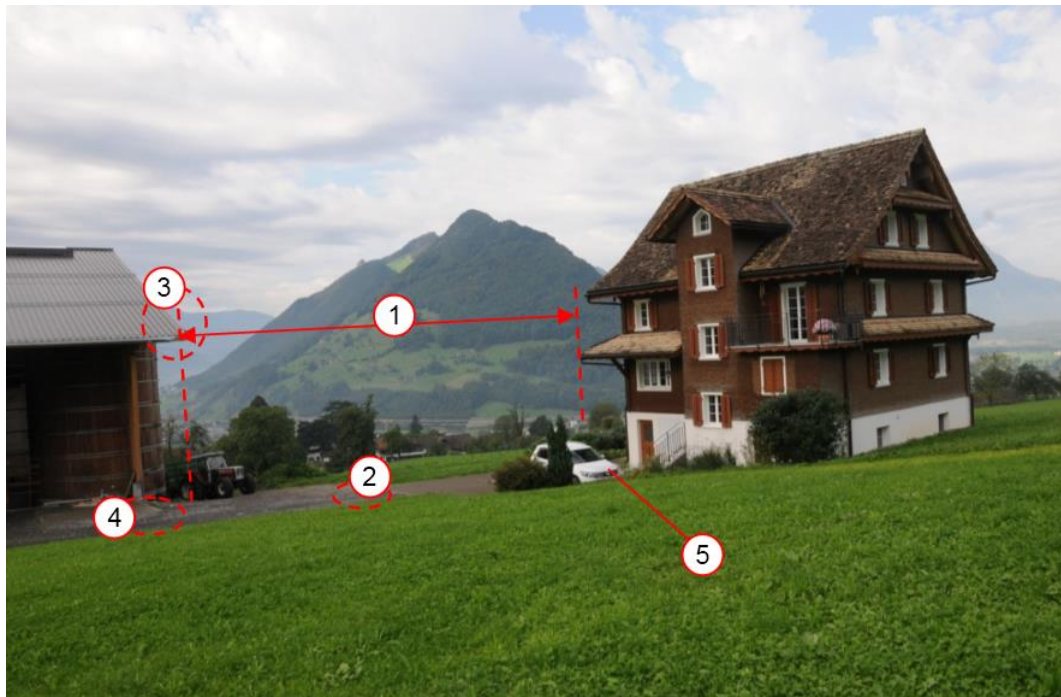
The accident site was located at Oberes Herrenfeld between a large barn and a farmhouse (see Fig. 2). The meadows next to and below the two buildings are gently sloping. Above the buildings the gradient increases, apart from a few level areas. The distance between the projecting barn roof and the farmhouse was 16.3 m. The white passenger vehicle was parked on the forecourt in front of the farmhouse during both helicopter landings. The difference in height between the projecting barn roof and the ground was approximately 6.4 m. The barn roof projected 3.3 m beyond the outermost pillars. The approach sector was in a south-westerly direction, while the departure sector was in a northerly direction.

**Figure 2:** Site of the accident: ① Distance of 16.3 m, ② HB-ZIX landing site, ③ point of collision between the main rotor blades and the projecting barn roof, ④ final position of the helicopter after the accident, ⑤ parked passenger vehicle.

The distance between the farmhouse and the projecting barn roof was 16.3 m. Landing directly between these two buildings gives a lateral rotor clearance of approximately 3 m on each side. Landing in such a tight space is not appropriate under the circumstances. On the second landing, the distance to the projecting barn roof decreased significantly since the landing took place 1 to 1.5 m further to the right. Furthermore, according to his statement, the pilot was not aware of the extreme forward projection of the barn roof. Neither was he aware of the passenger vehicle in the immediate vicinity of the landing site during the first landing. The gravel dust whipped up by the rotor wash means that landing directly next to a passenger vehicle should be considered inappropriate without a compelling reason.

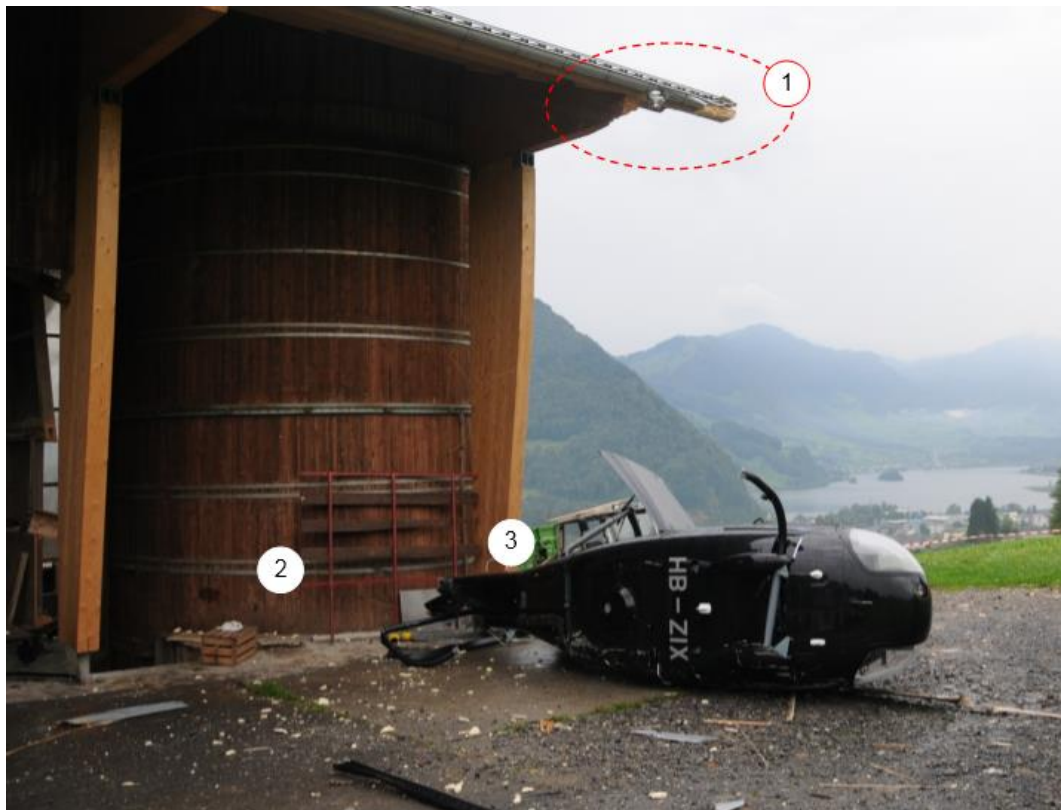
The wreckage was lying on its left-hand side below the projecting barn roof (see Fig. 3). The main rotor blades were separated from the rotor head at the blade roots and were severely damaged. Most of the landing gear was torn from the helicopter. The tail boom was severed in the middle, so that the rear half including the Fenestron<sup>1</sup> was only connected to the rest of the airframe by cables. Smaller items of debris were found within a radius of 25 m. Some fragments were embedded in the wooden silo. There was no leakage of fuel or oil.

**Figure 3:** Final position of the wreckage: ① Point of collision ② and ③ location of the passengers at the time of the accident.

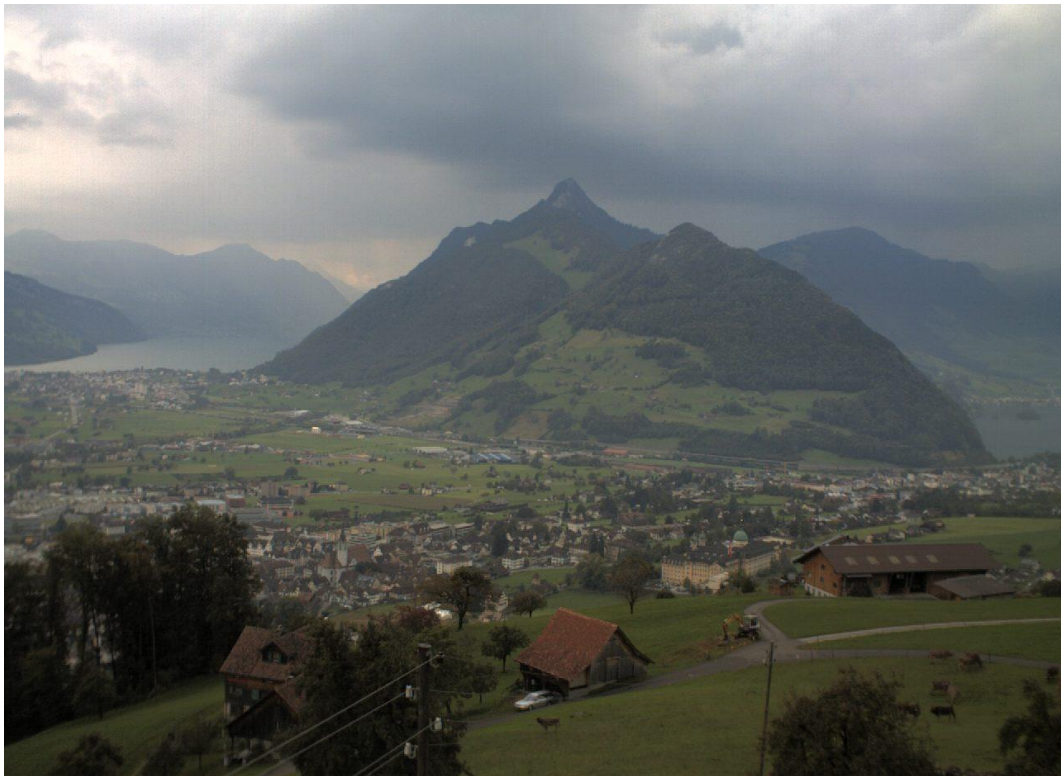
**Figure 4:** Schyz webcam, 26 September 2013, 17:11, 14 minutes before the accident.

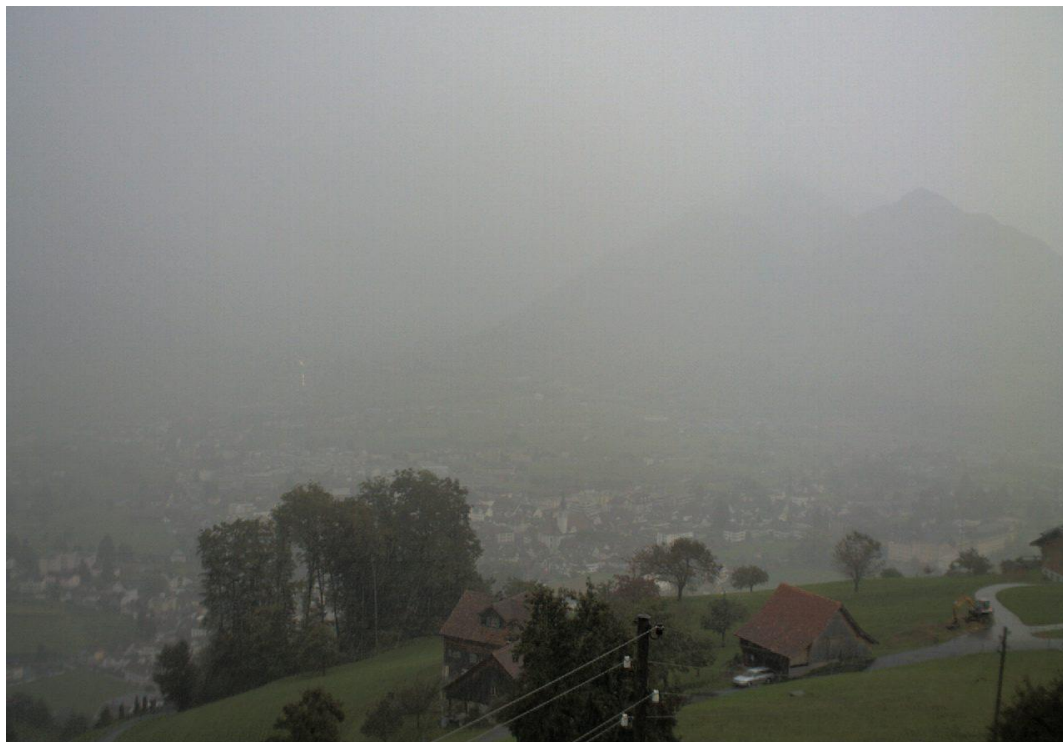
**Figure 5:** Schwyz webcam, 26 September 2013, 17:30, 5 minutes after the accident.
