Final Report No. 2254

concerning the serious incident involving
the AgustaWestland AW109SP helicopter,
registration HB-ZRS,

on 6 June 2013

Zurich Airport

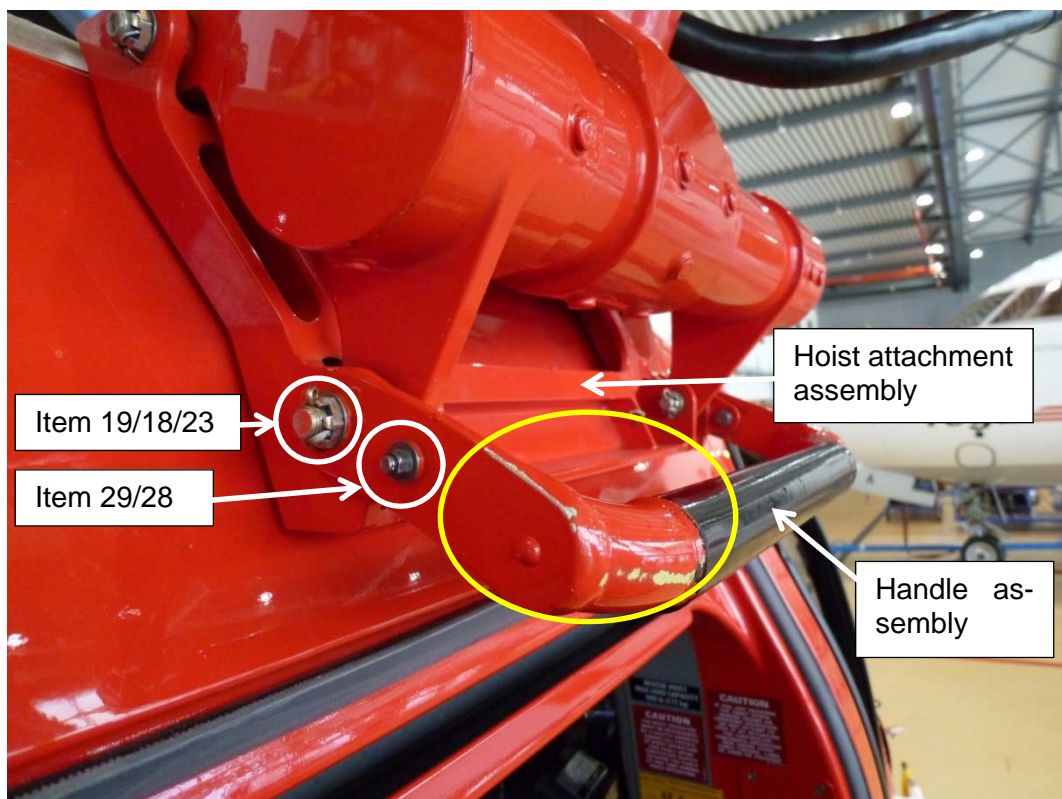
In the context of the investigation, signs of abrasion were detected on the upper edge of the flat brackets of the handle assembly and on the door frame of identical helicopters of this operator (fig. 2 yellow circle).

Figure 2: Rescue hoist installation. The picture is from an identical helicopter type.

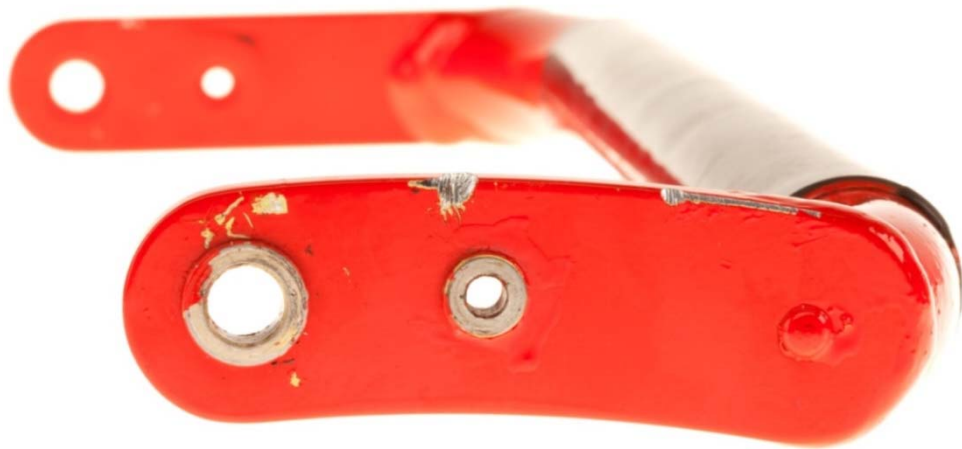
After the serious incident, damage was discovered along the upper edge of the aft flat bracket of the handle assembly, as well as on the nut (Item 29) and the corresponding washer (Item 28) (cf. Fig. 3 - 5). This damage was new, because all damaged paintwork on the handle assembly had been touched up the day before.

The imprint of the surface structure of the hoist cable was clearly visible on the damaged edge of the aluminium flat bracket of the handle assembly, on one side of the nut (Item 29) and on the corresponding washer (Item 28).

All this damage indicates that there was contact with the cable under load.

Figure 3: Handle assembly with the damaged flat bracket (for detail, see Figure 4).

For this reason, the two Hex-head attachment bolts of the Rescue Hoist Handle assembly shall be replaced with two Pan-Head screws from same strength. In addition, the screws are installed the other way round (head on outside instead of the inside) in order to improve the situation for the hoist cable."

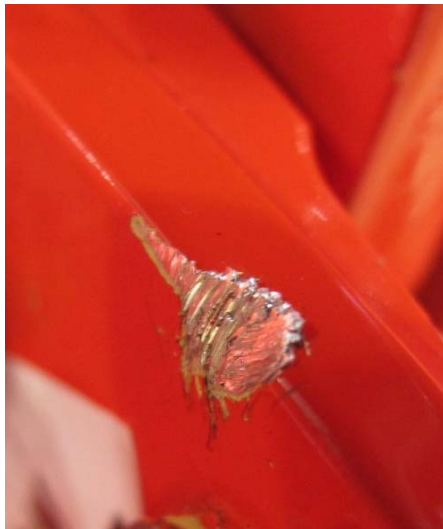
Figure 4: Detail of the damaged edge of the flat bracket with the imprint of the surface structure of the cable.

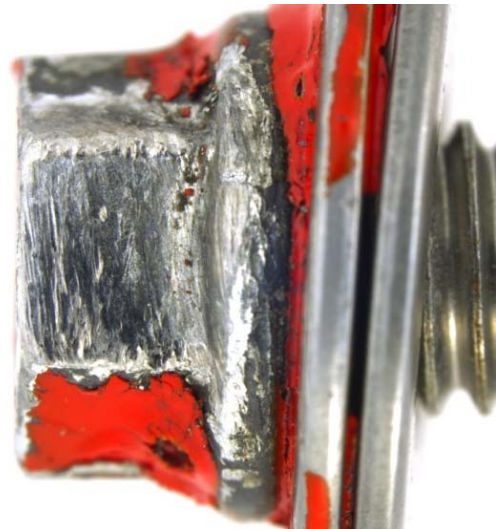
Figure 5: Detail of the damaged nut (Item 29) and washer (Item 28).

The findings of the investigation allow the conclusion that the hoist cable became snagged behind the nut before the load was lifted and subsequently broke under load.

In unfavourable conditions, the cable may become positioned behind the protruding nut (Item 29) of the handle assembly. There is therefore a danger that the cable becomes snagged behind this nut and is then not free to slide away from the side of the handle assembly when the cable is retracted or the load is lifted. As a result, the cable can be bent over the sharp edge of the flat bracket of the handle assembly. In addition, when the load is lifted, the cable loading is not shock-free and the cable could break. This must be prevented using appropriate design measures.

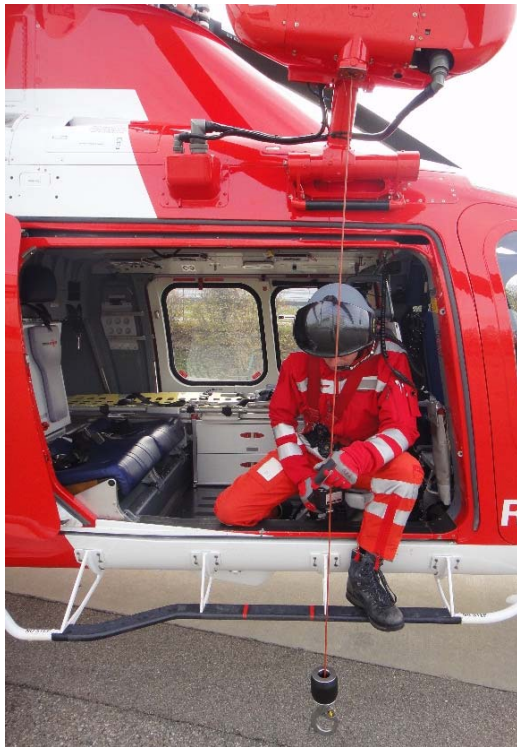
Figure 6: Hoist operator's working position in the case of a normal cable position. The red markings on the step show the limits for the longitudinal position of the hoist cable. They were added after an incident not related with this case based on an airworthiness directive (AD).

The newly added markers on the step bar do not improve the chances of being able to recognise a snagged cable.

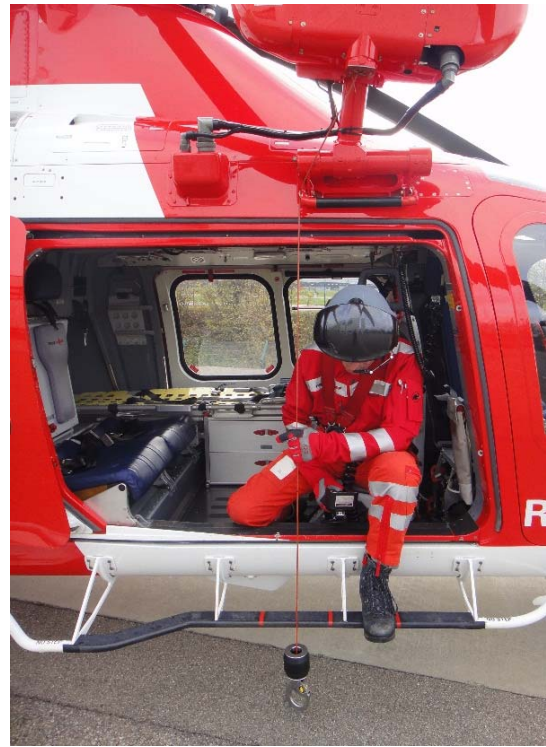
Figure 7: Hoist operator's working position in the case of a snagged cable. The lateral cable offset is approximately 15 cm compared to the normal cable position.

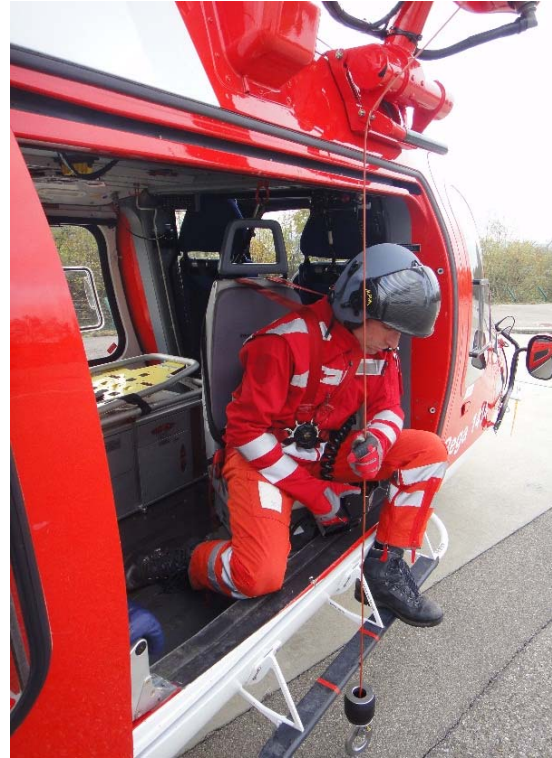
Figure 9: Hoist operator's working position in the case of a snagged cable. The cable hangs closer to the step bar compared to the normal cable position.

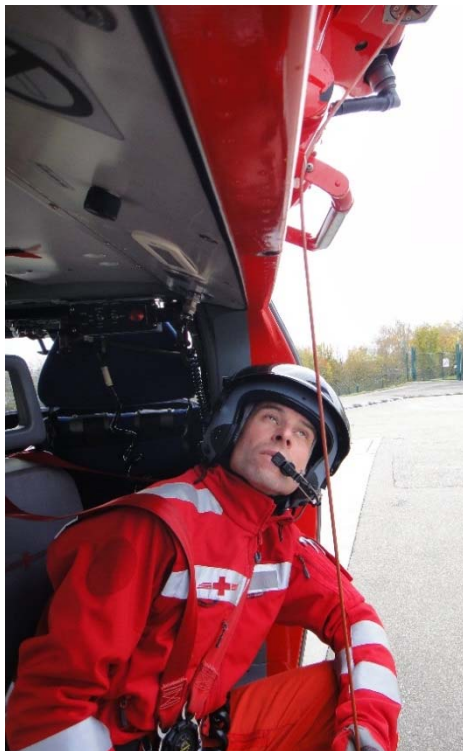
Figure 10: Required working position of the hoist operator to identify a possibly snagged hoist cable.

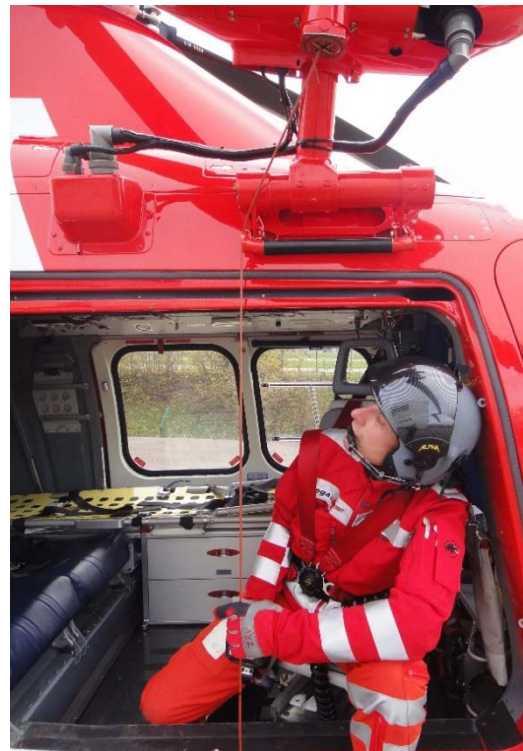
Figure 11: The hoist operator must lean forward until he is below the upper door frame in order to be able to see the rescue hoist.

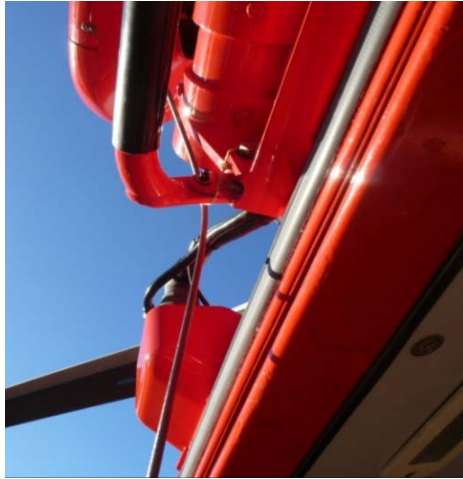
Figure 12: The visible range for the hoist operator if he leans out of the cabin and looks upwards, as illustrated in Figures 10 and 11.

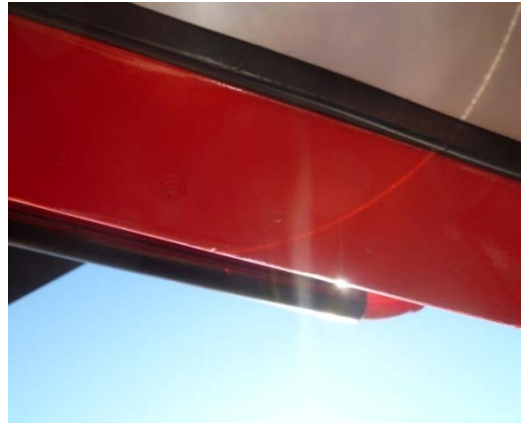
Figure 13: The visible range for the hoist operator if he looks upwards, but does not lean out of the cabin.

In principle, it is only possible for the hoist operator to determine that the hoist cable has snagged on the handle assembly if he is in a corresponding position and looking upwards. However, it should be noted that during operation of the rescue hoist, the hoist operator must focus mainly on events on the ground and on any obstacles in the helicopter's environment. According to the statement of the hoist operator, the visibility from his working position was not perfect and a direct view of the hoist was restricted by his helmet and the cabin structure of the helicopter.
