Final Report No. 2256

concerning the serious incident involving
the A320-214 Airbus aircraft, registration
HB-IOP

on 6 October 2014

at EuroAirport Basel Mulhouse Freiburg

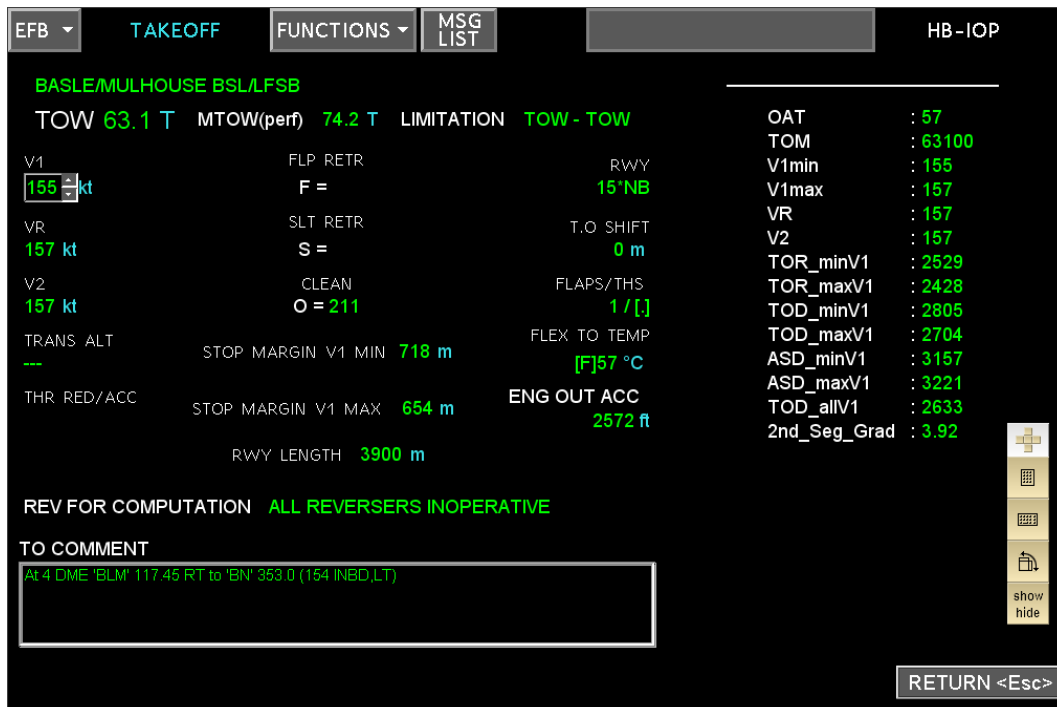
The reduced take-off engine power which had been set was based on the entire runway length of 3900 m and the V1², VR³ and V2⁴ speeds which had been entered in the FMGS were all 157 kt (cf. chapter 1.18.1, Figure 9).

In the present serious incident which is the subject of the investigation, both pilots had performed the calculations for a full-length take-off on runway 15 on their EFBs and entered the corresponding speeds in the FMGS (cf. Figure 9).

Figure 9: EFB calculations for a full-length take-off on runway 15 with a take-off mass of 63.1 tonnes. Resulting speeds: V1min = 155 kt, V1max = 157 kt, VR and V2 = 157 kt.

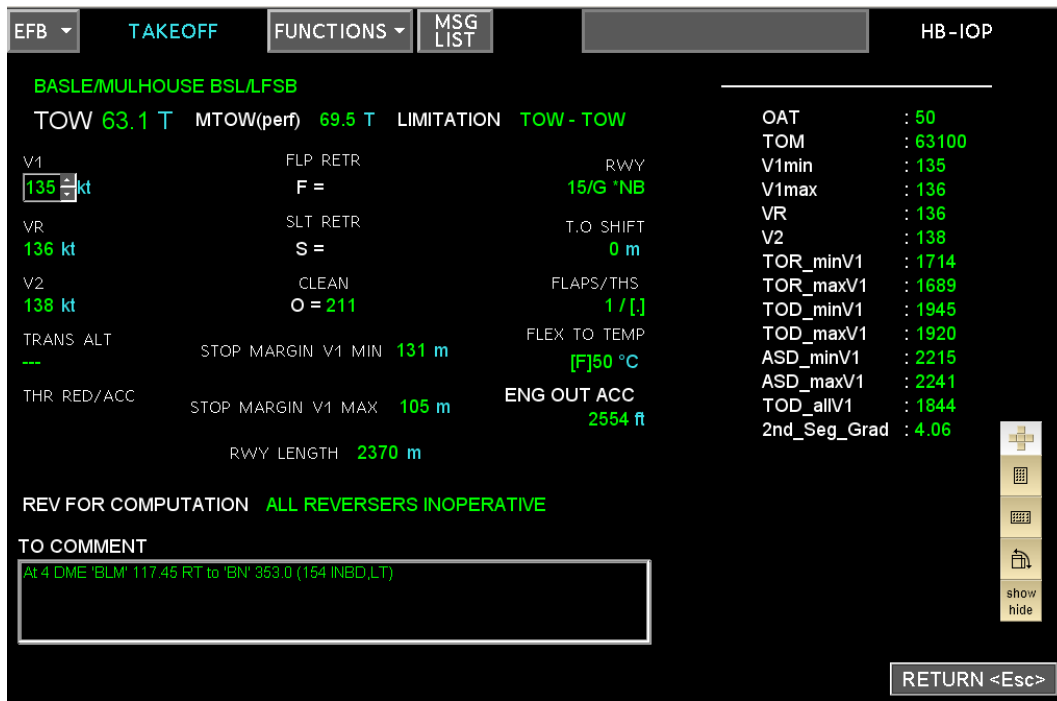
The commander had additionally performed a calculation for an intersection take-off from the Golf intersection (cf. Figure 10) and the copilot had performed a calculation for an intersection take-off from the Hotel intersection on their EFBs. The corresponding speeds were not entered into the FMGS.

Figure 10: EFB calculation for a take-off on runway 15 from the Golf intersection with a take-off mass of 63.1 tonnes. Resulting speeds: V1min = 135 kt, V1max and VR = 136 kt, V2 = 138 kt.

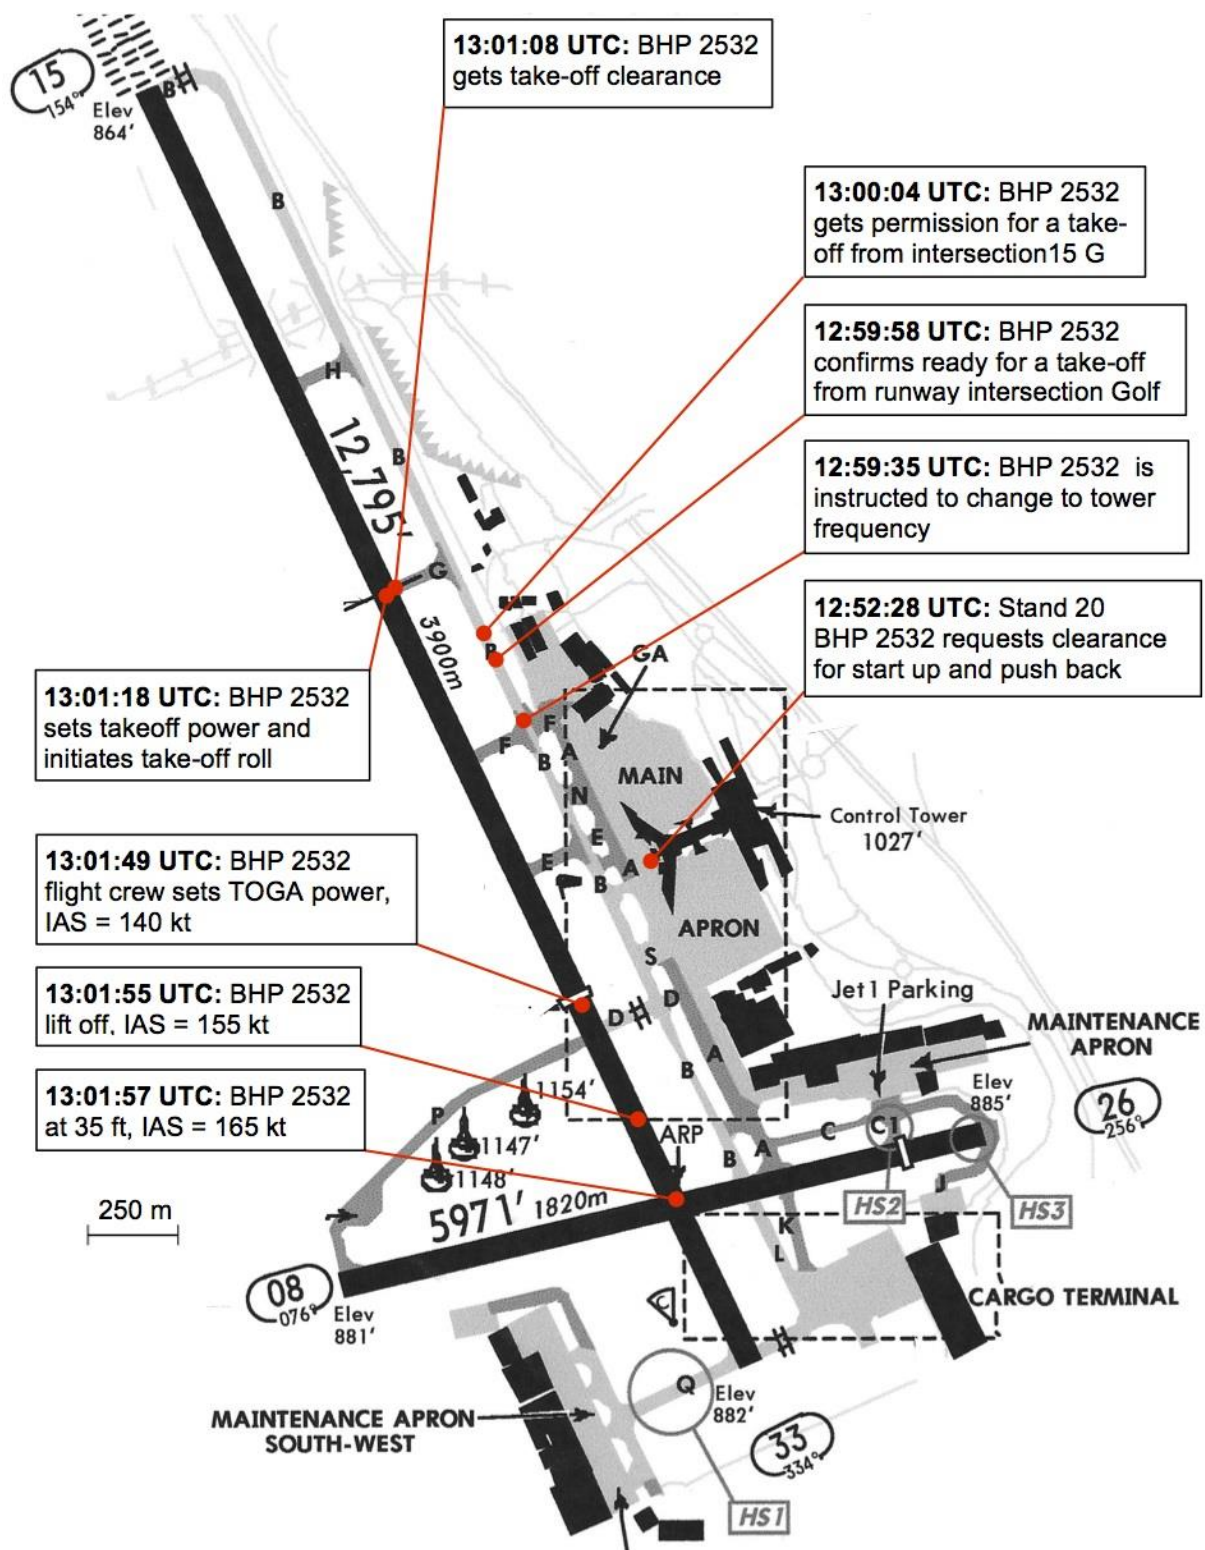
Annex 1: Chronology of the serious incident

Figure 11: Edited copy from the Jeppesen manual (10-9A); the red dots indicate the respective position of aircraft BHP 2532 at the specified time. Take-off from the Golf intersection.
