# **Final Report No. 2257**

## **by the Swiss Transportation Safety Investigation Board STSB**

concerning the serious incident involving  
the Airbus A320 aircraft, registration  
HB-IJU,

60 NM north of Marseille

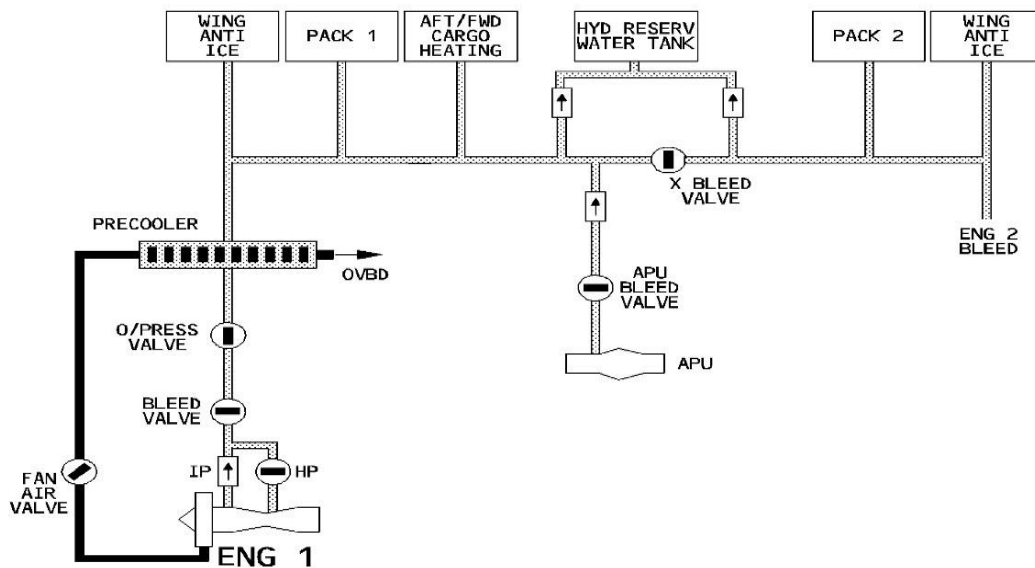
The fan air valve regulates the cooling airflow rate through the precooler, which cools the bleed air to approximately 200 °C before onward delivery to the consumers. An increase of this precooler outlet temperature above 257 °C leads to the automatic closure of the corresponding bleed valve, which is displayed to the flight crew on the ECAM as AIR ENG 1/2 BLEED FAULT.

**Figure 1:** The pneumatic system of the Airbus A320-214

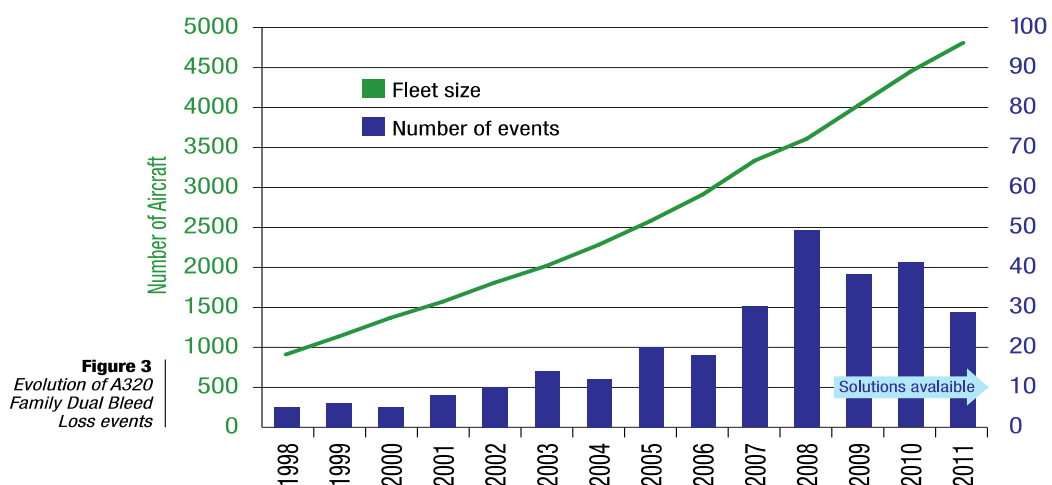
In Figure 3 of the relevant article the aircraft manufacturer shows statistically the decline in the number of AIR DUAL BLEED FAULT incidents since the availability of the modification, which is described in detail in Service Bulletin No. A320-36-1061.

**Figure 5:** Figure 3 from the „Airbus Safety Magazine”, issue No. 13 of January 2012
