Final Report No. 2258

concerning the accident
involving the AS350 B2 helicopter,
registration HB-XSO,

on 29 June 2013

approximately 900 m south of Iragna,
municipality of Lodrino/TI

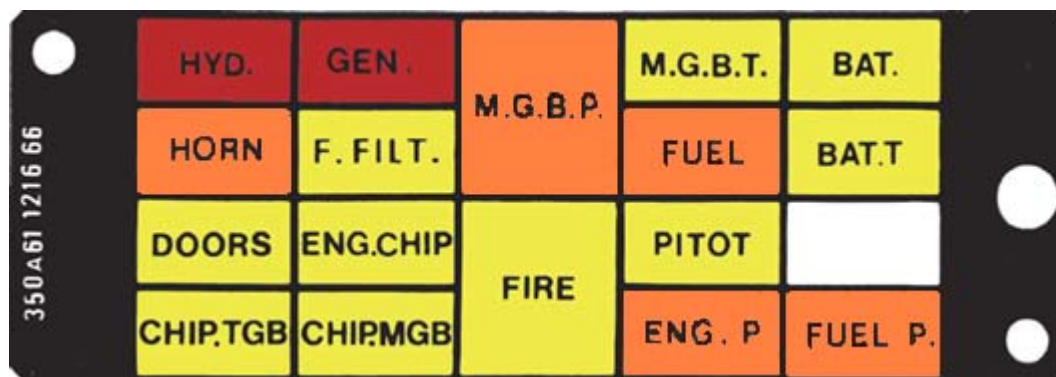
Figure 2: HB-XSO warning light panel.

From detailed investigations it was concluded that the filament bulbs of the HYD and GEN warning lights on the warning light panel were activated at the time of the impact (cf. Figure 2).

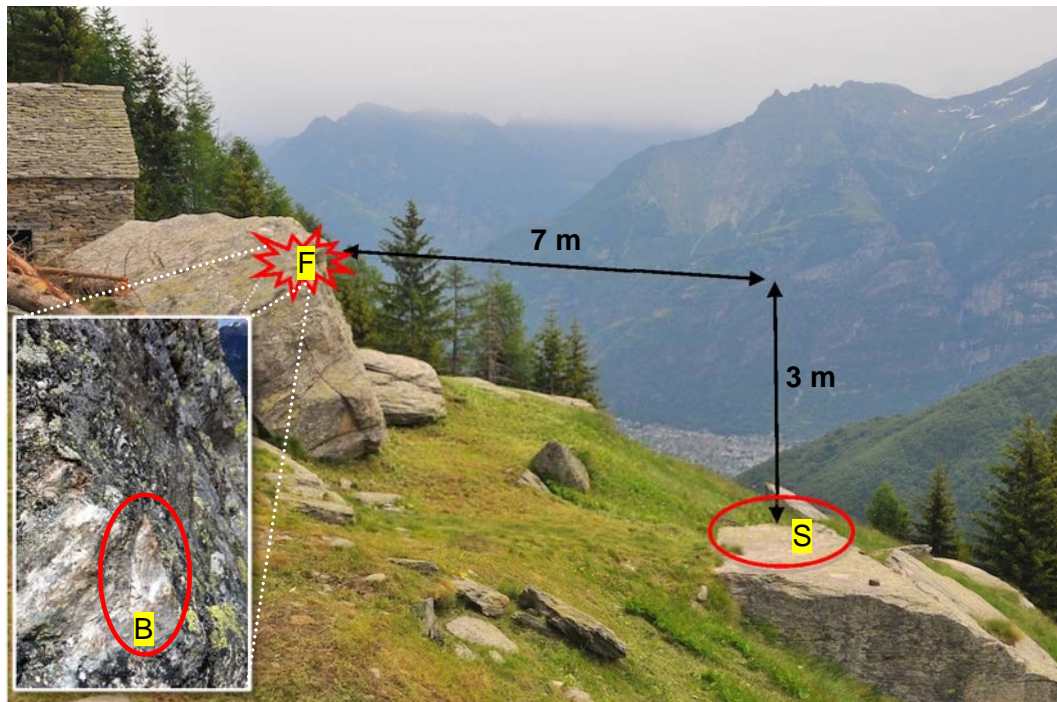
Initially during the climb, the pilot flew the helicopter towards some huts, which were approximately 200 metres to the right and below Alp Trüsp. In doing so, it was observed that the pilot had twice turned to the flight assistant during the climb in order for the flight assistant to point out the Alp Trüsp huts to him. The pilot asked the flight assistant where the second landing site on Alp Trüsp was. He then continued to climb and flew directly to the Alp Trüsp huts. When the helicopter was approximately 50 metres from the landing site, the flight assistant explained to the pilot on the radio where he should land (set-down). He also asked the passengers to unfasten the seat belts and to close them again to keep them from flapping about when the door was open. Shortly thereafter, the pilot of the HB-XSO hovered to touch down at 07:53, by partially setting the left skid down on a boulder (cf. Figure 3).

The landing site used by HB-XSO in front of the renovated Alp Trüsp huts is located on sloping terrain which is interspersed with various pieces of rock and does not allow the helicopter to set down completely. Hovering is possible, with one skid set-down on a flat, slightly inclined stone surface (S) (cf. Figure 3).

After the left skid touched down, the tips of the main rotor blades of HB-XSO were rotating in close proximity to the rock (F), which was in front of the helicopter.

Figure 3: Landing site, with horizontal and vertical distances between the stone surface (S) and the rock (F) with traces of contact (B) shown enlarged in the box.

While the skid was supported in hovering flight, the tips of the main rotor blades came into contact with the rock (F). At a height of approximately 3 metres above the stone surface (S), traces of contact were found on this rock. Rub marks were found on the stone surface (S).

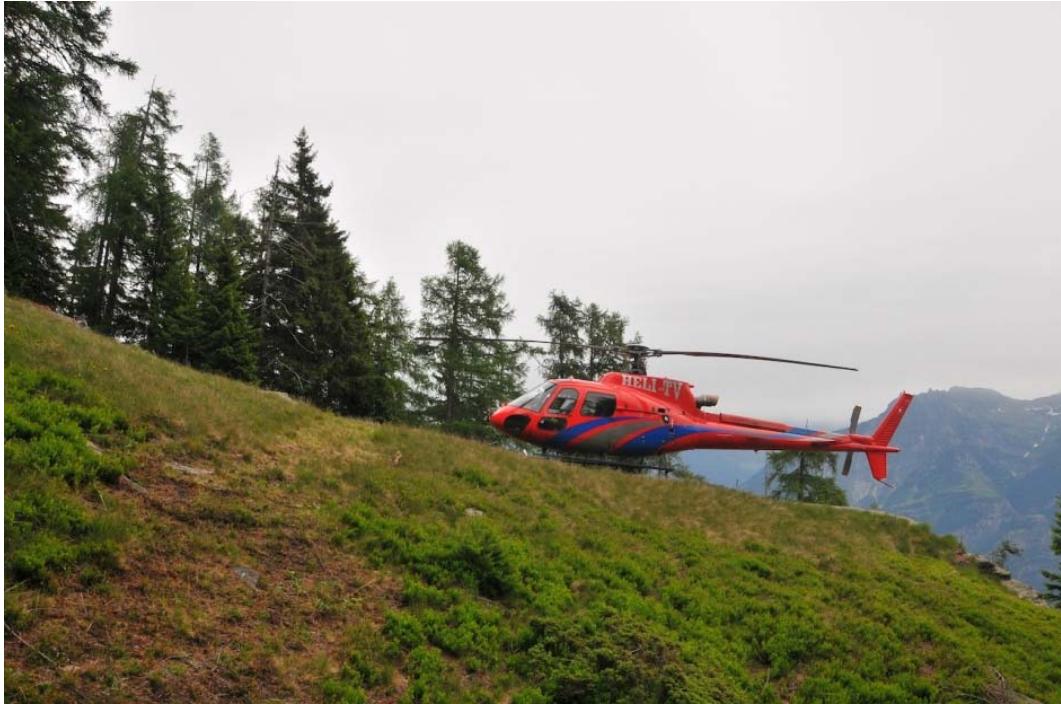
In 2011 a new landing site, designated “Er dal Zelar” was completed, some 300 metres from Alp Trüsp and free from obstacles. On the valley side, some trees were shortened, in order to ensure an approach which was as free from obstacles as possible. This landing site was evaluated by one of the operator's pilots and assessed as suitable. This is the only place in the immediate vicinity of Alp Trüsp where landing a type AS350 helicopter is possible and where the engine can be shut down.

Figure 4: Landing site “Er dal Zelar”; the helicopter shown in the picture is not HB-XSO which was involved in the accident.

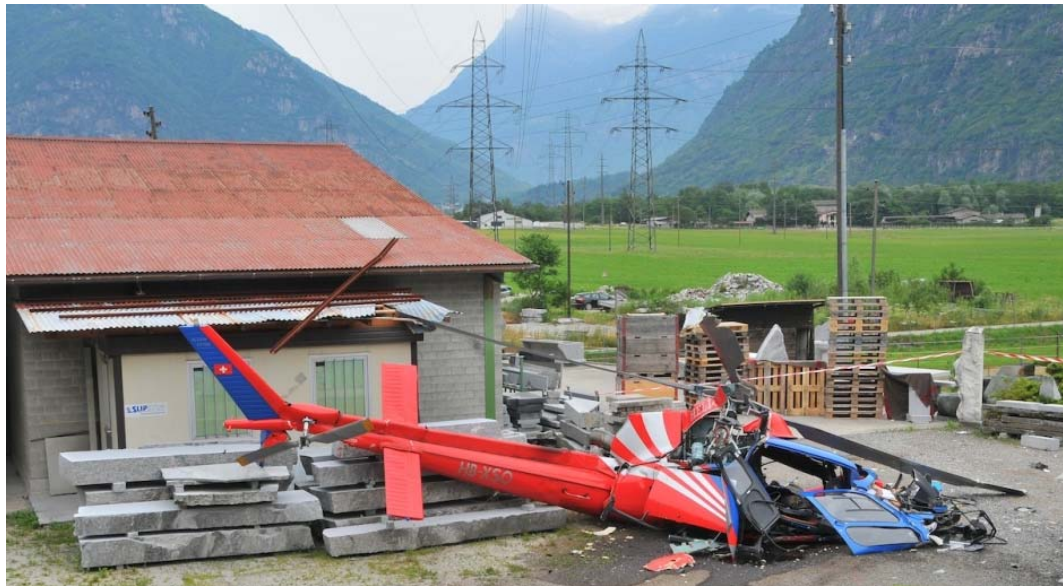
The helicopter was destroyed on impact with the ground. Fire did not break out. The Kannad 406 AF-H automatic emergency locator transmitter (ELT) was triggered.

A section of the front left skid was found approximately 100 metres away from the wreckage.

The seat belts on the rear row of seats were all found to be closed and tightened. The lap and shoulder belts on the two front seats were open.

The guarded hydraulic cut-off switch was in the ON position. The drive belt for the hydraulic pump was not found.

The input casing of the main gear box exhibited fractures.

Figure 5: Wreckage of the HB-XSO at the site of the accident.
