# **Final Report No. 2259**

concerning the accident involving the  
CSA Sportcruiser aircraft,  
registration HB-WYC,

on 26 May 2014

at Lommis airfield / TG

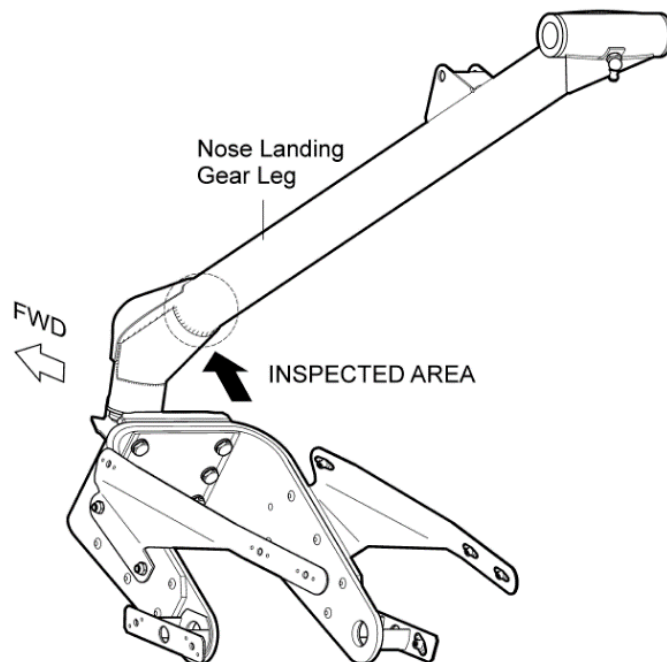
On 9 October 2013 the manufacturer first published service bulletin SB-CR-016. It required a periodic inspection of the nose landing gear leg for cracking in the area of the welded joint at its lower end (cf. Figure 2). Regarding the background of this requirement, the manufacturer wrote:

*“Some SportCruiser / PiperSport PS-28 Cruiser aircraft have developed cracks in the bottom side of the lower section of the nose landing gear (NLG). The cracks develop on the NLG-assembly along the weld of the tube and the bracket. To address this potential condition, an inspection of the bottom side of the lower section, in the place of the weld of the tube and the bracket is required.”*

**Figure 2:** Nose landing gear leg with the area to be inspected for cracks according to service bulletin SB-CR-016

The inspection required by service bulletin SB-CR-016 was carried out most recently on HB-WYC as part of the 100-hour check on 24 April 2014.

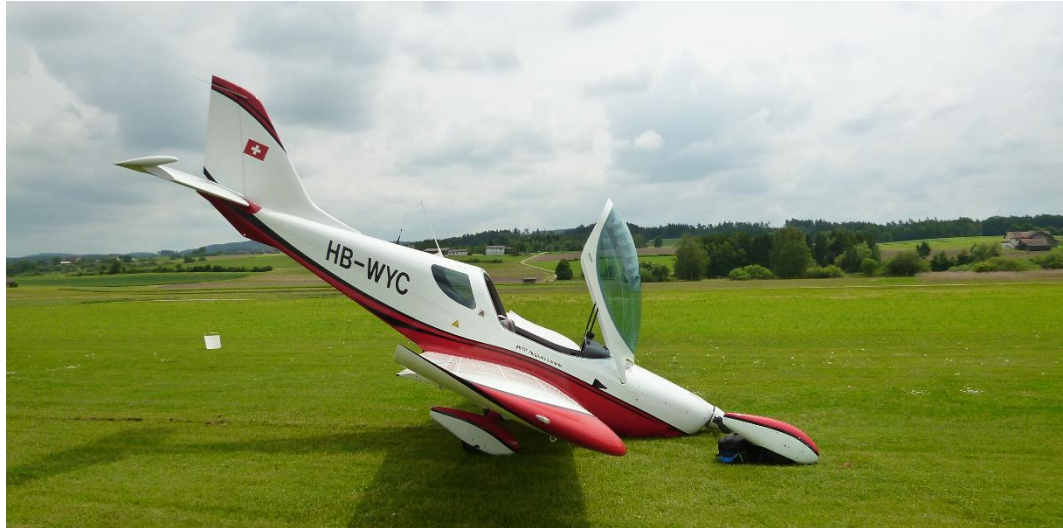
The aircraft's final position was 310 m after the threshold of runway 24, which has an available runway length of 615 m. The location of the main landing gear's initial contact with the ground could not be determined (cf. also section 1.5). The furrow in the grass runway caused by the broken-off nose gear leg is approximately 17 m long.

**Figure 3:** Final position of HB-WYC on runway 24 at Lommis airfield

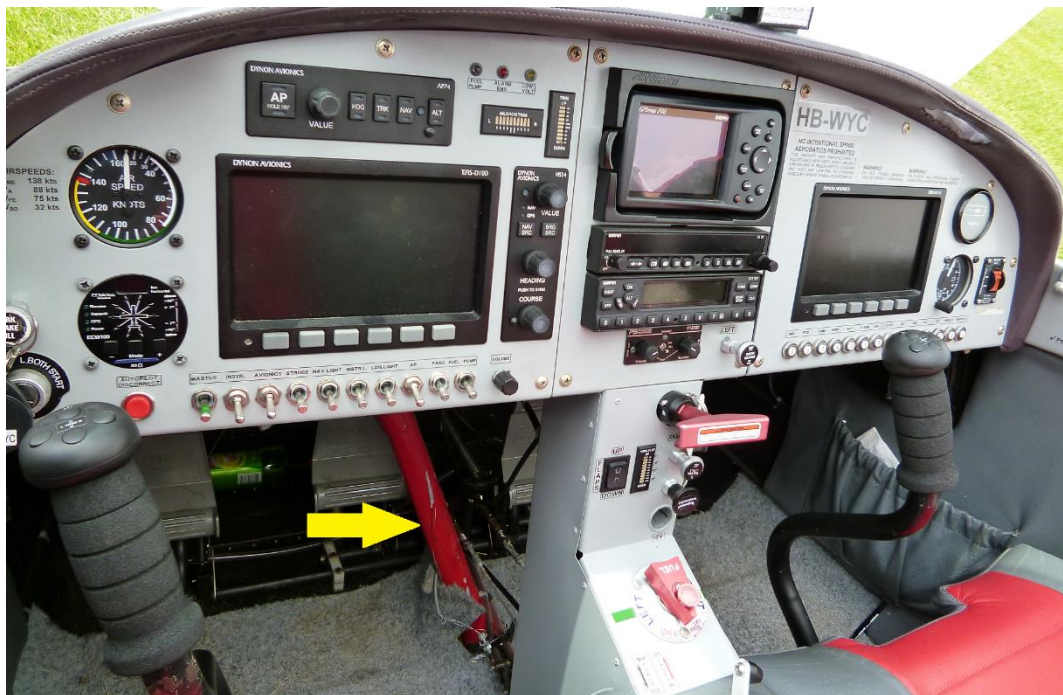
The nose landing gear wheel which was separated from the landing gear leg lay beside the aircraft on the runway. The landing gear leg itself had separated from the aircraft. When the aircraft's nose hit the runway, the nose gear leg penetrated the fuselage and was inside the cockpit in direct proximity to the rudder control pedals (cf. Figure 4).

**Figure 4:** Cockpit of HB-WYC; the yellow arrow indicates the broken-off leg of the nose landing gear which penetrated the cockpit

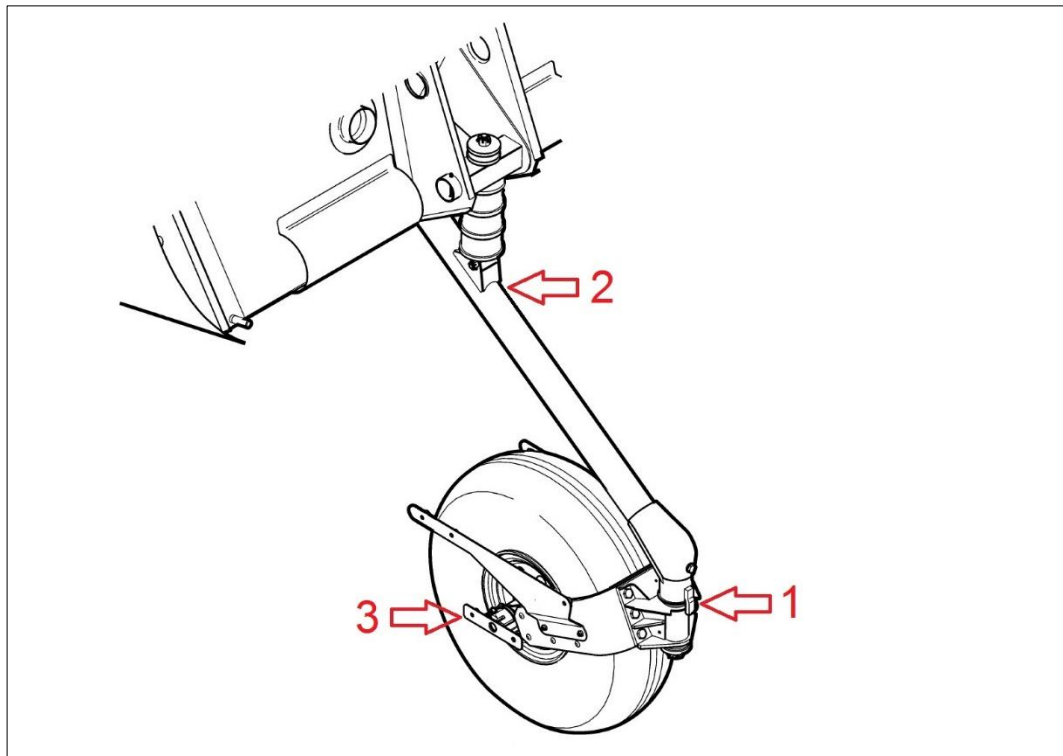
Parts of the nose gear were subjected to a detailed technical materials analysis to determine the cause of the damage. The fractures of the steering axle, the landing gear leg and the attachment points of the nose wheel fairing (cf. Figure 6) were examined.

**Figure 6:** Location of the fractures: steering axle (1), landing gear leg (2) and attachment points of the nose wheel fairing (3)

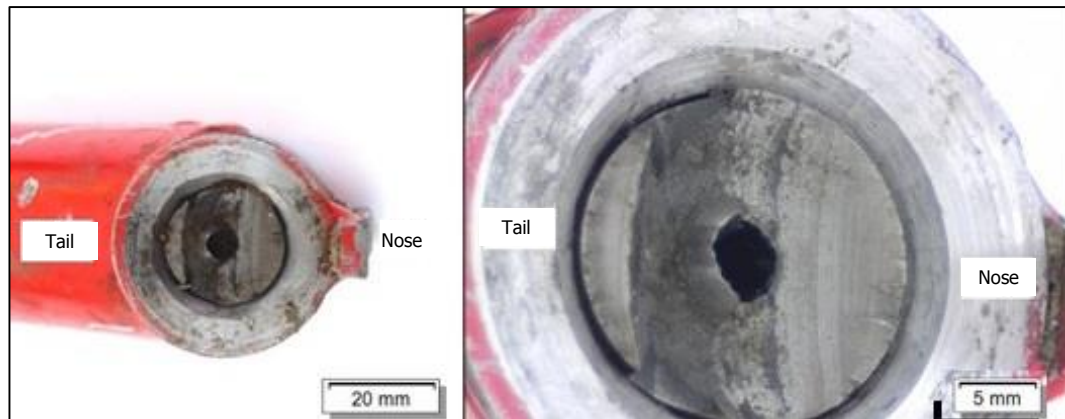
The steering axle fracture is a fatigue fracture resulting from reversed bending stresses. It is the result of fatigue cracks which grew larger over an extended period, until final failure occurred.

The fracture surface exhibited multiple fracture zones. Based on the beach marks, a forward and an aft crack formation area is evident. The discoloration of the aft fracture zone indicates that this was older than the forward fracture (cf. Figure 7).

**Figure 7:** Fracture area of the steering axle

Fatigue cracks which had formed over a long duration were found on the nose gear steering axle. This resulted in a significant, pre-existing weakening of the steering axle.

In the course of the landing the remaining area not affected by the cracking was overloaded and this caused the steering axle to fracture. As a result of the rotation of the lower part of the landing gear which was breaking off, a high tensile load was imposed on the steering axle, and this caused major deformation of the retention bolt. The nose gear leg, also weakened by fatigue cracking, contacted the runway, broke off to the rear and pierced the floor of the fuselage.

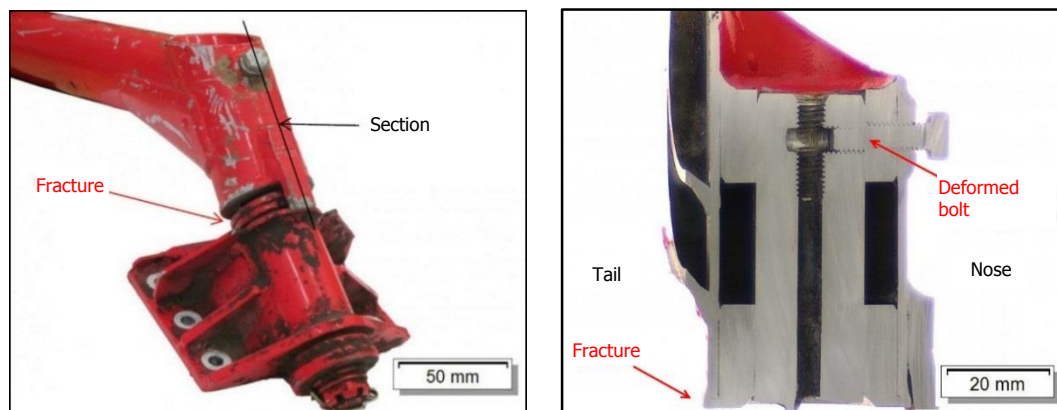
From the longitudinal section through the part of the steering axle above the fracture it can be seen that the position of the steering axle secured in the tube is vertically displaced. Given the extensively deformed retention bolt, a large force must have been applied to result in such a displacement of the steering axle (cf. Figure 8).

**Figure 8:** Displacement of the steering axle in the tube of the landing gear leg

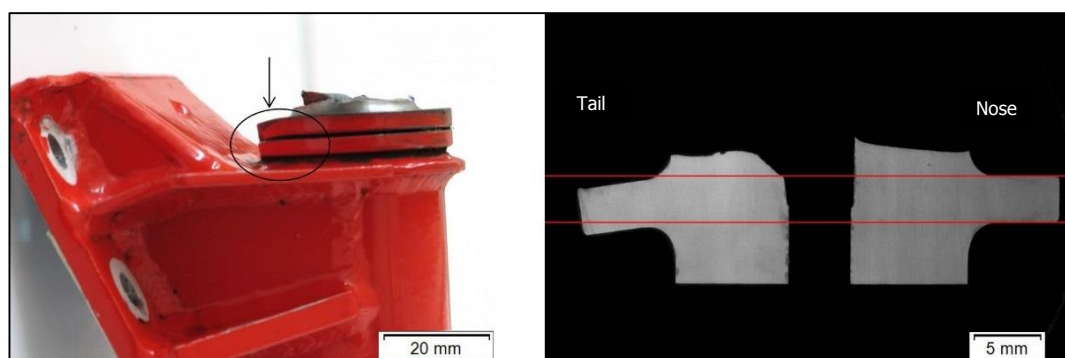
The pronounced deformation of the steering axle flange on its aft side also indicates exertion of considerable force (cf. Figure 9).

**Figure 9:** Deformation of the steering axle flange

The steering axle could no longer be rotated after the accident. This fact is explained in the investigation report as follows: *"Extensive plastic deformation of the flange occurred at the rupture. As a result of this deformation, the axle was no longer able to rotate after the rupture."* The possibility that the deformation of the steering axle flange (bending) was already present before the accident flight is explicitly excluded by the experts.

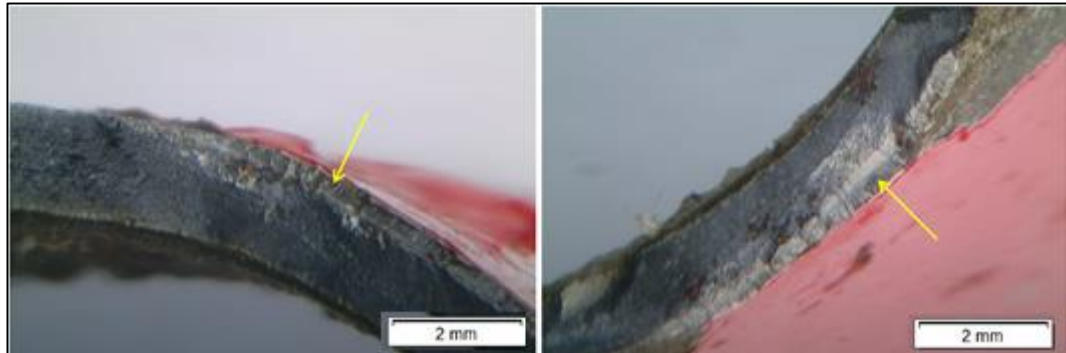
The analysis of the surface of the landing gear leg fracture permits the conclusion that the fracture was due to fatigue crack formation perpendicular to the direction of travel. However, the proportion of these in the entire fracture surface was small. The remainder of the fracture indicates a ductile instantaneous fracture.

**Figure 10:** Surface of the landing gear leg fracture with fatigue cracks

The material of the landing gear leg was determined to be 34CrMo4 heat treated steel, which corresponded to the requirements of the aircraft manufacturer. There were no signs of material-related defects such as embrittlement. On the inner surface there were corrosive attacks in the form of pitting corrosion.

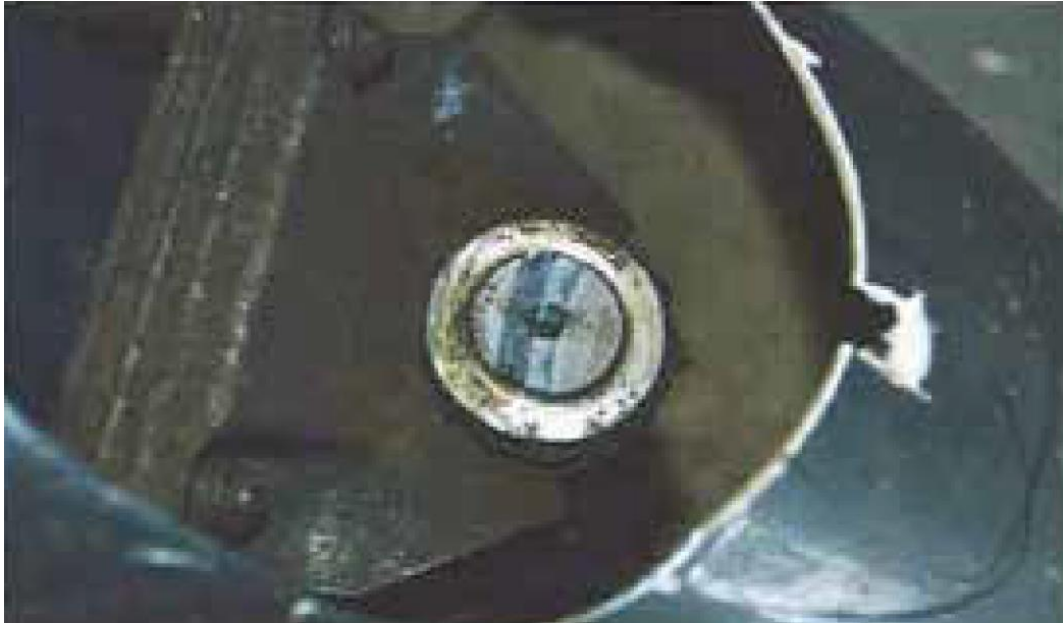
*"Following a normal approach and touchdown at a private grass airstrip, the nose landing gear failed. The nose wheel detached and the aircraft came to a rest within a short distance. Examination of the failed components showed what appeared to be a fatigue failure in the nose landing gear leg."*

A technical materials analysis such as the one performed in the present case was not carried out. However, the damage to the fractured steering axle corresponds to that on HB-WYC.

**Figure 12:** Fractured steering axle of G-EMSA (AAIB Bulletin 11/2014)

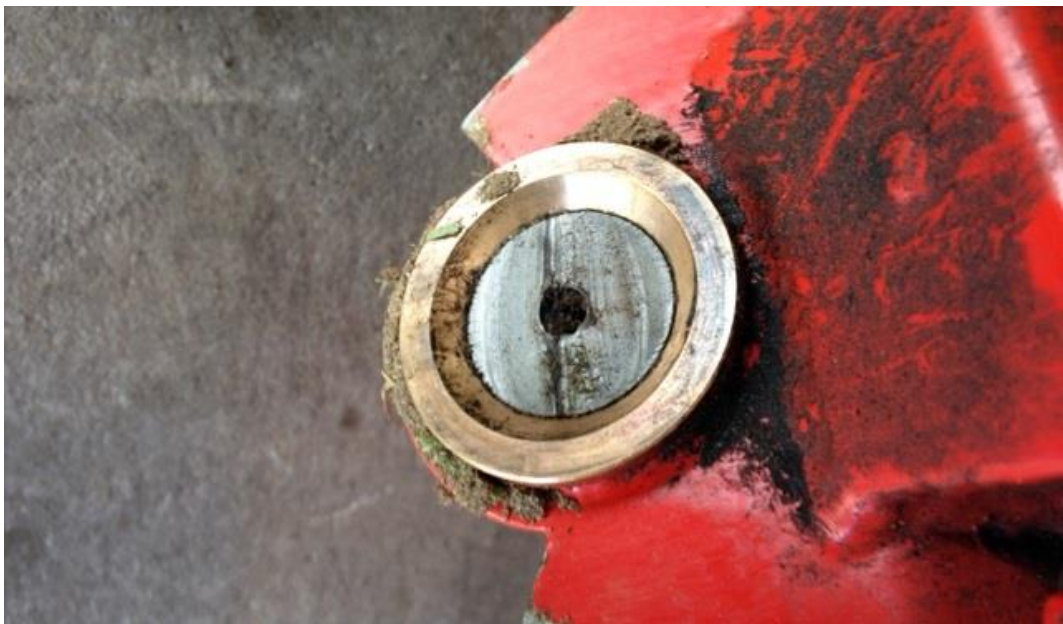
On 4 May 2015 in Germany, the steering axle of a CSA Sportcruiser aircraft, registration D-EGPZ and serial number 290, fractured after a touch-and-go. The subsequent landing of the aircraft without a nose wheel was made on a concrete runway with the engine shut down, without the nose gear leg fracturing.

**Figure 13:** Fractured steering axle of D-EGPZ

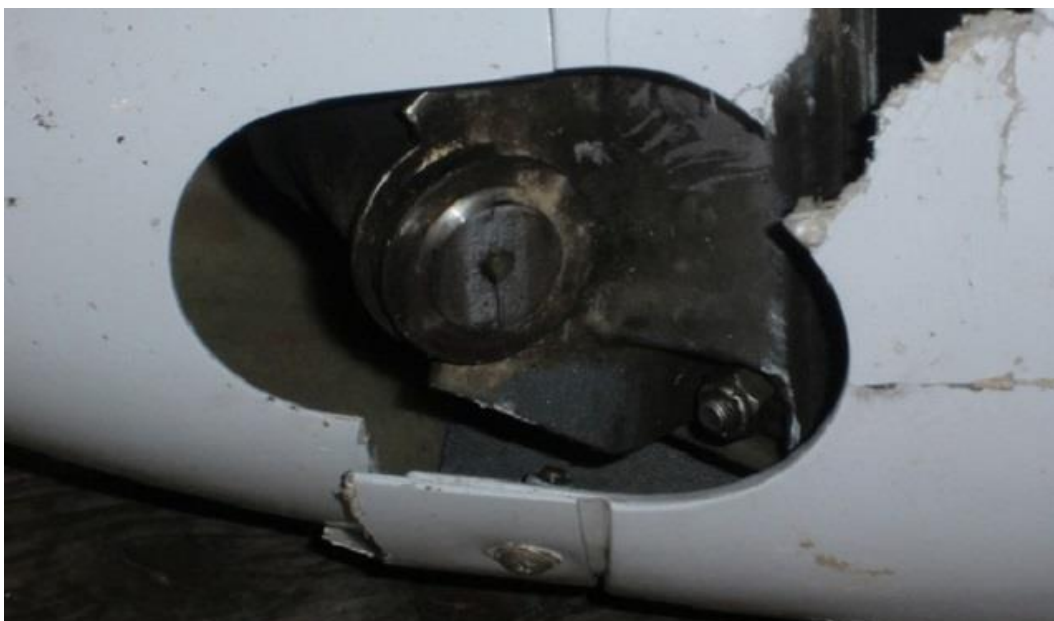
On 20 August 2015 in Germany, the nose wheel of a CSA PS-28 Cruiser, registration D-EMNA and serial number 459, broke loose shortly after the aircraft took off for a training session in the aerodrome traffic circuit. The instructions specified in the *emergency airworthiness directive* (EAD) 2015-0109-E of EASA (cf. chapter 4.3) seem to have been carried out without findings by a local maintenance shop.

**Figure 14:** Fractured steering axle of D-EMNA

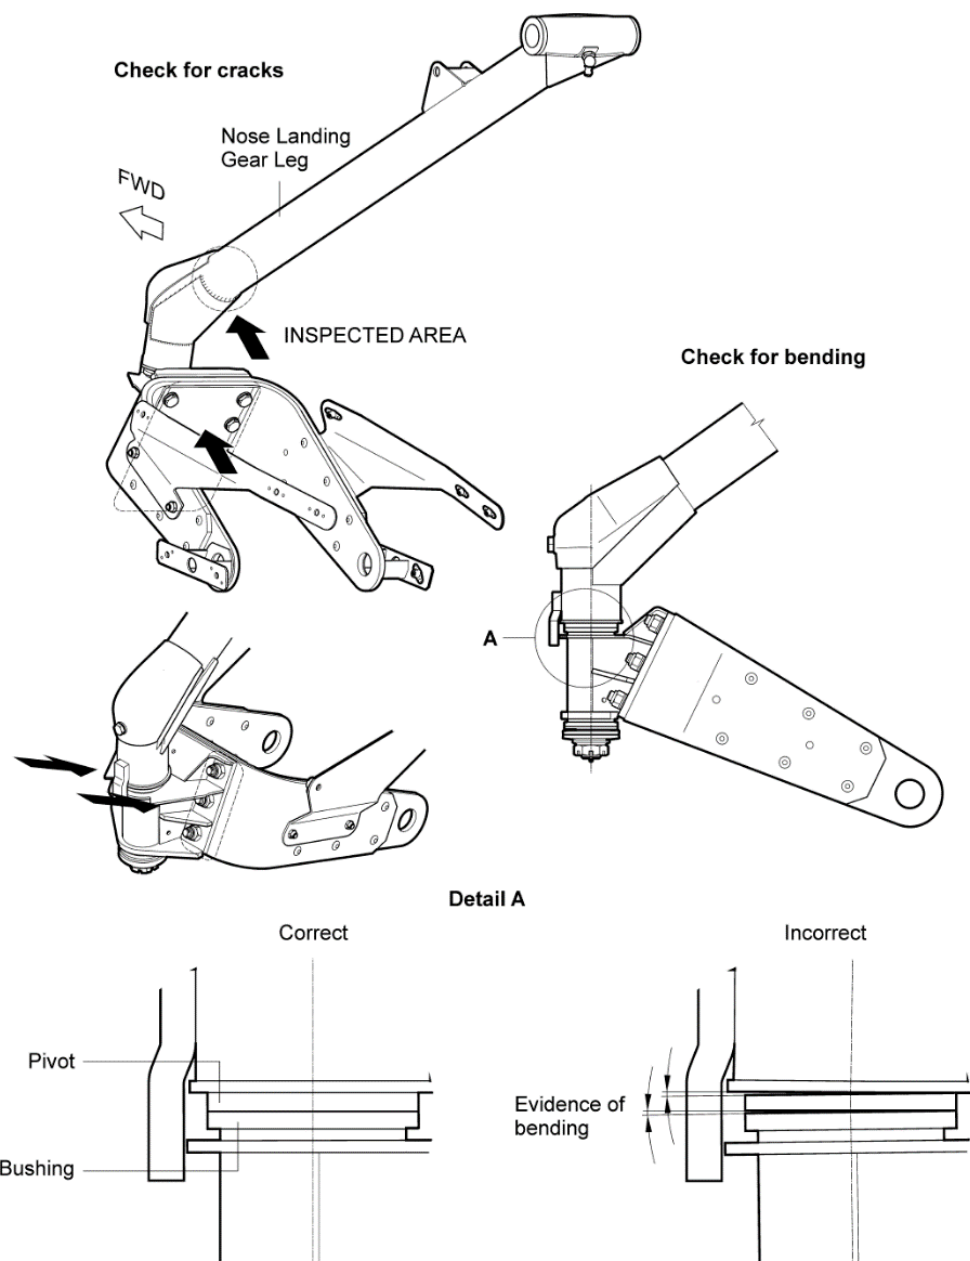
**Figure 15:** Extended examination of the nose landing gear according to SB-CR-016 Rev.6

The manufacturer's service bulletin SB-CR-016 was published on 26 June 2014 in a revised version (Rev. 1). In addition to the existing inspection of the nose gear leg for cracks, an inspection of the front steering axle for bending was prescribed (cf. Figure 15).

On 10 July 2014 the aircraft manufacturer published an additional service bulletin SB-CR-021. It recommends replacement with a re-designed nose gear instead of the inspection of the nose gear prescribed in accordance with SB-CR-016:
