Final Report No. 2260

Concerning the serious incident (Airprox)
between the airplane Piper PA-28-181, HB-PLY,
and the airplane Hawker 800 XP, CS-DRC, operated by
NetJets under flight number NJE 424R
on 20 March 2014
at Zurich Airport

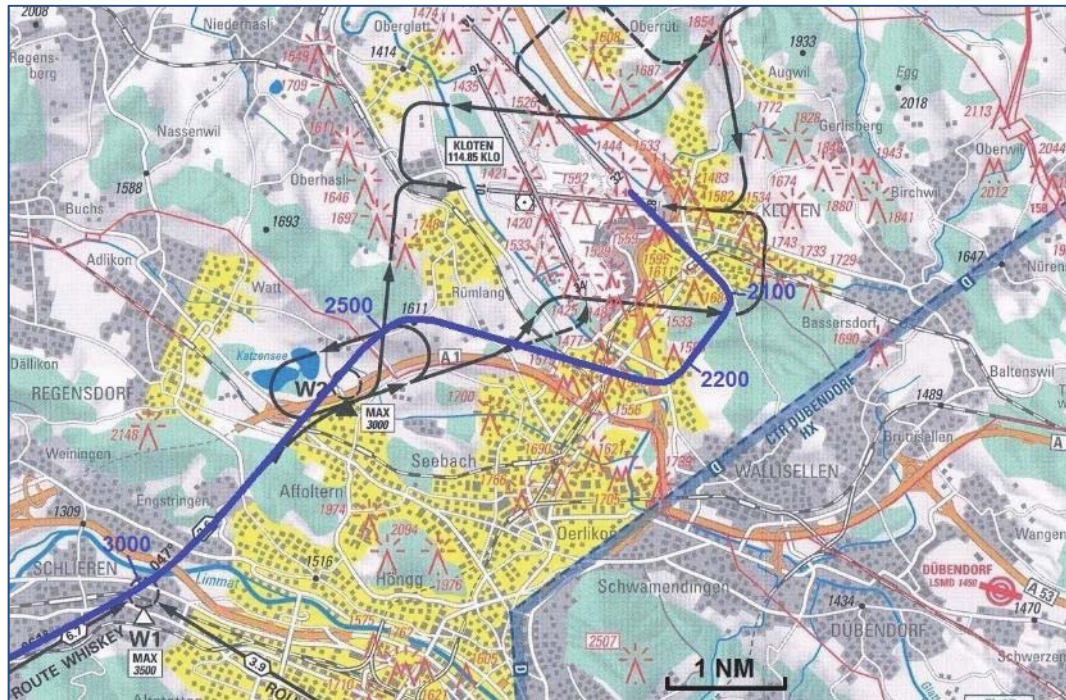
roger, after Whiskey two, join left downwind for runway two eight.” The pilot confirmed this clearance and at 18:44:40 UTC, shortly after passing reporting point W2, he entered what he thought was the left-hand downwind approach to runway 28 (see illustration 1 and appendix 1). This phase was navigated with visual references without the use of navigation instruments.

Illustration 1: Detail of the visual approach chart of Zurich Airport. Approach path and flight altitude AMSL of HB-PLY in blue. The airfield traffic pattern height is given as 2500 ft AMSL. Reproduction of the map approved by Federal Office of Topography (JA123456).

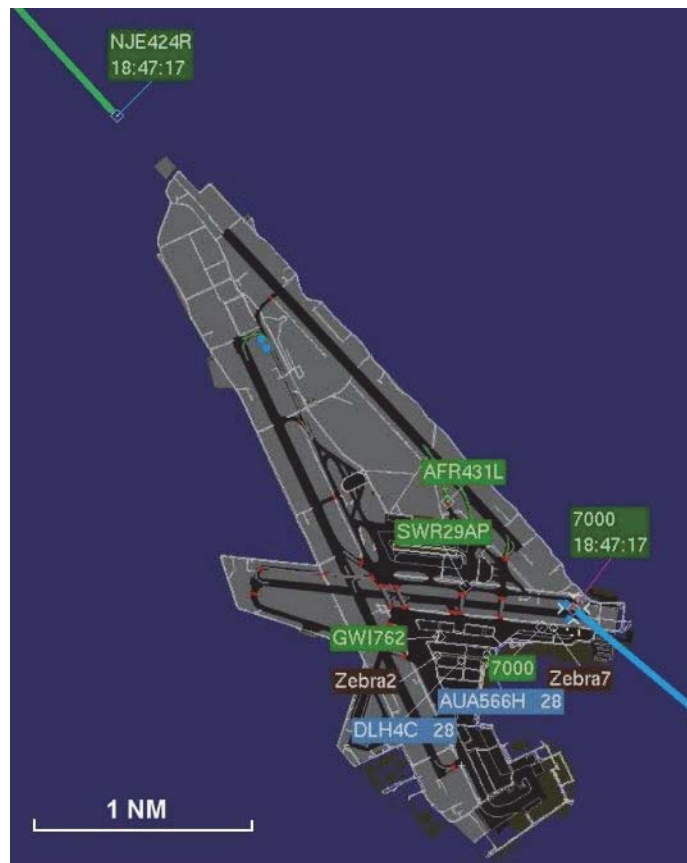
During the short final approach to runway 32, immediately after he had flown over runway axis 28, the pilot of HB-PLY realised that he was approaching the wrong runway. His altitude at this moment in time was approximately 1700 ft AMSL. The flight paths of both airplanes were already being recorded by the ground radar SAMAX by that time (see illustration 2).

Illustration 2: Recording of the ground radar SAMAX with highlighted flight paths of NJE 424R (green) and HB-PLY (blue) at 18:47:17 UTC, shortly before the go-around of HB-PLY.

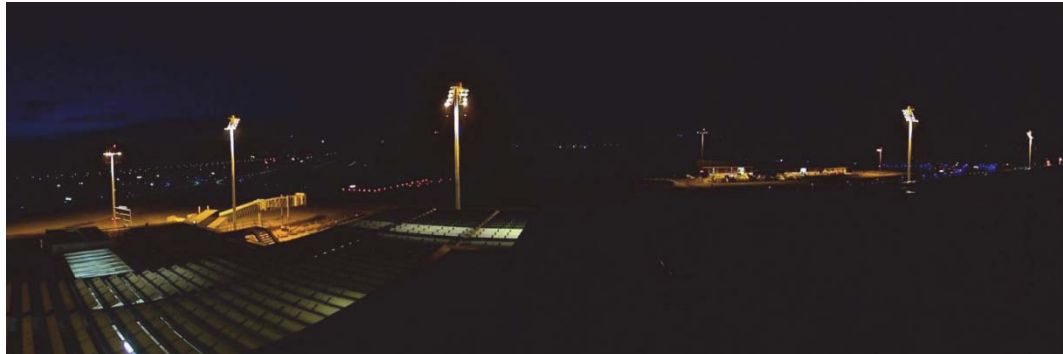
1.4.4 Webcam picture

Illustration 3: Webcam on finger dock E, looking west-southwest, picture taken at 18:30 UTC

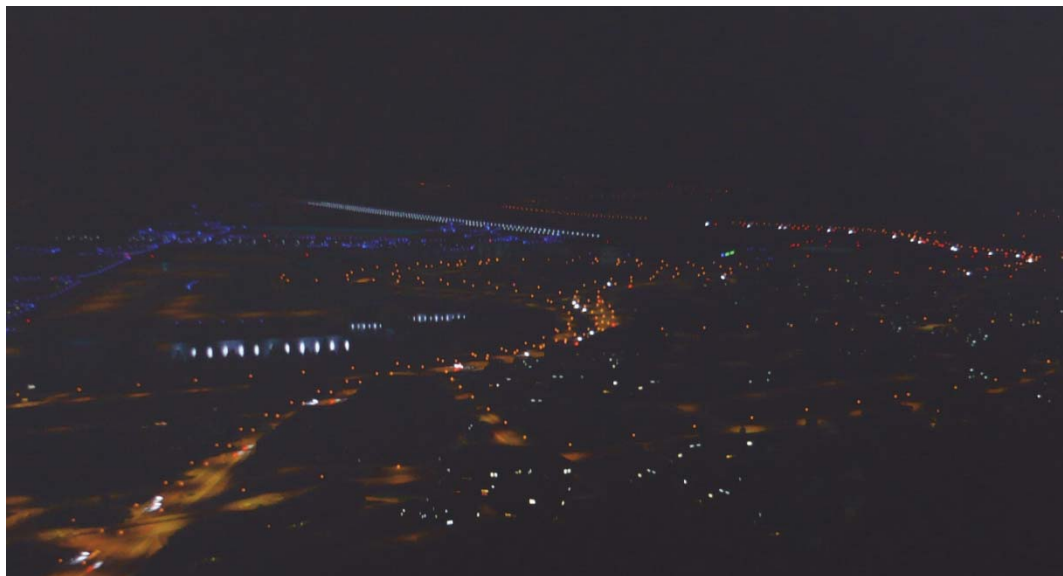
Illustration 4: Flight path as taken by HB-PLY: view of Zurich Airport from the left baseleg of runway 32 at an altitude of 2200 ft AMSL in the simulator. Runway 28 is barely visible.

The actual take-off in Nuremberg was at 17:12 UTC. The approach was normal up to reporting point W2. Subsequently, the pilot noticed the distinctively bright illuminated runway 32 whilst he was unable to identify runway 28. He approached runway 32. This is understandable as runway 32 was more brightly illuminated and easier to spot among its surroundings than runway 28. Runway 28, in contrast, was partially hidden behind buildings and more difficult to identify because of numerous bright light sources in its surroundings. In addition, even after he had turned into the baseleg, the pilot could not identify runway 28 because of his position which was too far south, and the altitude which was too low (see chapter 1.7).

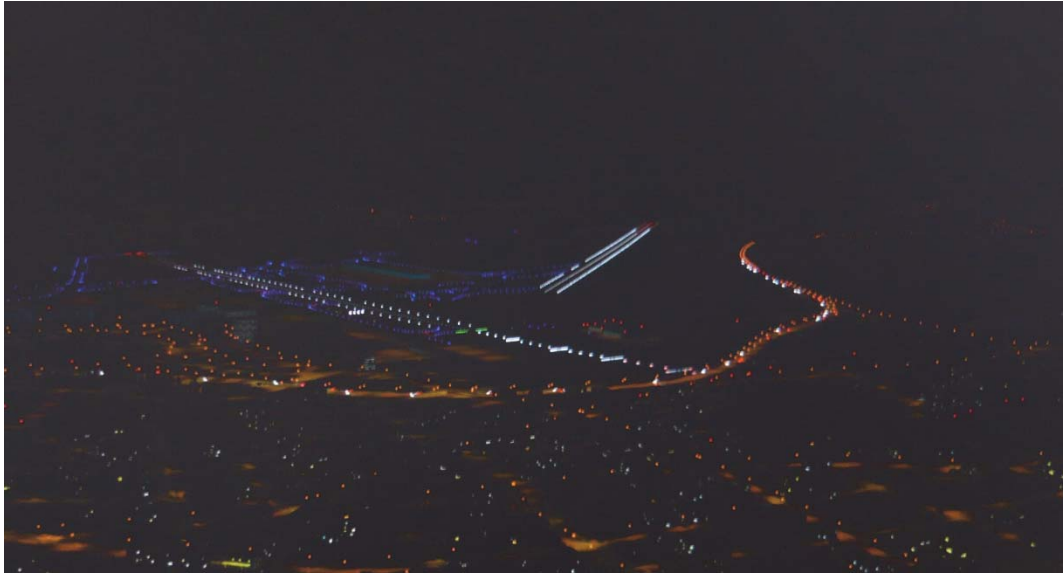
Illustration 5: Flight path according to approach chart: view of Zurich Airport from the left baseleg of runway 28 at an altitude of 2400 ft AMSL in the simulator. Runway 28 is visible in the foreground.
