# **Final Report No. 2261 of the Swiss Transportation Safety Investigation Board STSB**

concerning the accident involving the  
Cameron Z-120 hot-air balloon, HB-QOW,

on 6 August 2013

at la Comba d'Avau  
north of Montbovon  
Haut-Intyamou / FR municipality

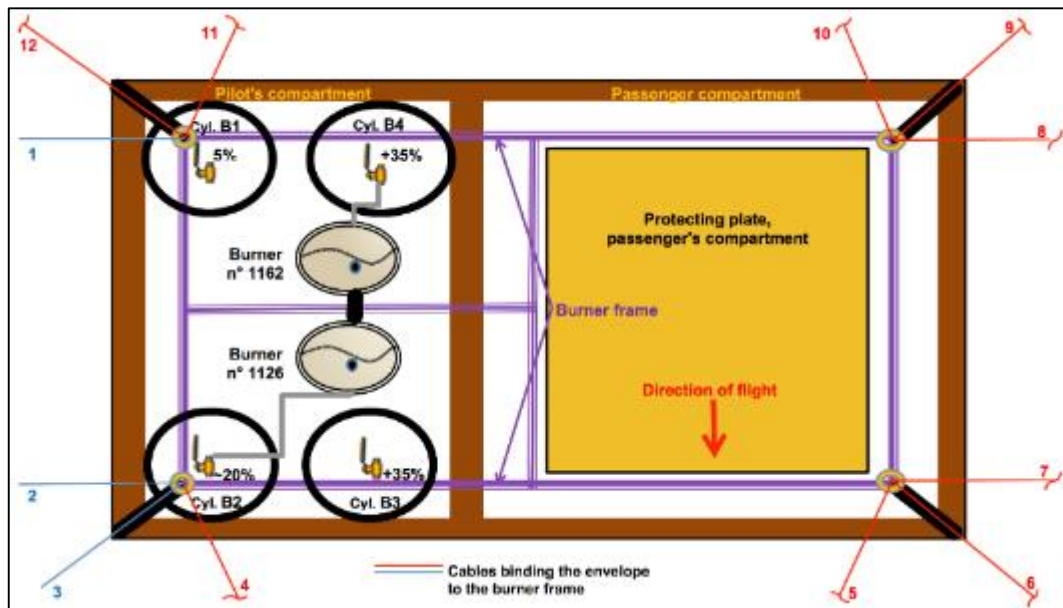
**Figure 1:** Diagram of the general layout of the basket, with the position of the cables which connect the envelope to the burner frame. The cables shown in blue were intact and the severed ones are shown in red.

The various electric arcs caused nine of the twelve cables connecting the envelope to the burner frame to sever. The upper part of the equator of the envelope slid between the upper 60 kV conductor and the earth conductor cable (figure 8).

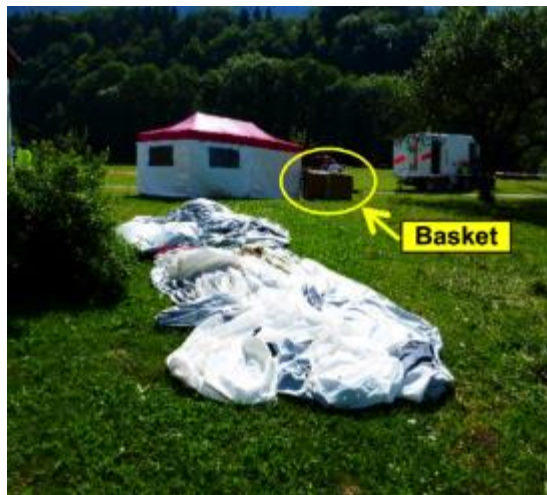
Following the impact the basket tipped onto its side and then came to rest against a small fruit tree. The envelope, dragged by the fall of the basket, slid onto the conductors. It landed in the direction of flight, completely deflated, in front of the basket, partially on the access road to the hamlet and in the garden of the property.

**Figure 3:** Envelope moved before the intervention of the emergency services.

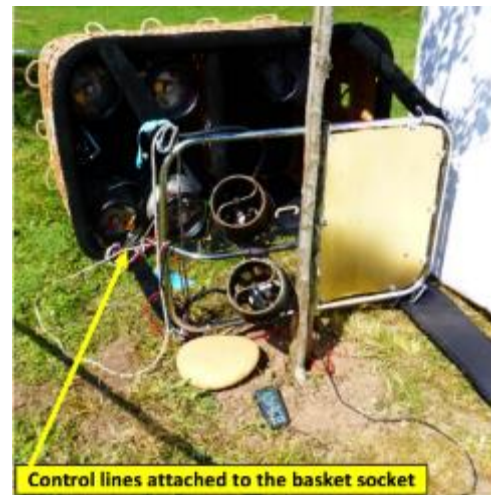
**Figure 4:** Final position of the basket with the burner frame.

The structure and the partition of the basket compartment were deformed by the impact. The wooden skids fixed under the basket and the floors broke in several places. The rope handles fixed inside the basket were not damaged. Short-circuit marks are visible on some karabiners and on the forged steel intermediate rings installed between the burner frame's karabiners and those of the envelope cables.

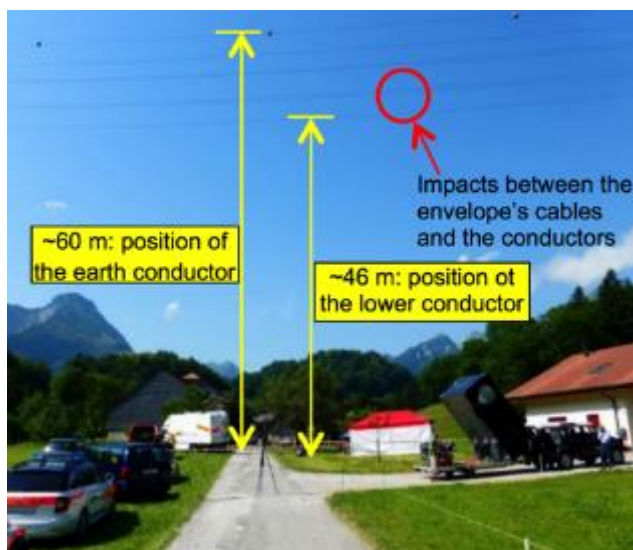
**Figure 7:** View towards La Comba d'Amont from the accident location with the position of the power line conductors.

The lower conductors are located approximately 46 metres above the ground. The earth protection cable is approximately 60 metres above the ground (figure 7).

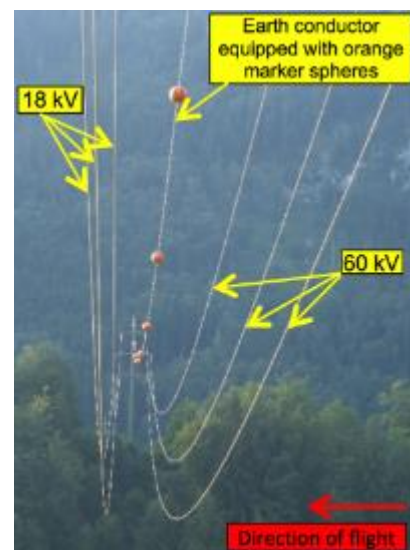
**Figure 8:** View of the conductors towards Montbovon.

A visual inspection by technicians found that the 6 phases were marked and blackened. These are Aldrey conductors<sup>8</sup>; they have a cross-sectional area of 300 mm<sup>2</sup>.

The conductors were damaged but withstood the collision. The pylons were not damaged.

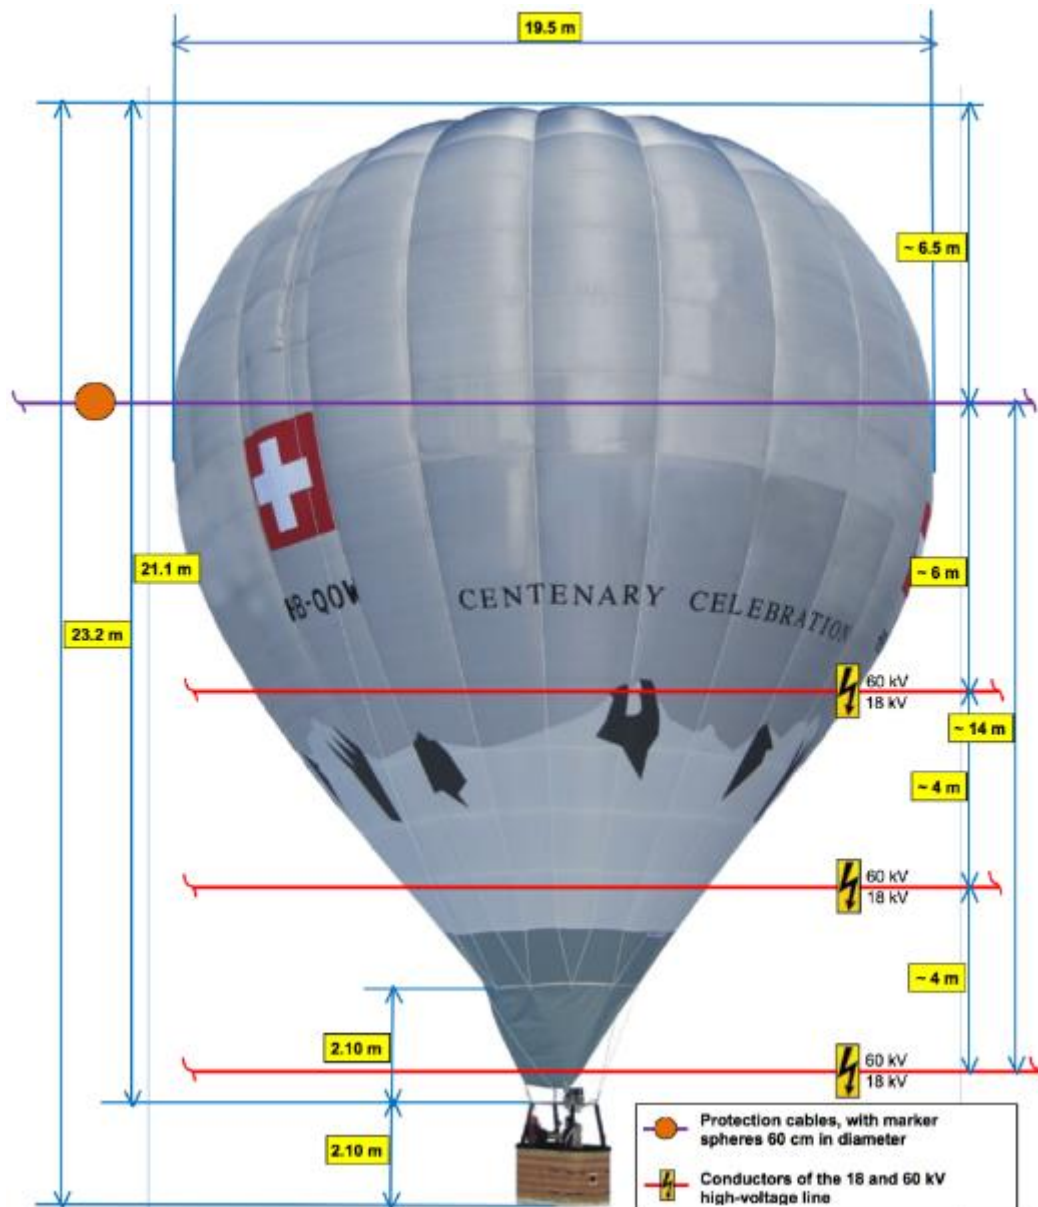
The collision occurred at 08:37:56 between the lower conductors of the high-voltage power line and the cables connecting the envelope to the burner frame (figures 9 and 10).

**Figure 9:** Dimensions of the balloon showing the positions of the conductors in red and the earth conductor cable in violet, at the time of the collision.

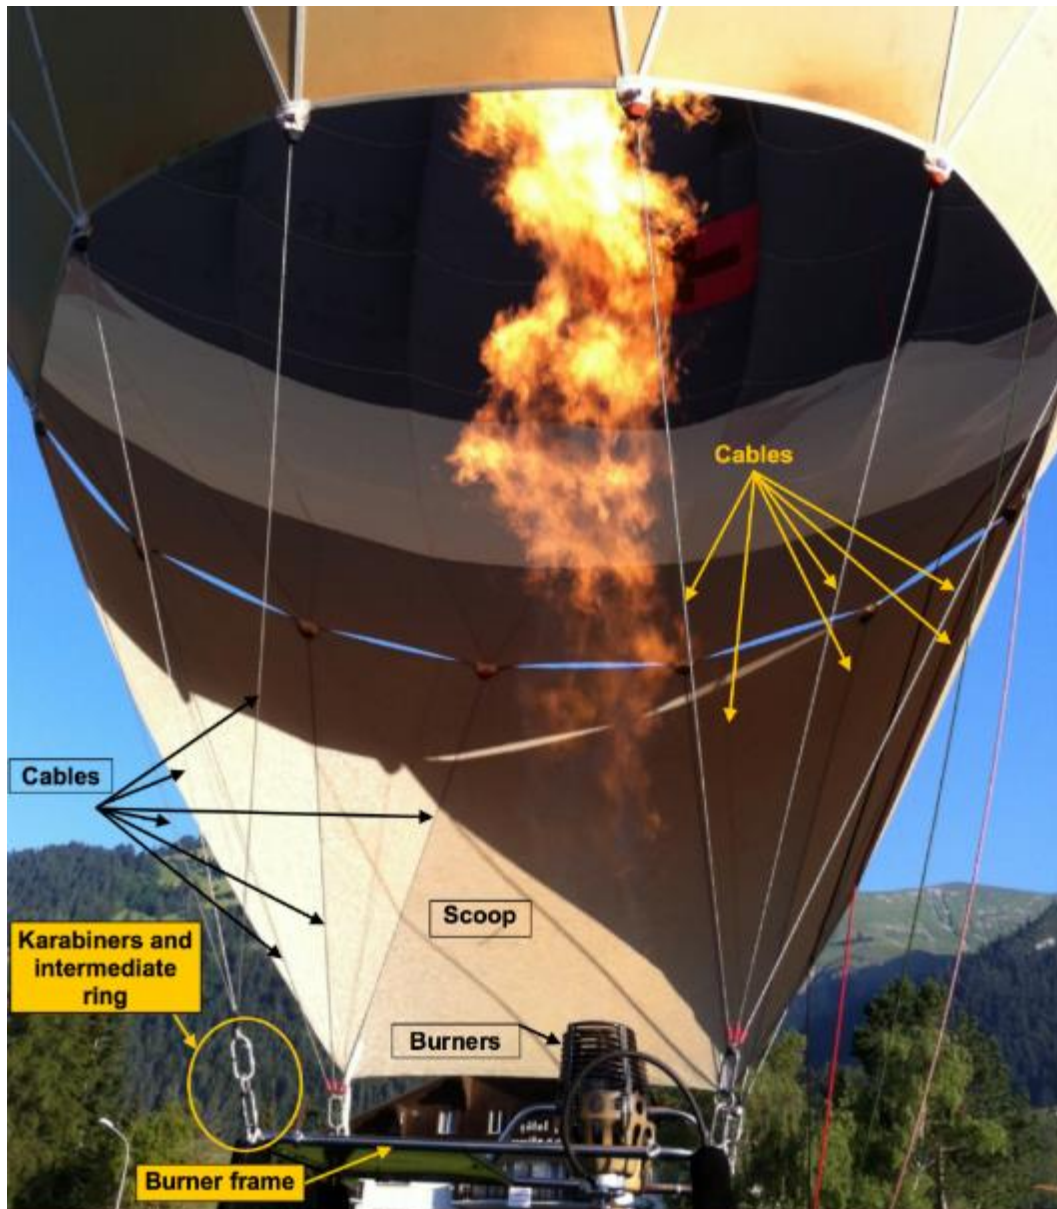
**Figure 10:** Photograph taken before the take-off of the accident flight, showing the scoop, the burners and the cables of the envelope connected to the burner frame.

Aldrey particles from the conductors of the high-voltage power line were found on all the cables connecting the envelope to the burner frame. Out of a total of twelve cables with a diameter of 4 mm (figure 10), only three located in the two corners of the pilot's compartment withstood the collision (figure 1). The other three cables on the side of the pilot's compartment and the six cables on the side of the passenger compartment were severed. Of the latter, five were severed in two different places. The breaks, mechanical or due to melting, are between 0.33 m and 1.68 m above the karabiners securing the envelope to the burner frame. The scoop (figure 10), fixed to the base of the envelope, was badly damaged. The two fasteners of the lower part fixed to the karabiners of the burner frame were torn off. Tears, segments of burnt fabric and traces of Aldrey were found on the outside of the scoop. It was not possible to determine the origin of these traces of burns, i.e. to know if they were due to the short-circuit or the flames from the burners. The fixings of the upper part were not damaged.

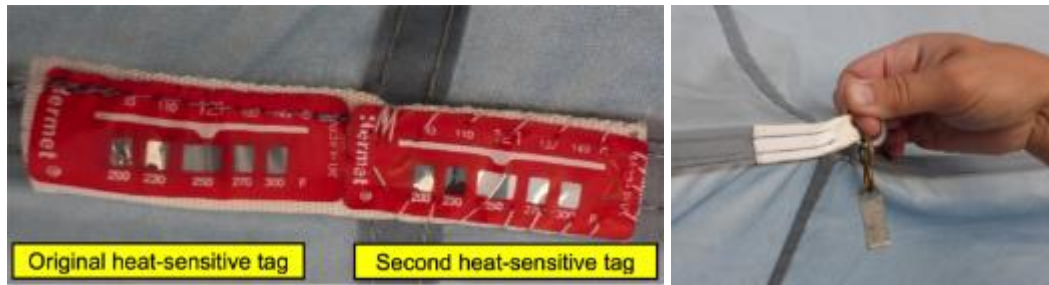
was not found at the site of the accident. The heat-sensitive tags sewn onto a strap in the top of the balloon indicated 149 °C for the original tag and 121 °C for the second added tag (figure 11).

According to the technical documentation, the second heat-sensitive tag was added at the time of the annual inspection carried out on 7 December 2010 at 31:40 hours TSN, whilst the original tag indicated 121 °C black. At the time of the annual inspection carried out on 9 January 2013 at 141:20 hours TSN, the two tags indicated a temperature of 121 °C.

**Figure 11:** Heat-sensitive tags.

The fact that the streamer fixed to the top of the envelope by the melting link was detached allows the conclusion that the pilot definitely made continuous use of the two burners just before the collision. The difference in indication between the two heat-sensitive tags can be explained by the relative reliability of these devices.

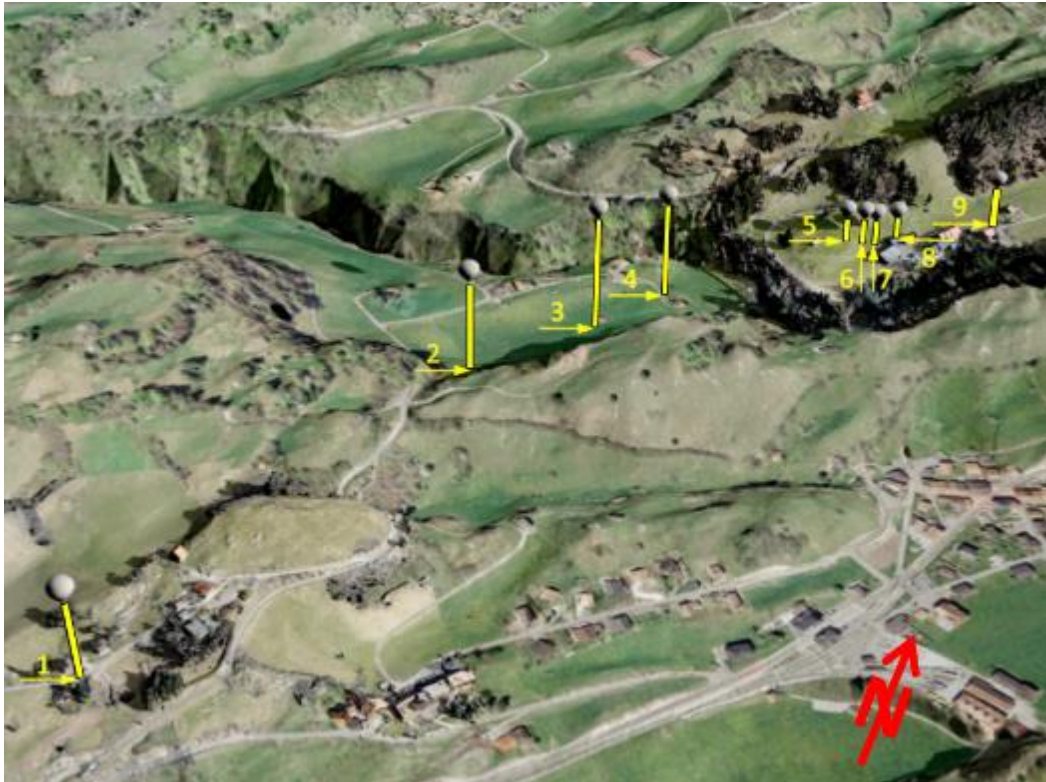
**Figure 13:** Successive positions no. 1 to no. 8 of the balloon. The position no. 9 corresponds to the collision with the power line.

After the balloon passed position no. 4, which corresponds to passing over La Comba d'Amont, the reconstructed profile shows a descent phase, which was stabilised at approximately 25 m above ground level. This situation was aggravated by the presence of the local wind known as the *Ruchio*, blowing in the lower strata, which caused the balloon to accelerate in the direction of the obstacle. At that moment, i.e. in the area of positions no. 5 and no. 6, the balloon was at a distinctly lower height than that of the earth conductor of the power line and in an acceleration phase, which constituted a dangerous situation. This inadequate flight tactic can be explained by a temporary lapse of memory concerning the position of the obstacle on the part of the pilot, the cause of which is difficult to explain. It may be that it was caused by the pilot's preoccupation with landing at this location in order to end the flight as soon as possible to comply with the passengers' schedule. This preoccupation may have caused a "tunnel vision" effect, i.e. a focus on a single factor or objective, in this case the landing manoeuvre, without taking account of the presence of the obstacle.

When the pilot became aware of the presence of the power line, probably around position no. 7, his decision was to try to cross it by constantly activating the two burners. This emergency manoeuvre could not succeed in this context. In fact, the

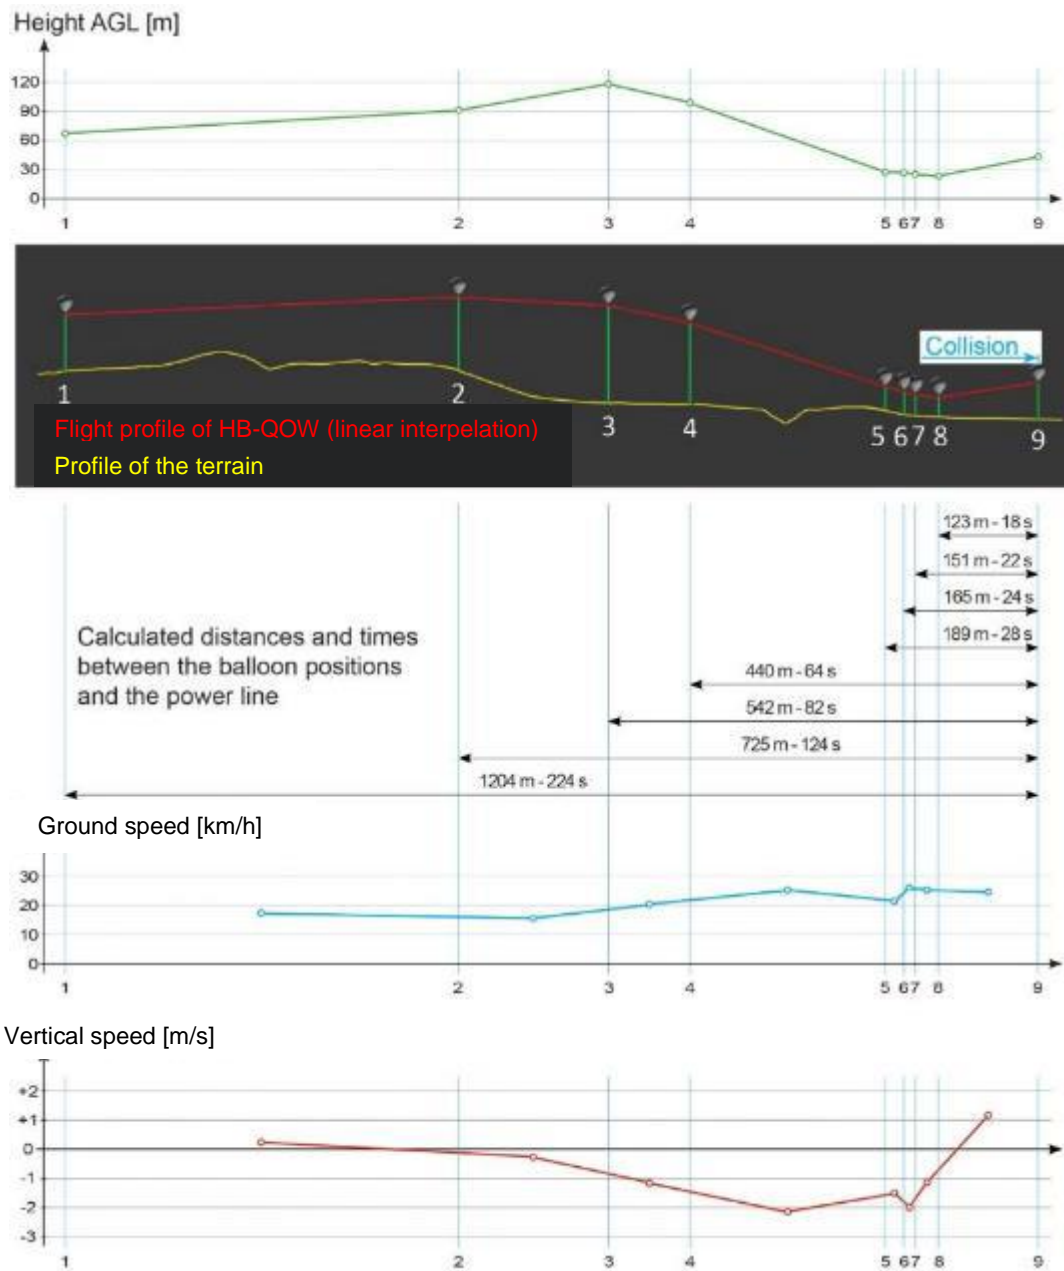
Profiles and graphs of the values for height, ground speed and vertical speed for positions no. 1 to no. 9.

During this final flight phase, the late activation of the burners enabled a climbing phase of flight to be established; however, the following factors reduced the balloon's climbing performance:

- A mass close to the authorised maximum value.
- An outside temperature of 18 °C.
- The use of two burners, one of which was supplied by a cylinder containing only approximately 20% propane.
