# **Final Report No. 2264 of the Swiss Transportation Safety Investigation Board STSB**

concerning the serious incident involving  
an AVRO 146-RJ100 aircraft, registration  
HB-IYY,

operated by Swiss European Air Lines  
with the callsign SWR35R

on 24 March 2013

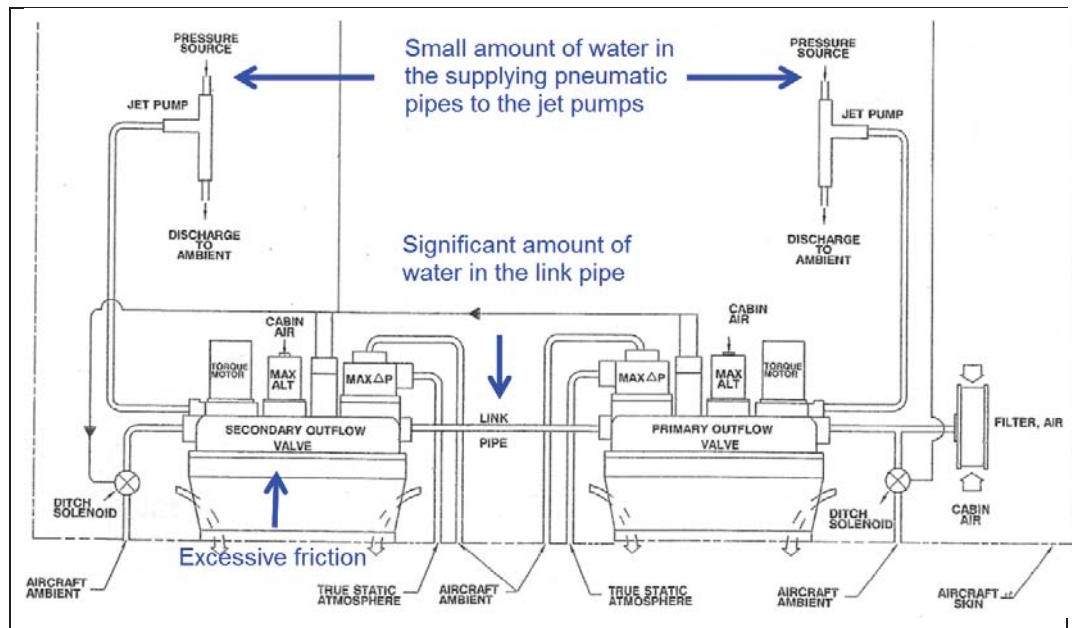
**Figure 7:** Diagram of the pneumatic connections of the outflow valves

- that the pressurisation system tests were not satisfactory;
- the presence of a significant amount of water due to condensation in the pneumatic link pipe between the outflow valves;
- the presence of a small amount of water due to condensation in the pneumatic pipes supplying air to the jet pumps;
- excessive friction slowing down the opening and closing of the secondary outflow valve;
- the absence of defects in the wiring of the pressurisation system and passenger mask drop out system;
- the absence of defects in the aneroid safety capsule and its wiring;
- that the passenger masks in seat rows 2 (seats DEF), 3 (seats DEF), 14 (seats DEF) and 16 (seats DEF) were not connected to their oxygen generators;

In addition, the maintenance company identified the pneumatic pipes and pneumatic regulator of the outflow valves as the components most exposed to moisture and freezing.

After the serious incident flight, a significant amount of water due to condensation was found in the link pipe between the outflow valves. The aircraft was flying for a sufficiently long duration at a temperature well below zero for this water, or part of it, to freeze. Following the descent from FL 310 to FL 270, frozen water could have obstructed the link pipe and caused a malfunction in the pneumatic control system between the outflow valves. In addition, the excessive friction reported in the secondary outflow valve also interfered with its operation. These two factors could have caused erratic movements of the secondary outflow valve, causing cabin climb or descent rates not corresponding to the CPC set values and perceived as unusual by the crew. As the primary channel was not able to hold these set values, the system protecting against excessive CPC rates switched to the secondary channel. This was confirmed by the PRI error code and the white “PRESSN” warning light as reported by the commander.

- the two outflow valves were replaced;
- the pneumatic pipes were cleaned;
- the CPC was replaced as a precautionary measure;
- all the passenger masks and oxygen generators were replaced.
