Final Report No. 2265

concerning the accident
involving the AS350 B3e helicopter,
registration HB-ZMO,

on 1 July 2013

‘Mändliteifi’ area

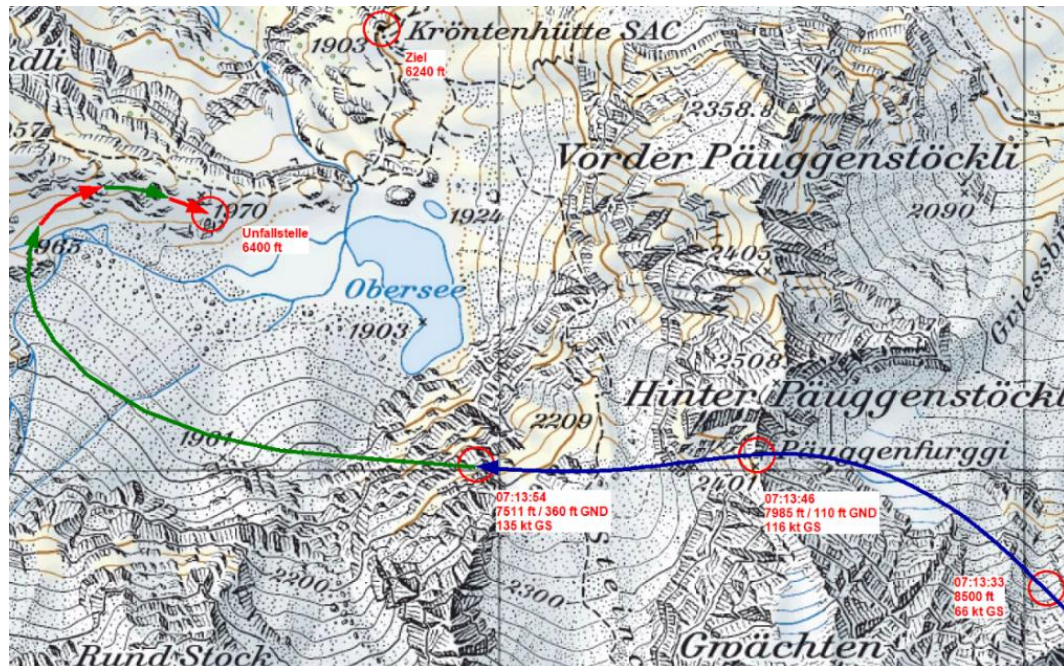
Descending with a high forward speed, the helicopter crossed the Steinchelen area. According to the last recording of the satellite-based navigation computer, the ground speed was about 135 kt (approx. 250 km/h).

Figure 1: Flight path of HB-ZMO: the flight path as recorded by the navigation computer (blue), flight path observed by witnesses (green) and the not-observed flight path (red); base map 1:25 000, reproduced by permission of the Federal Office of Topography Swisstopo (JA150149).

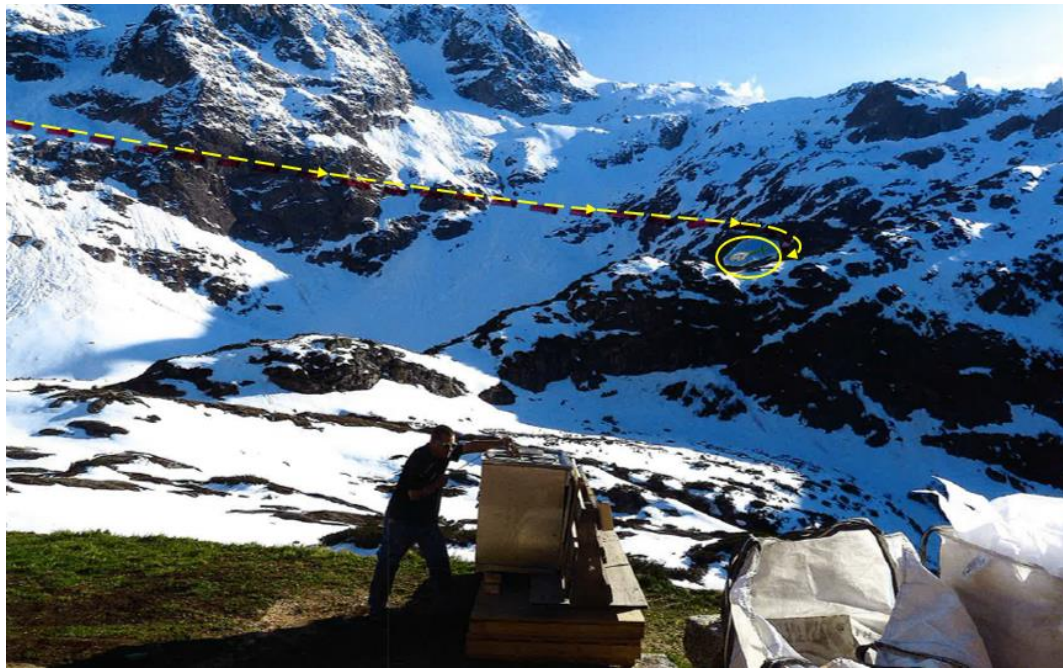
Figure 2: Flight path of HB-ZMO flying into the basin according to an observer's flight reconstruction viewed from the Kröntenhütte. The picture was not taken on the day of the accident. The underside of the photoshopped helicopter, circled in yellow, is visible. This photo montage illustrates the position and location of the helicopter immediately prior to the accident behind the crest.

This surprised some observers who were expecting the helicopter to follow a path towards the Kröntenhütte in a direction out of the basin after turning above the sloping ridge.

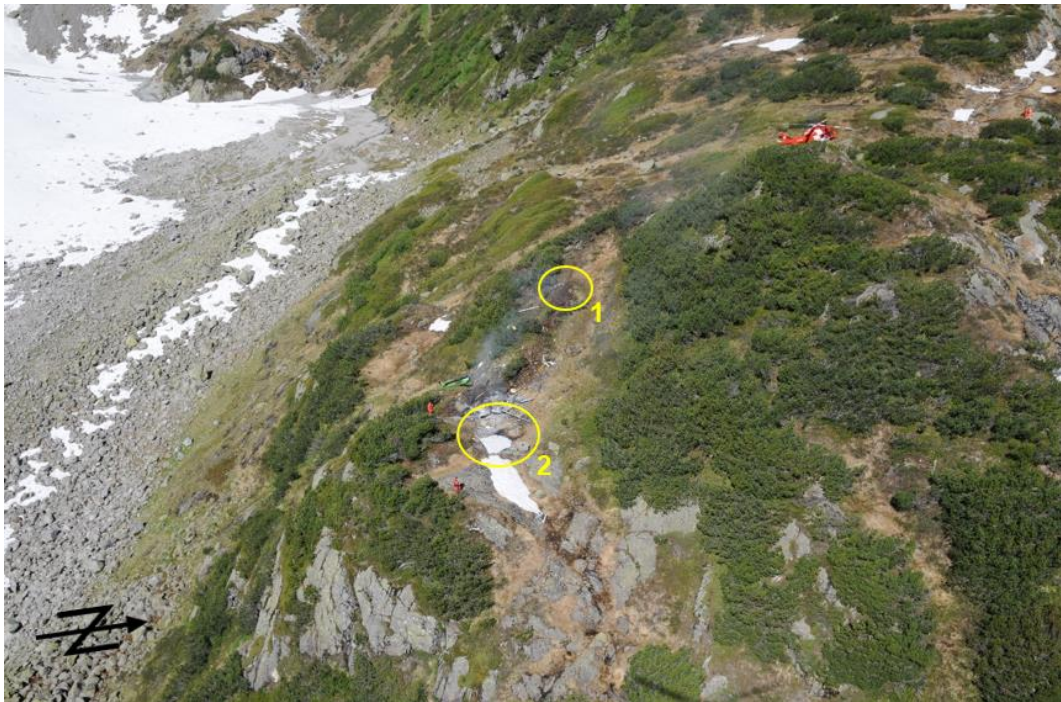
Figure 3: Position 1 shows the first impact marks of the helicopter and position 2 the final position of the wreckage on the ridge below the Oberseemandli mountain, between the Mändliteifi area and Obersee lake.

In the first area there were clear impact marks such as displacements of soil and snapped pine shrubs. The first longitudinal marks of the impact came from the landing skids. The initial and most westerly longitudinal marks were line-like marks in a direction of 090° and pointing towards the main wreckage. Pieces of the landing skids and various pieces of the cowling were found in this first location.

The second location was 25 m east from the first marks. This is where the completely destroyed and burnt-out helicopter cabin was found together with the engine, pieces of the main rotor blades and the transmission, with transport equipment spread around the site.

The tail boom with the comparatively less damaged tail rotor was in the third location which was south of the second location and bordering on the terrain sloping towards the basin.

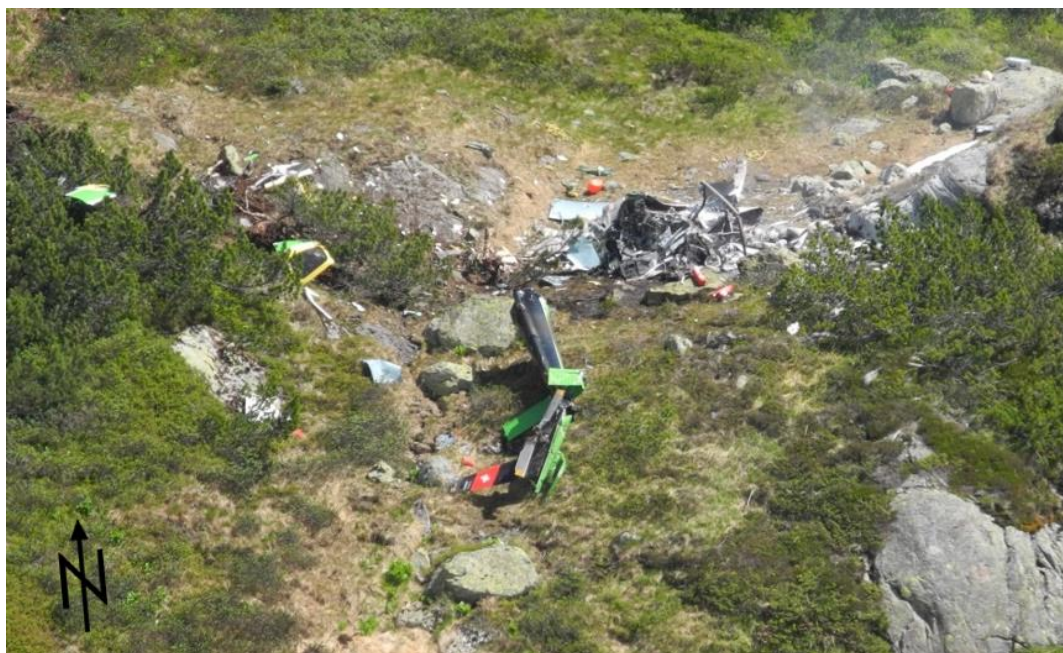
The main wreckage was on a flat area on the ridge. The helicopter was destroyed by the impact and the subsequent fire. The engine as well as remnants of the main transmission, swashplate and main rotor head lay in the middle of the main wreckage. All the main rotor blades were connected to the rotor head. Two blades were severely damaged by the impact; the third one was destroyed to a large extent by the fire. The damaged instrument panel of the cockpit was found outside of the fire-affected area. The tail boom including tail rotor, the left-hand side cockpit and sliding door, the left-hand side luggage hold cover, the right-hand side cockpit door including door pillar together with the small rear door and a cowling cover were a couple of metres away from the main wreckage. These parts were damaged by the impact but not affected by the fire. In the area between the first impact and the main wreckage, pieces of the landing skids were found.

Figure 4: Final position of the HB-ZMO wreckage.

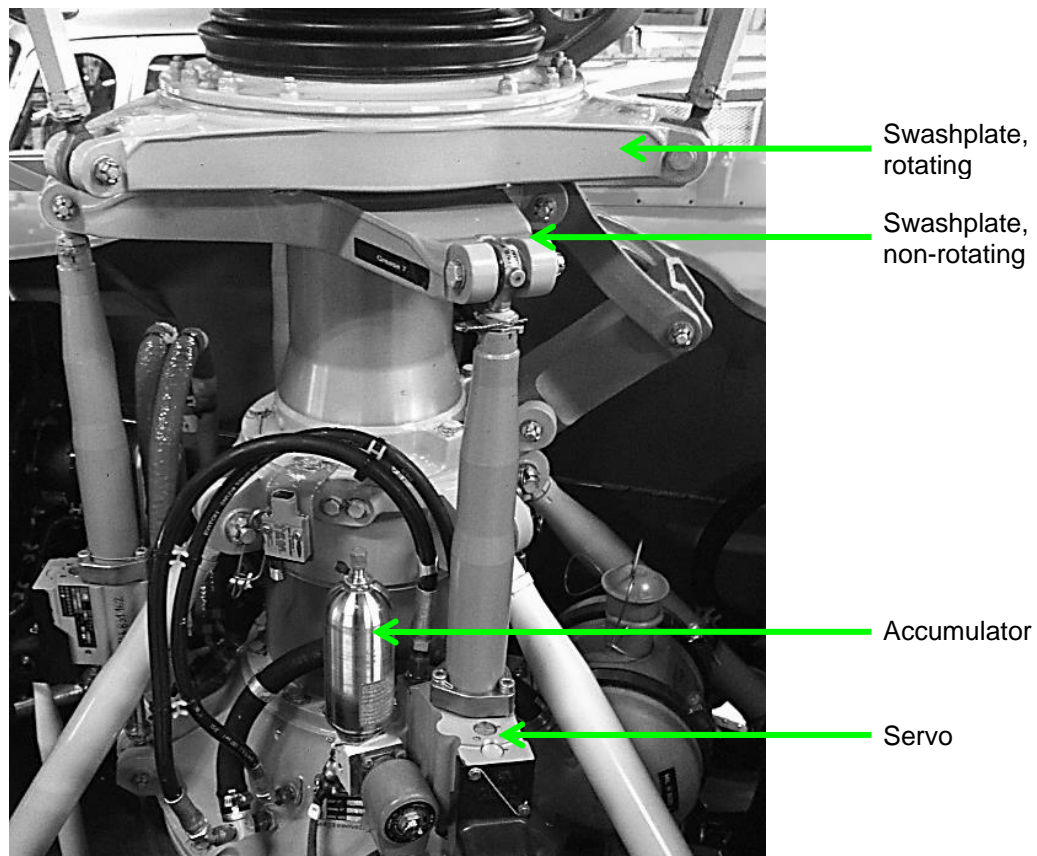
HB-ZMO was fitted with a single hydraulic system and did not have the respective warning light.

Figure 5: Hydraulic servos with accumulators and control rods to the swashplate.

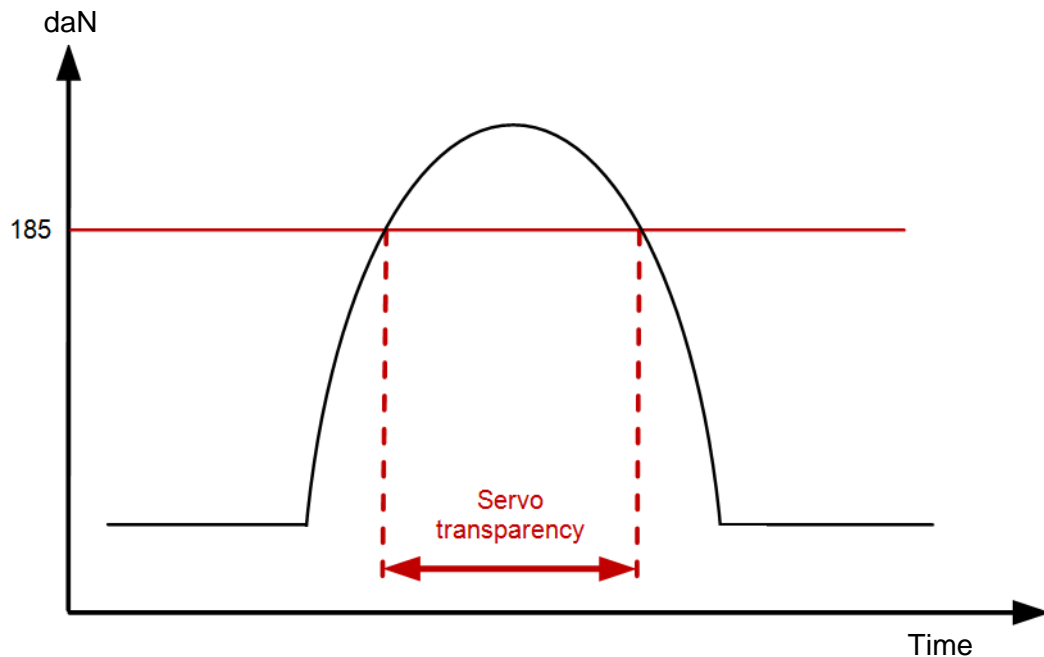
The graph below shows schematically that servo transparency occurs for as long as the 185 daN maximum force of the servos is exceeded. If the load factors on the main rotor momentarily add up to for example 195 daN, the pilot has to provide the required additional effort manually. This steering input builds up instantaneously. As only small efforts are normally required to control the cyclic stick of a AS350, the surprised pilot perceives the additional and suddenly required effort of 10 daN as if the controls were jammed.

Figure 6: Servo transparency – the required output exceeds the servo’s capacity in the period between the dotted red lines. The servo can output a maximum force of 185 daN.

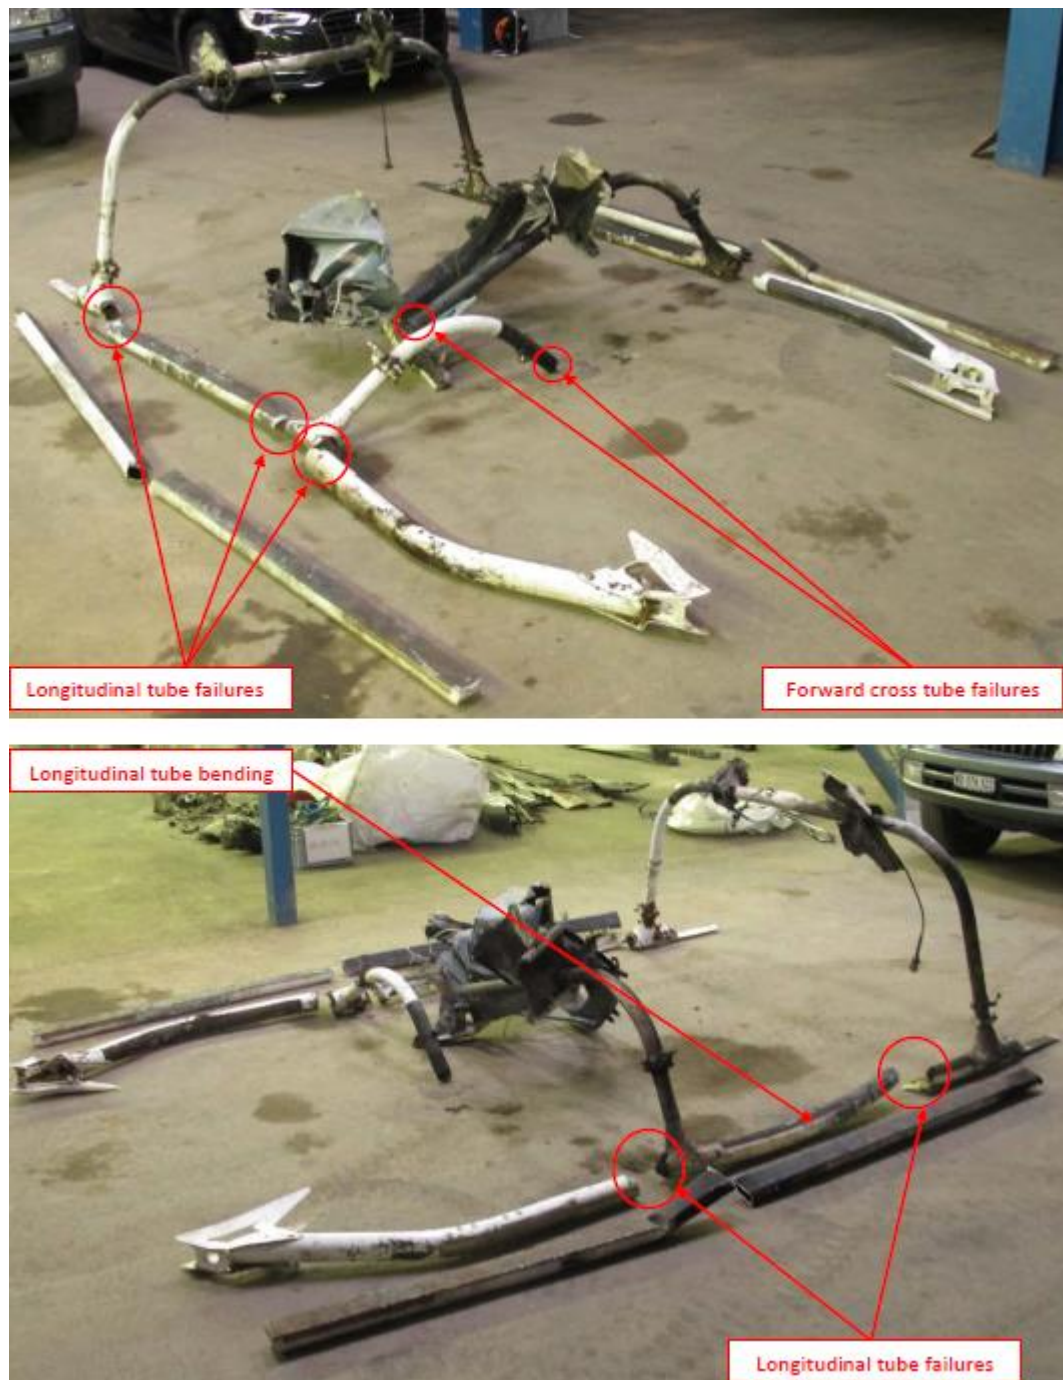
The landing skids showed some longitudinal tube failures at the connection points with the cross tubes. A forward cross tube failure was found in the area of the right-hand airframe connection.

The left-hand landing skid showed clear longitudinal tube bending upwards, which is more likely to be attributed to displacement or deformation during the disintegration sequence than to a vertical impact.

Figure 7: The pieces of the landing skids were set up to their original position. Significant fractures are marked in red.

The findings on the landing skids indicate the main direction of movement and the flight attitude of the helicopter at the time of the accident:

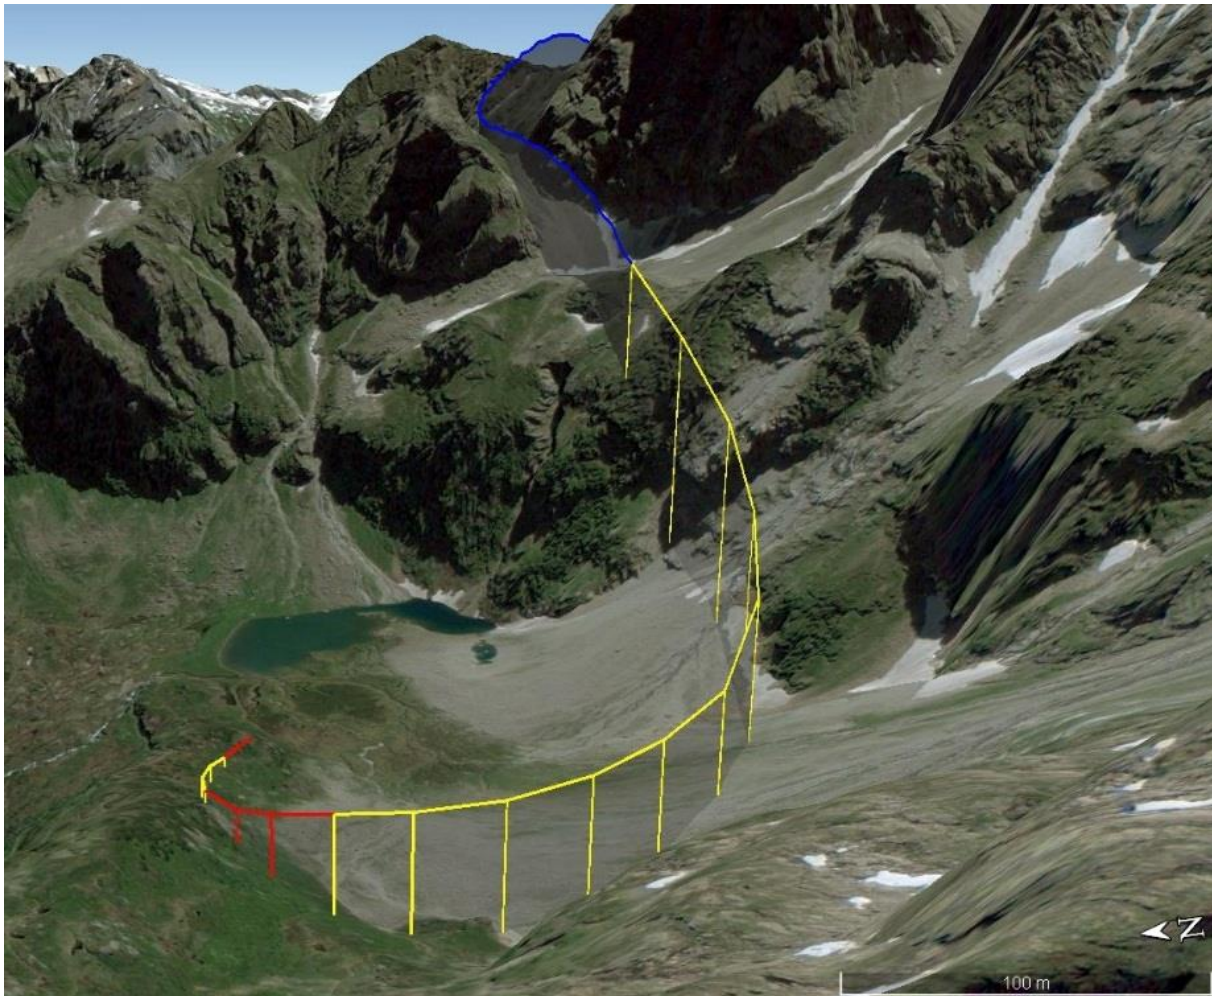
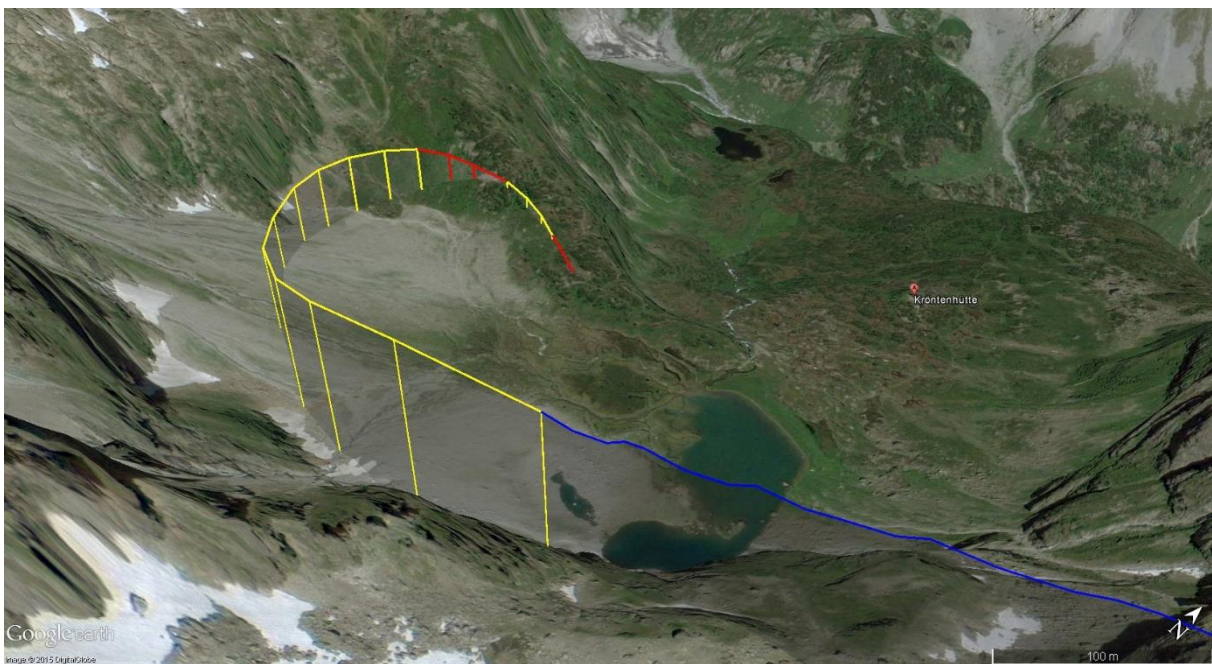
Appendix 1: Flight path of HB-ZMO marked on Google Earth

Flight path of HB-ZMO: the flight path as recorded by the navigation computer (blue), flight path observed by witnesses (yellow) and the not-observed flight path (red).
