Final Report No. 2267 by the Swiss Transportation Safety Investigation Board STSB

concerning the accident involving the
helicopter Cabri G2, HB-ZLJ,

on 13 July 2013

Neuhaus, Municipality Wichtrach/BE

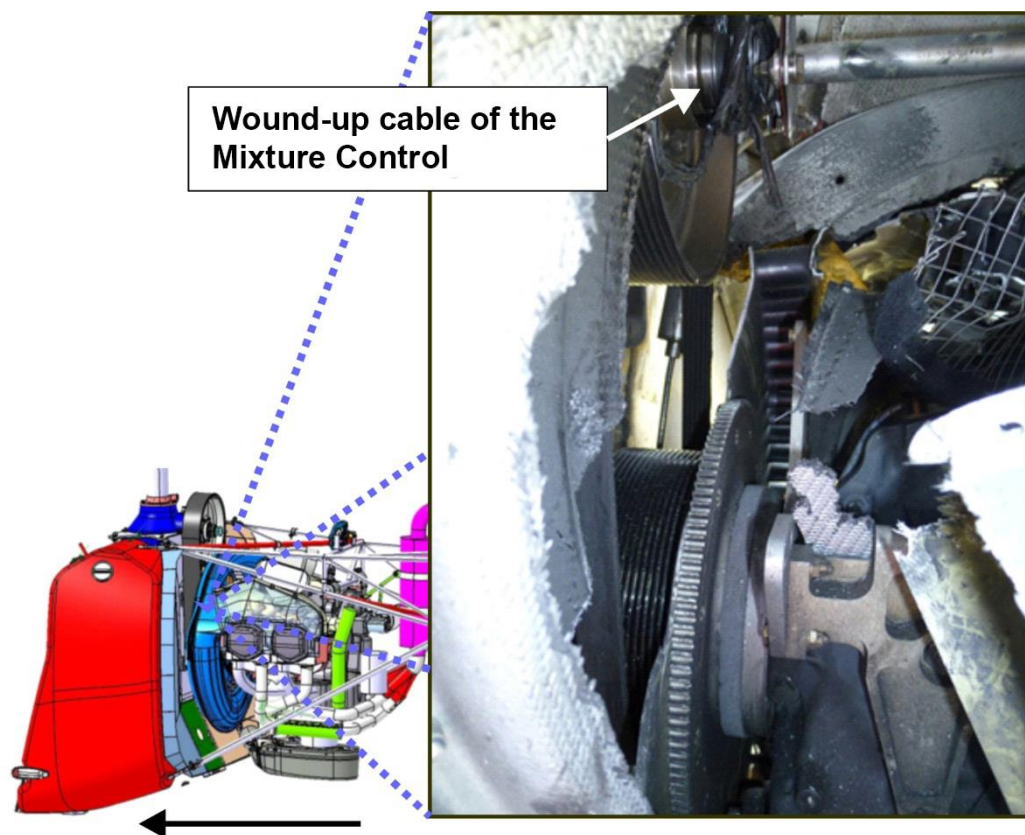
At the accident site, it was established that the air cooling housing was destroyed and the cooling fan severely damaged. A large segment was torn off (see illustration 7). As a result of the cooling fan's disintegration, the mixture control cable wound up to the point that it ruptured. This caused the engine to stop at a height of almost 2400 ft, which corresponds to around 200 m above ground.

Illustration 7: Damage in the area of the cooling fan. The black arrow indicates the flight direction.

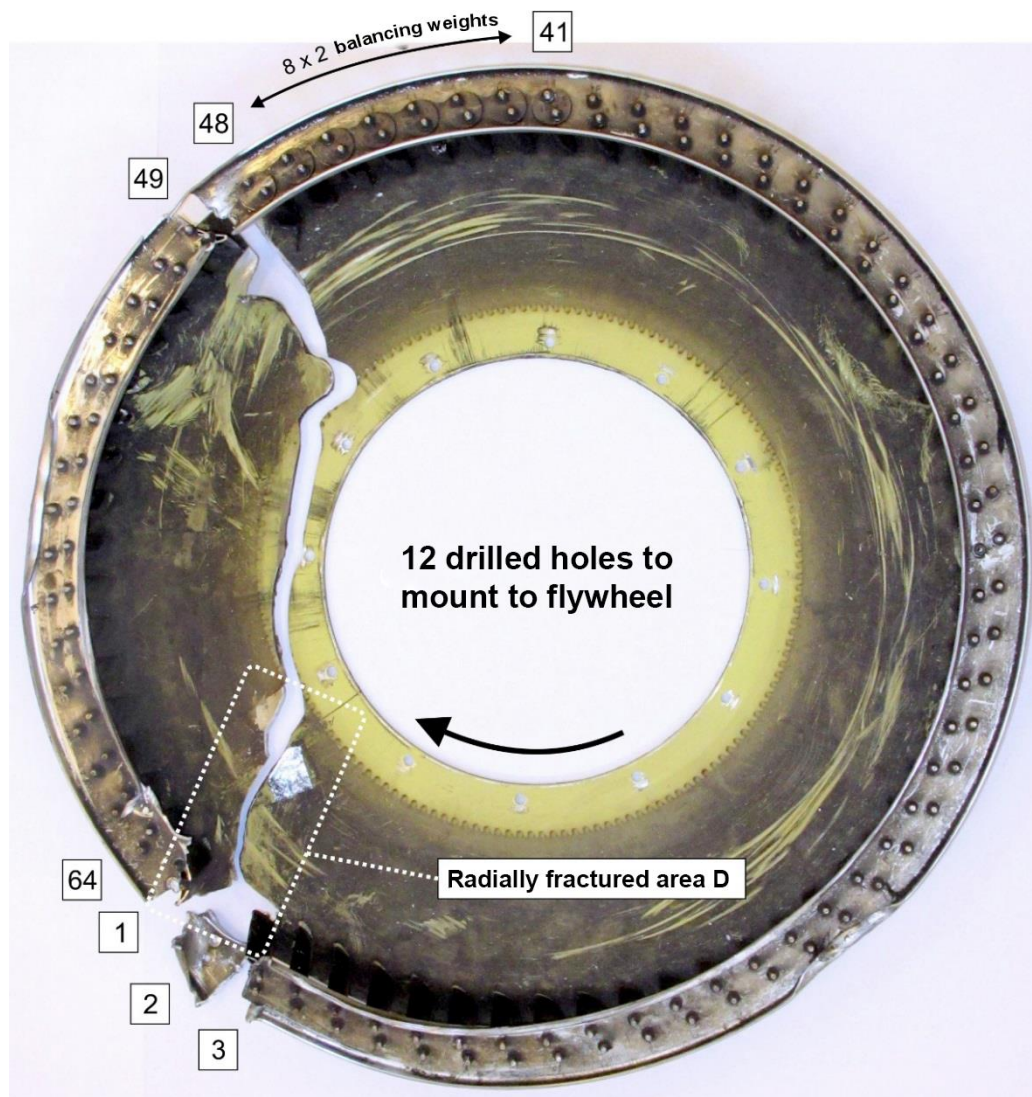
A first assessment of the severely damaged cooling fan showed (see illustration 8):

One segment of the cooling fan was torn off. The innermost diameter of the front disc still remained intact despite the disc's fracture.

The torn-off segment, consisting of a piece of the front disc, a piece of the rear ring and 17 fan blades attached to it, was partially plastically deformed. The affected blades are numbered 49, 50 to 64 and 1. Several blades showed impact marks.

In the area of the eight blades numbered 41 to 48, there were two round balancing weights per blade under each mounting nut towards the rear ring. One balancing weight had a mass of 2.77 g. The total balancing mass was thus 44.32 g.

Illustration 8: Rear view of HB-ZLJ's damaged cooling fan. The black arrow indicates the direction of rotation. The numbers in the white squares correspond to the numbering of the fan blades.

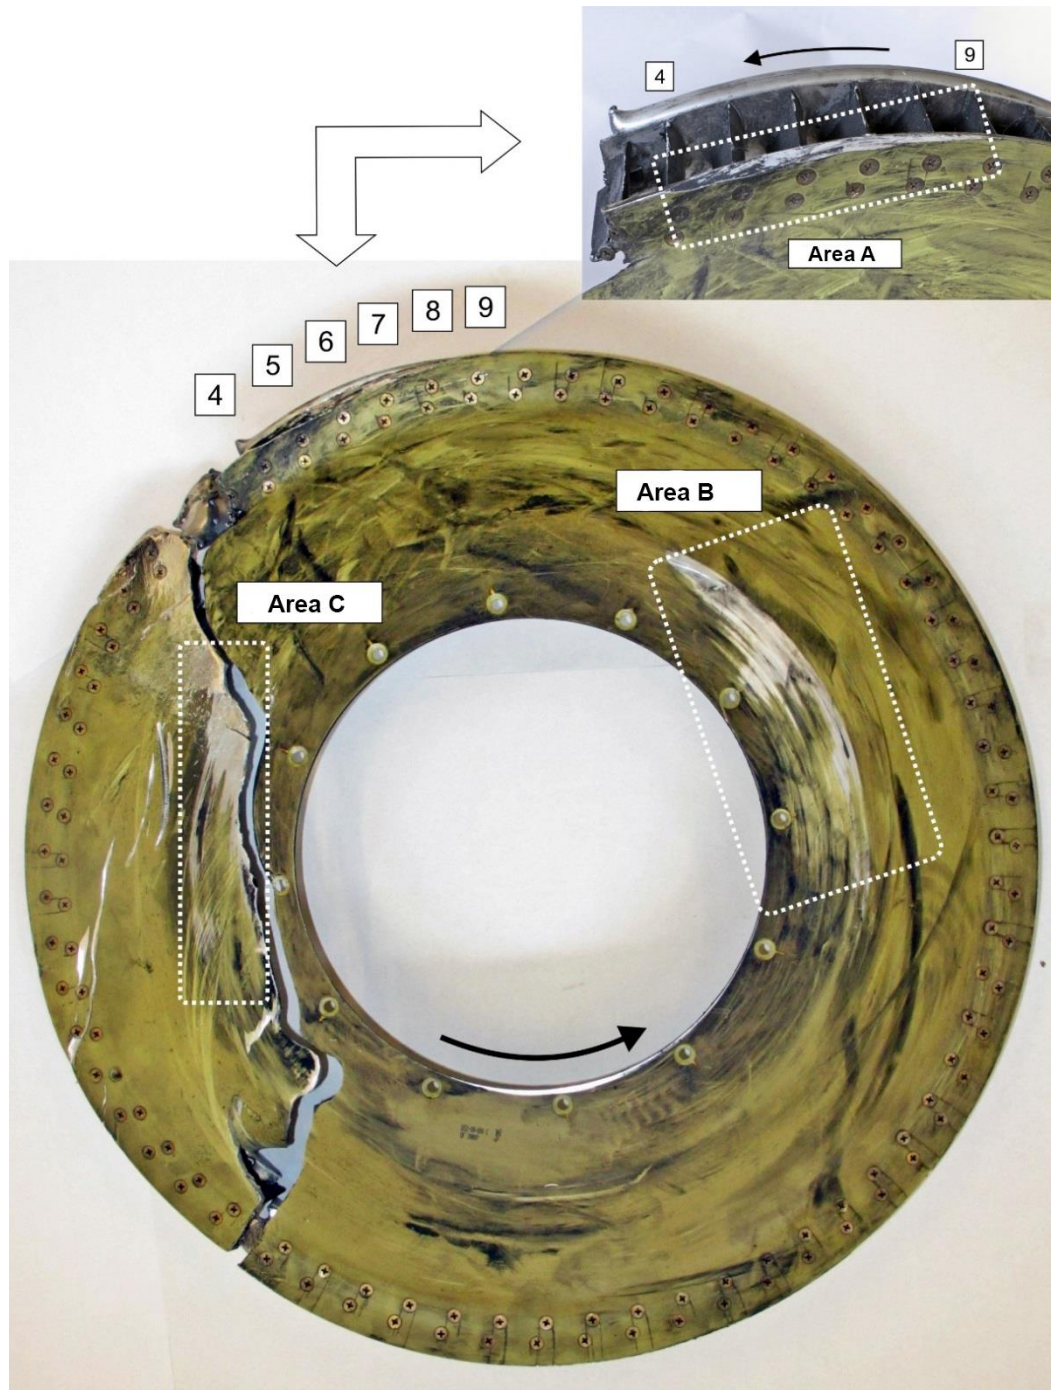
Abrasion marks in the direction of rotation of the cooling fan were found on the front of the front disc.

After the accident, the larger part of the cooling fan was still fixed to the flywheel of the engine with the 12 countersunk screws. The fracture ran through the bore hole of one of these screws. This part of the front disc showed plastic deformations, particularly in the outer area, in close proximity to the radial fracture area D (see illustration 8). The outer edge of the front showed significant abrasion marks in area A. There were also abrasion marks in the areas B and C (see illustration 9).

Illustration 9: Front view of HB-ZLJ's damaged cooling fan with detail of the abraded outer edge. The black arrow indicates the direction of rotation.

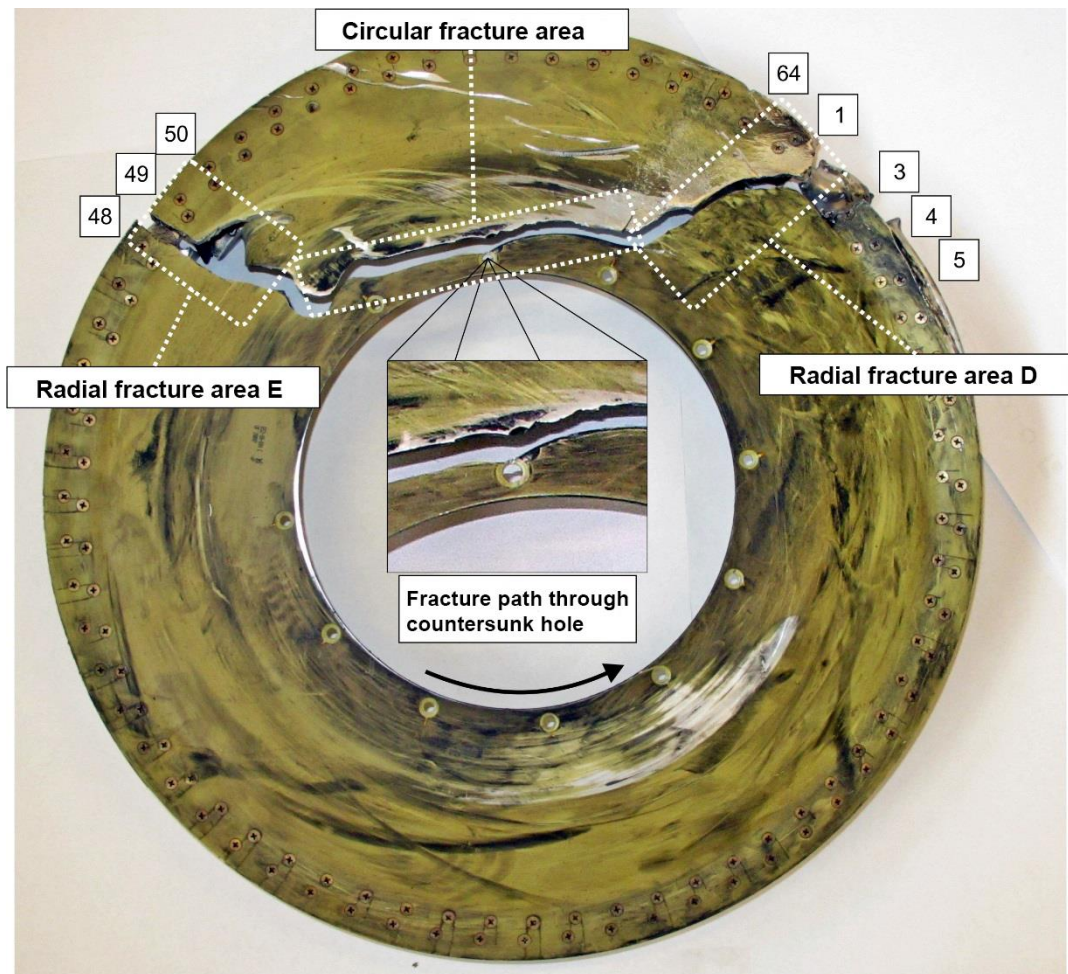
The entire length of the fracture surface of the circular fracture area showed striations typical for a fatigue fracture. These striations were also present in the radial fracture area E in close proximity of the circular area (see illustration 10). In the outer radial fracture area E – near the blade fixing – the fracture surface showed a honeycomb-like structure. This suggests a ductile overload fracture.

The characteristic striations of a fatigue fracture were found at several places in the radial fracture area D.

Illustration 10: Circular and radial fracture areas with close-up view.

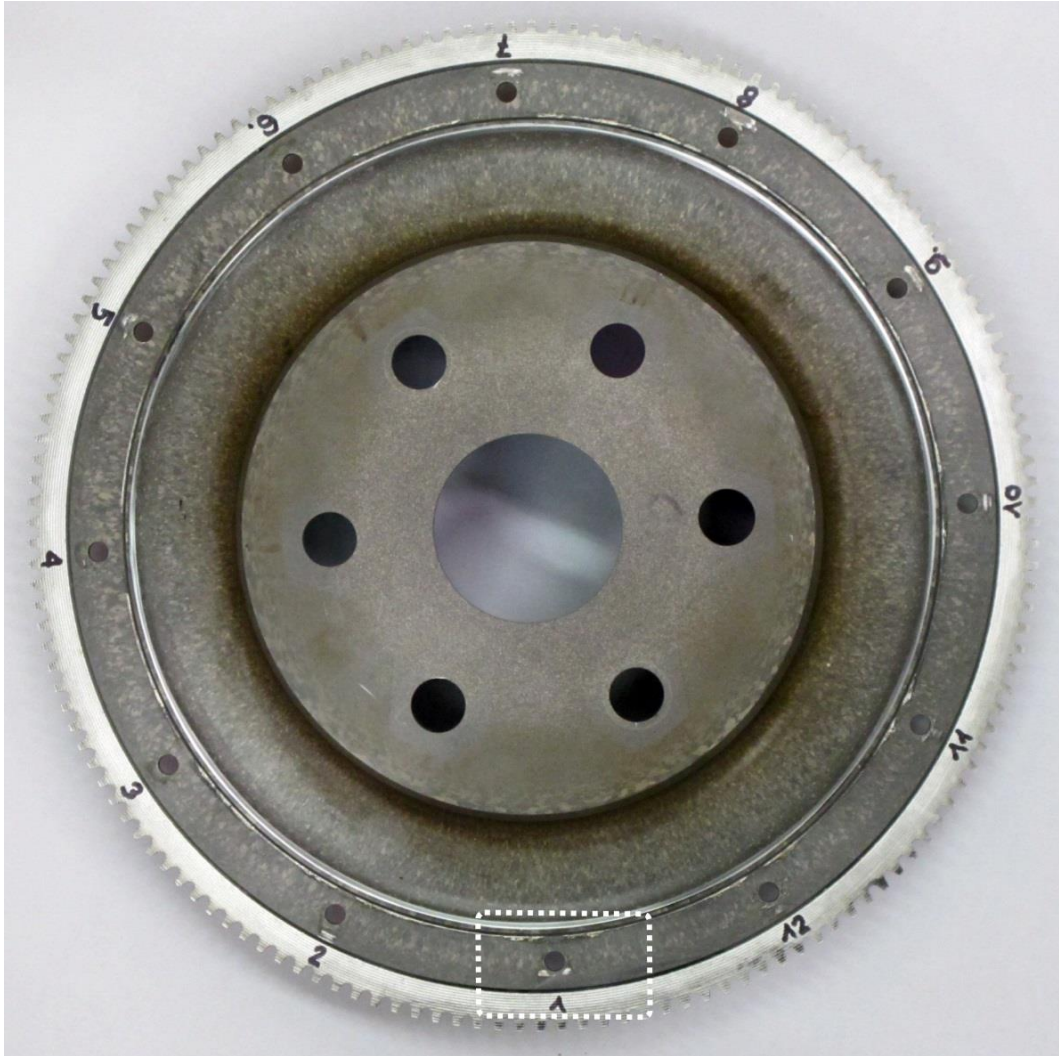
If a component is constantly stressed by impact on the surface, impact wear of the surface layer occurs. This depends on the type and frequency of the stress. The examination of the surface in contact with the front disc of the cooling fan after mounting to the flywheel showed abnormal impact wear in the area of the 12 mounting points.

Visually, such an area can easily be confused with corrosion marks. No corrosion damage was found on the front disc or on the flywheel.

Illustration 11: Mounting surface of the flywheel to which the front disc of the cooling fan was mounted. The area of mounting point 1 is framed.

Abnormal marks were found on the contact surfaces between flywheel and cooling fan in the area near the 12 mounting points (see illustrations 11 and 12). The marks on the flywheel were consistent with the marks of the opposite side, i.e. the contact surface of the front disc of the cooling fan. These marks are created by impact wear. This kind of wear is caused by constant impact stress on two surfaces that are in contact with each other. These marks were so unique that contact corrosion can be ruled out.

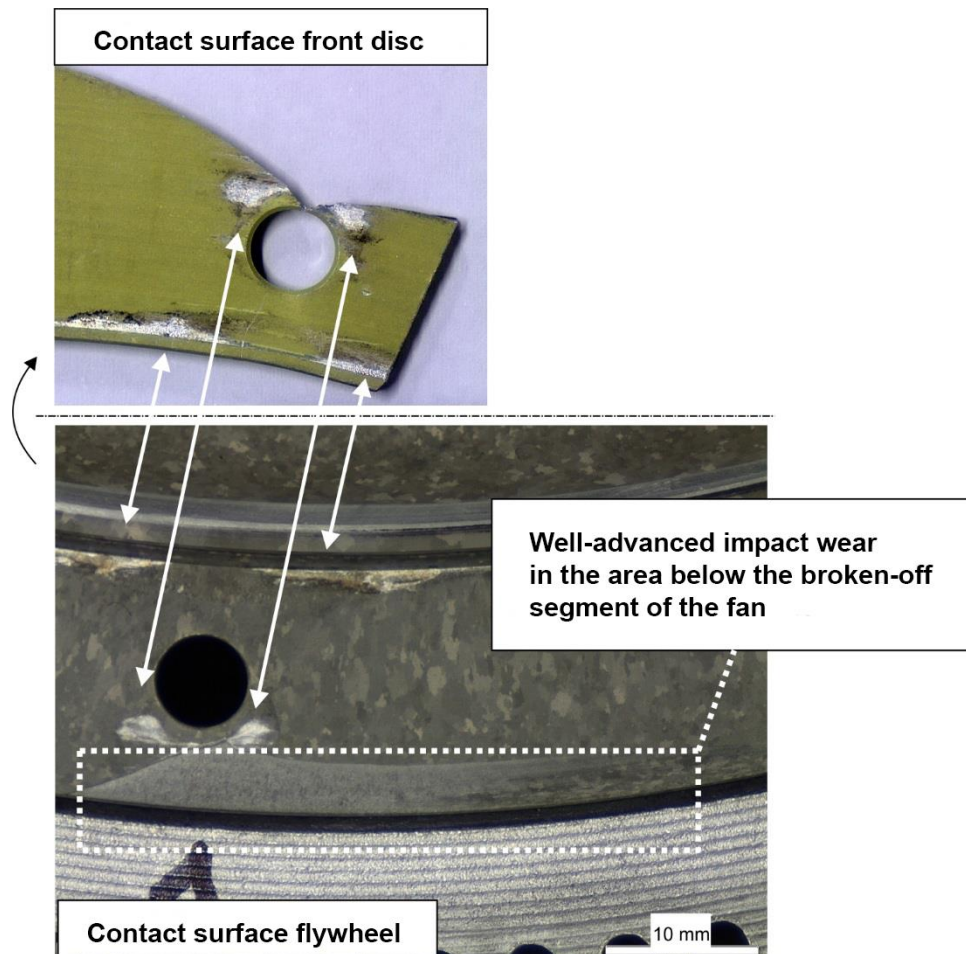
Signs of impact wear were found at all 12 mounting points. The impact wear between the flywheel and the part of the cooling fan still mounted after the accident was very distinctive at mounting point 1. The worn surfaces of disc and flywheel were consistent (see illustration 12). The circular fracture propagated through mounting point 1. The impact wear on the flywheel surface was very advanced in the contact area of the broken-off segment of the cooling fan.

Illustration 12: Contact surfaces between flywheel and cooling fan with the consistent impact wear in the area of mounting point 1.

In the contact area of the broken-off segment of the cooling fan, the impact wear on the flywheel surface is well-advanced. This is consistent with the impact wear on the broken-off segment which is also well-advanced. On the front of the flywheel, the fracture path of the front disc of the cooling fan is clearly visible (see illustrations 12 and 13).

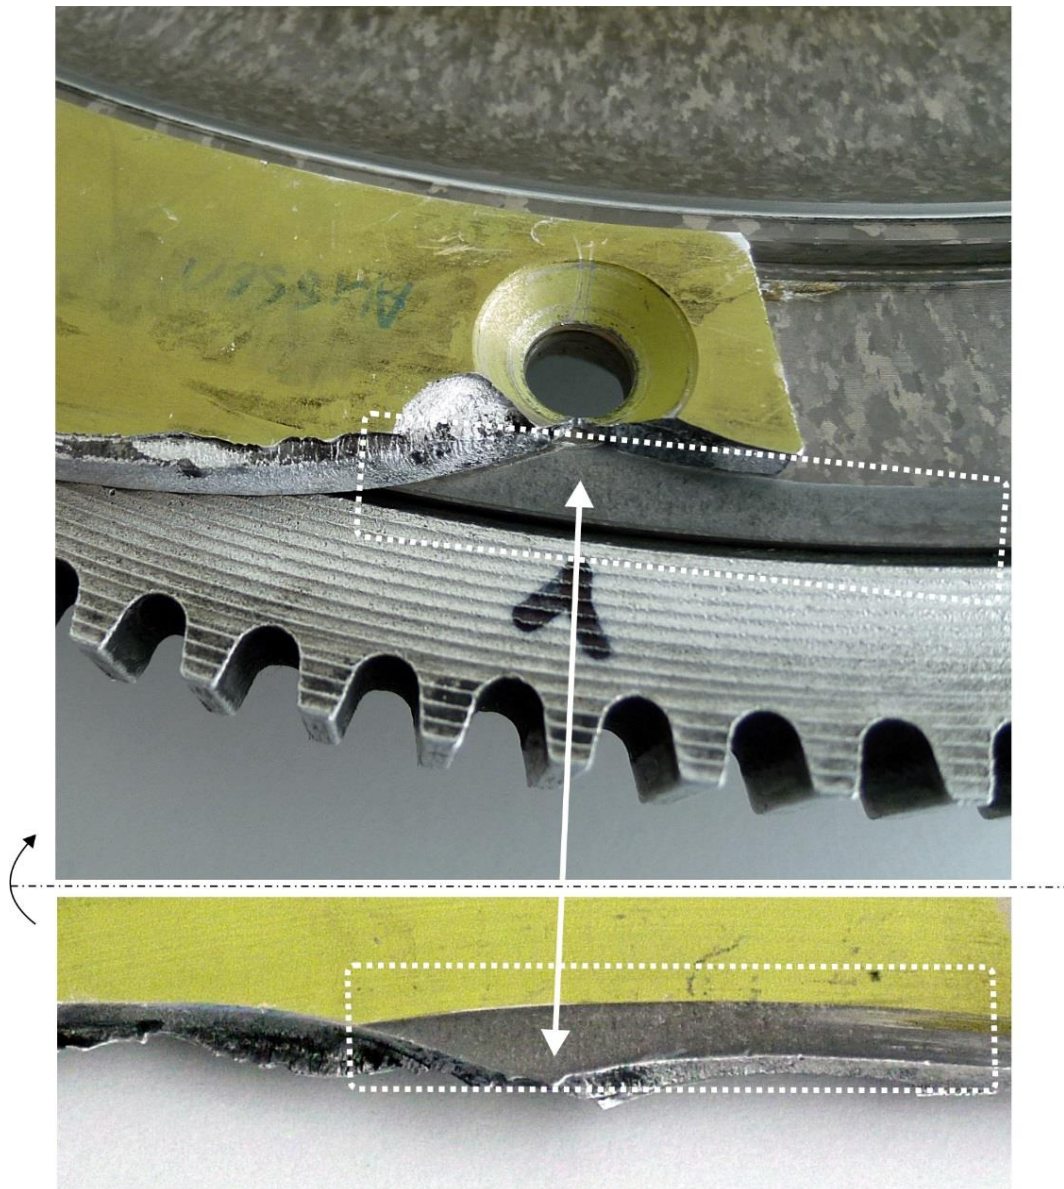
In addition, this contact area aligns with the well-advanced impact wear of the broken-off segment of the cooling fan (illustration 13).

Remarkable is the clearly visible mark of the fracture path of the cooling fan's front disc on the mounting surface of the flywheel.

Illustration 13: Consistent, well-advanced impact wear on the flywheel and the broken-off segment of the cooling fan.

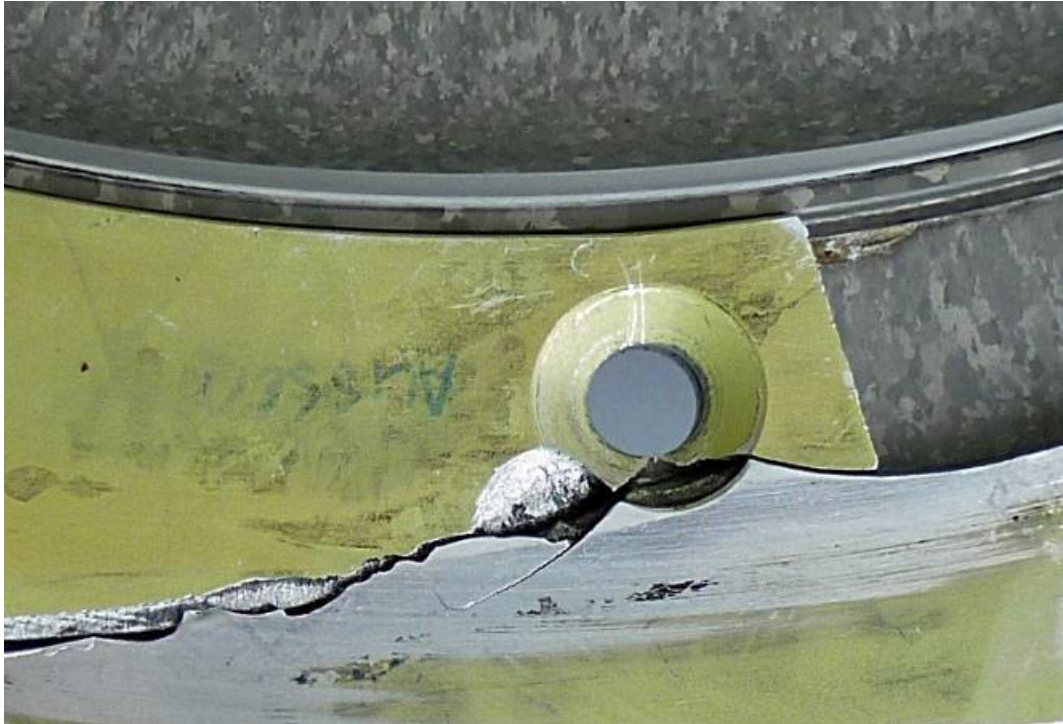
The impact wear in the countersink of the broken-off segment was very deep. At mounting point 1, there were only abrasion marks on the disc surface of the broken-off segment (see illustration 14).

Illustration 14: Deep impact wear in the countersink and distinct abrasion marks on the broken-off segment.

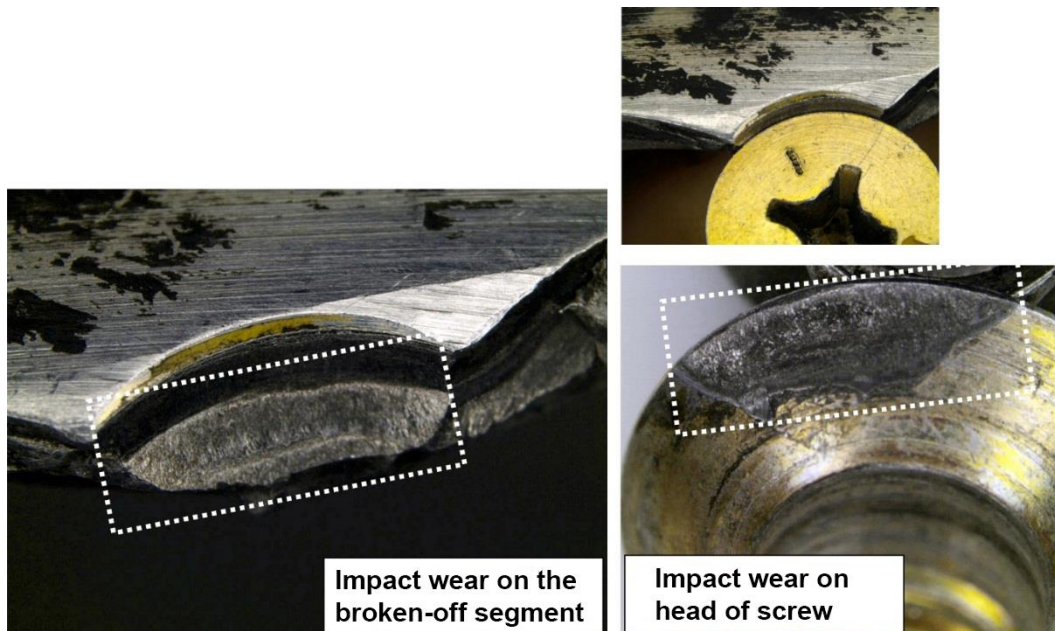
The examination of the 12 mounting screws found that the cone-shaped part of the head of one screw showed impact wear. The mark of this impact wear was consistent in shape and size with the worn countersink of the broken-off segment (see illustration 15).

Illustration 15: Comparison of the impact wear on countersink and screw head.

The impact wear is very deep in the countersink of the broken-off segment (see illustration 15). The mark of this impact wear was also found as wear on the cone-

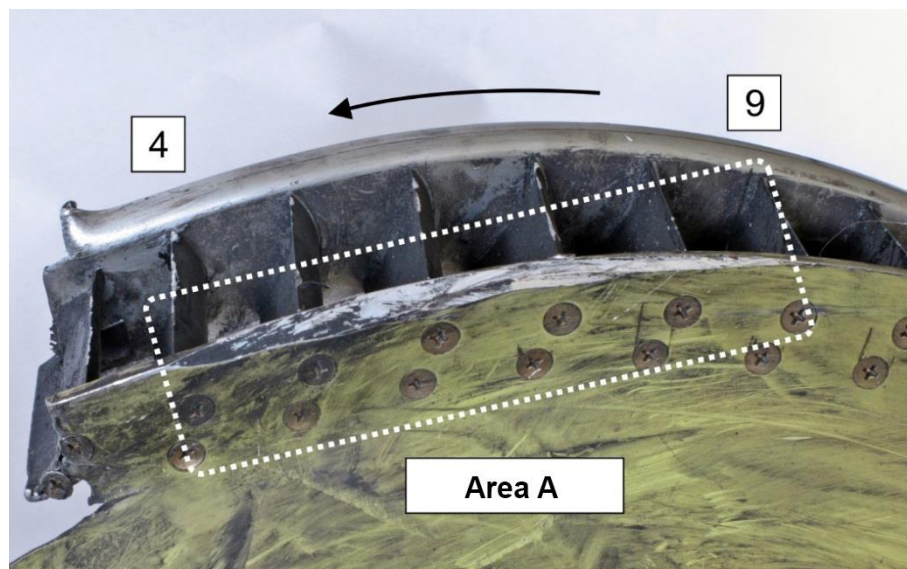
The examination of the outer edge of the disc front provided the following results in area A (see illustration 16):

- The edge was ground down to a sharp burr.
- Deposits found on the ground-down surface contained carbon fibres.
- The ground-down surface structure was fused through overheating.

Illustration 16: Ground-down outer edge of the disc front.

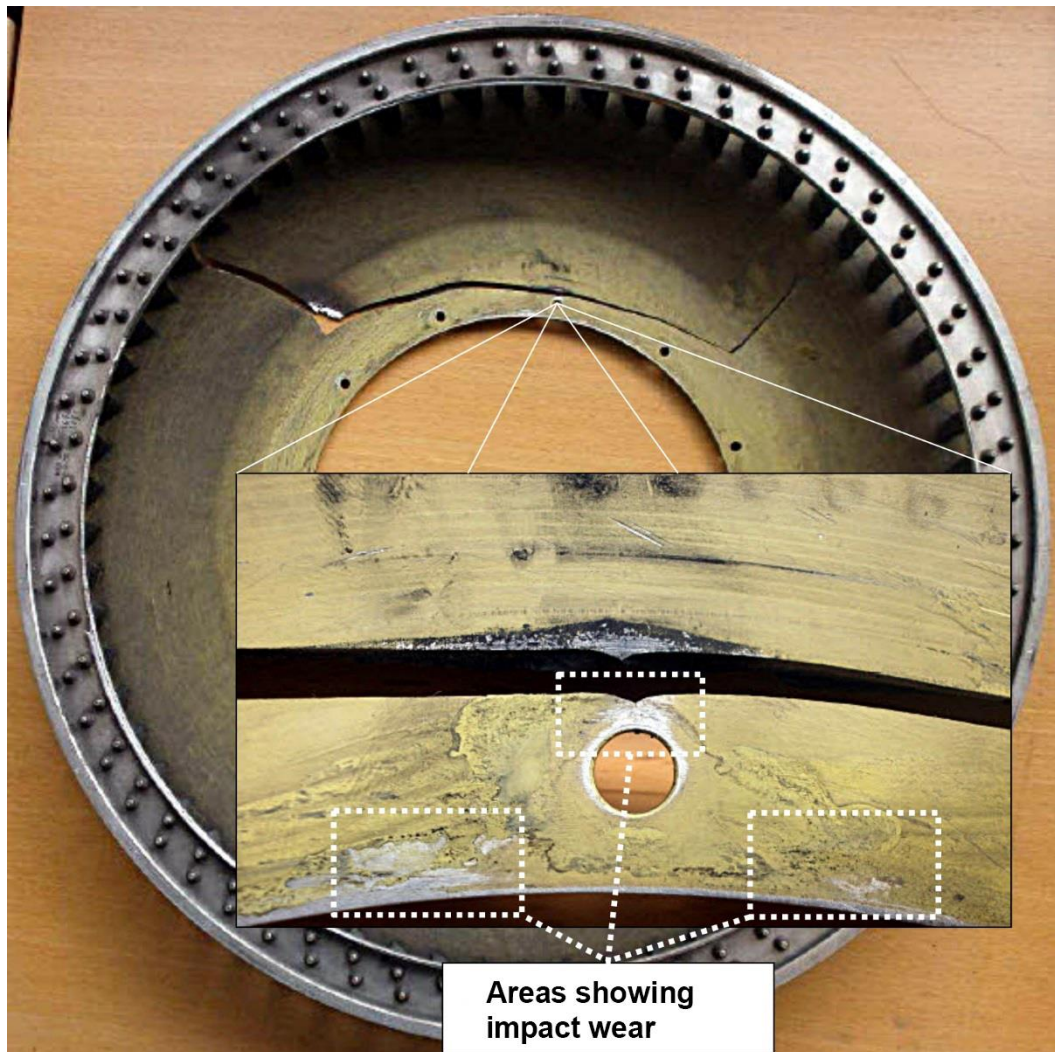
On 12 August 2014, when SE-HJR had approximately 3600 operating hours, an almost identical incident to that involving HB-ZLJ occurred during a training flight. After the crew had noticed an unusual noise coming from the engine bay, an emergency landing was initiated immediately. Subsequently, the following damage to the cooling fan of SE-HJR was found (see illustrations 17 and 18):

Illustration 17: Rear view of the damaged cooling fan of SE-HJR with close-ups.

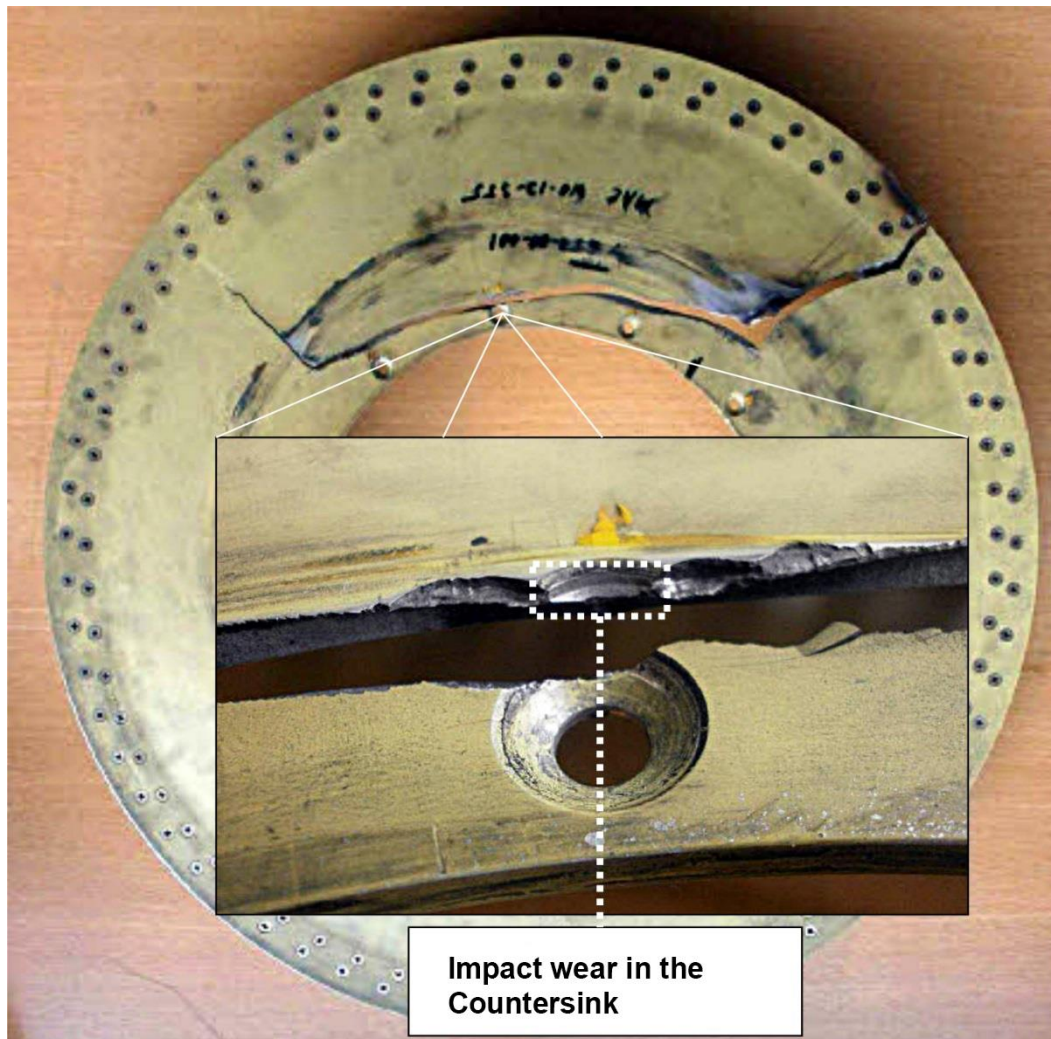
Illustration 18: Front view of the damaged cooling fan of SE-HJR.

The manufacturer of the helicopter included the findings of the HB-ZLJ accident investigation in the analysis of the incident involving SE-HJR and concluded that the failure of the cooling fan had the same cause in both cases.

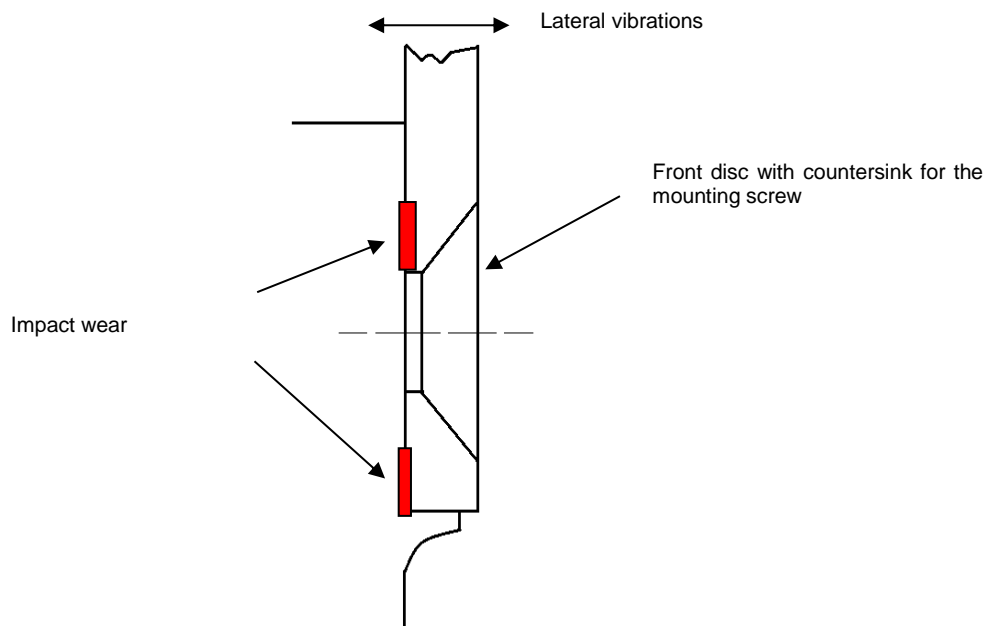
Illustration 19: Area of the impact wear on the contact surfaces of the flywheel and the front disc prior to the start of the crack propagation.

Impact wear is caused by dynamic fretting. From the type of impact wear found here, it can be concluded that the lateral vibrations were transmitted from the flywheel to the front disc of the cooling fan. This was promoted by an inadequate screw connection and insufficient lateral stiffness of the disc.

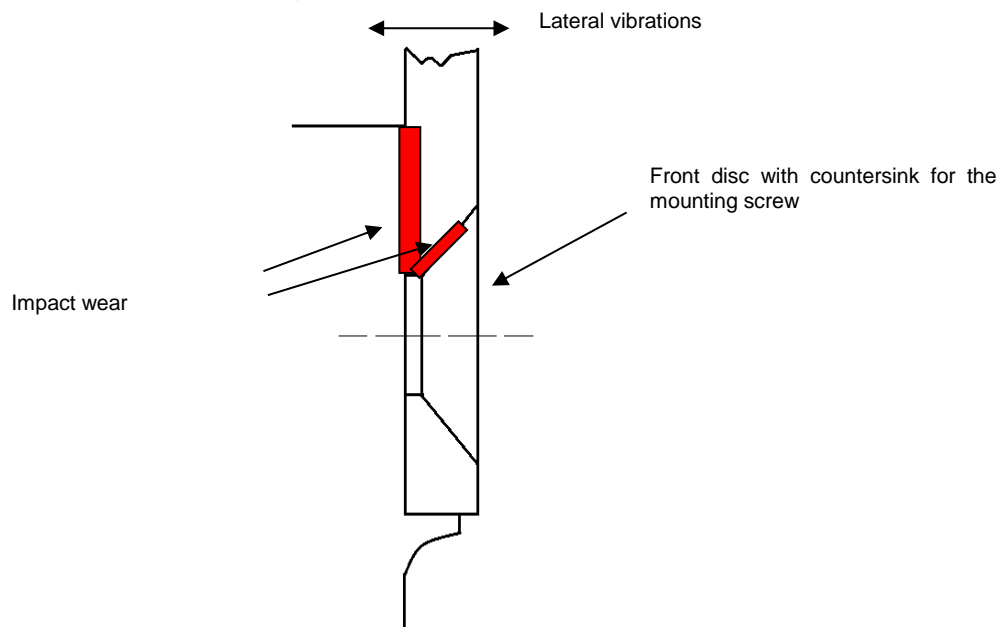
Illustration 20: Area of the well-advanced impact wear on the contact surfaces and in the countersink after the start of the crack propagation.
