# **Final Report No. 2269**

## **by the Swiss Transportation Safety Investigation Board STSB**

concerning the serious incident of the  
commercial aircraft Airbus A330-343,  
HB-JHB,

on 21 November 2014

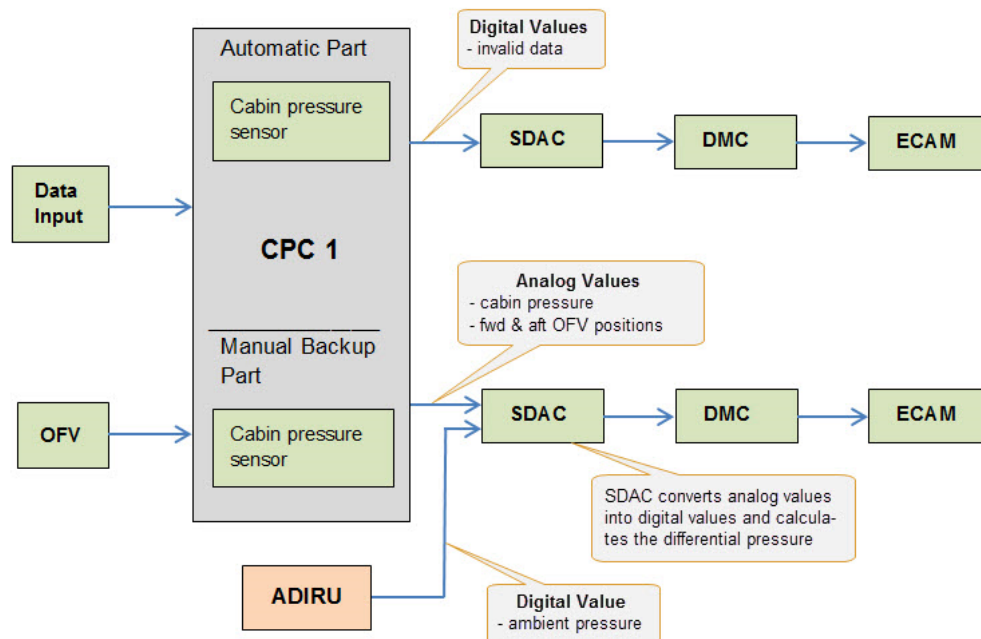
**Figure 2:** Data flow diagram for ECAM displays in manual mode (SYS 1 FAULT)

The cabin pressure parameter is transferred to the SDAC as direct current (analogue) signal. There it is converted into a digital parameter from which the cabin altitude is calculated. The direct current has a lower and upper limit as a result of which this parameter is no longer displayed from a cabin altitude of -2060 feet.

The cabin altitude rate parameter is derived from the cabin altitude. The differential pressure parameter is calculated from the formula  $\Delta P = P_{\text{cabin}} - P_{\text{ambient}}$ . The ambient pressure is supplied by the ADIRS. The data flow is shown in figure 2.

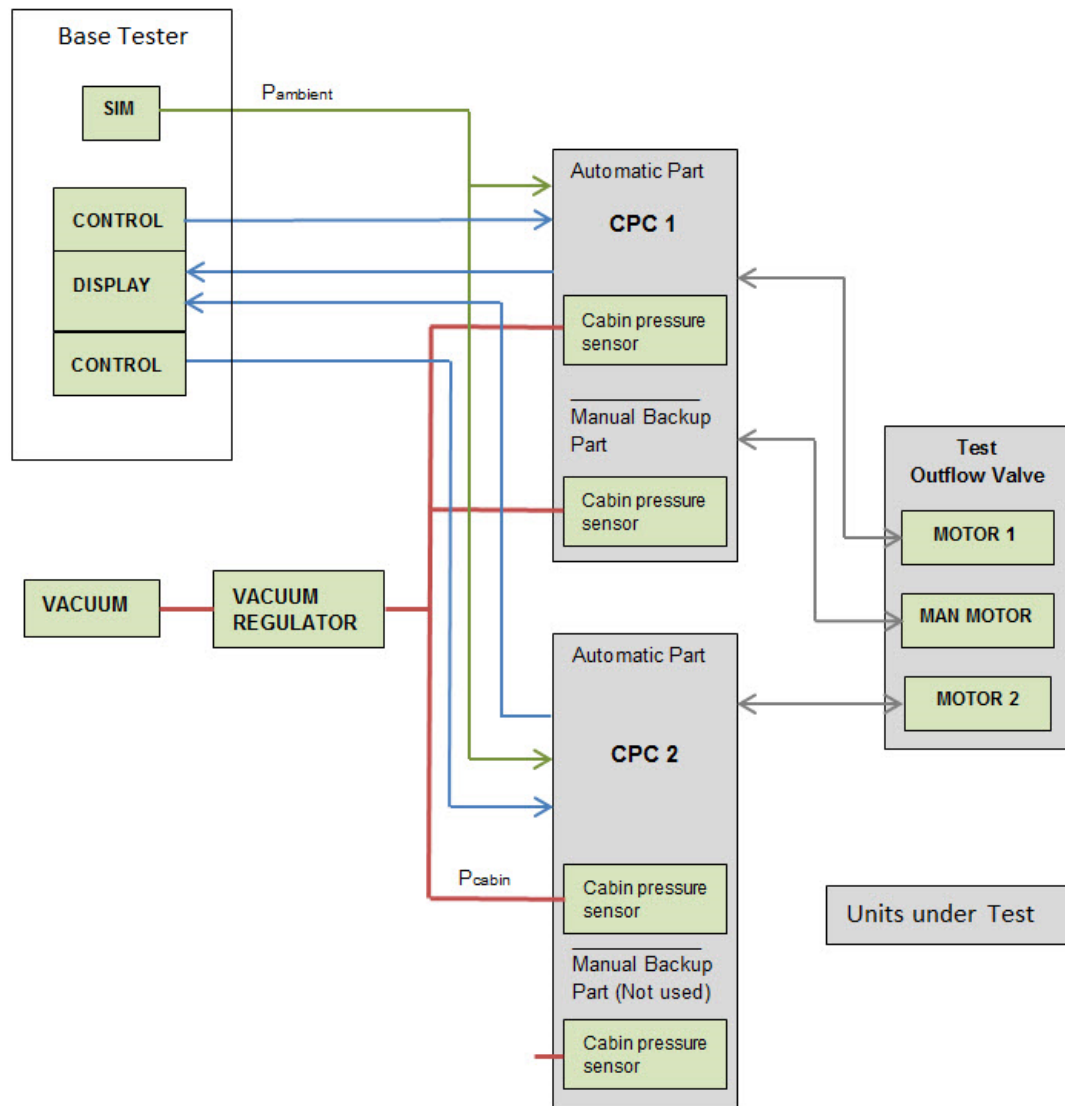
**Figure 7:** Simplified presentation of the Nord Micro base tester

The aft outflow valve got jammed in a position close to closed, in order to force a loop closure failure. Both CPCs entered standby fault (failure state) status successively, which was consistent with expectations. This chronological course corresponded almost exactly to the QAR recordings.

On the base tester display, the Arinc 429 digital output signals of both CPCs were observed. All showed the status 'invalid status' (ssm = 00).

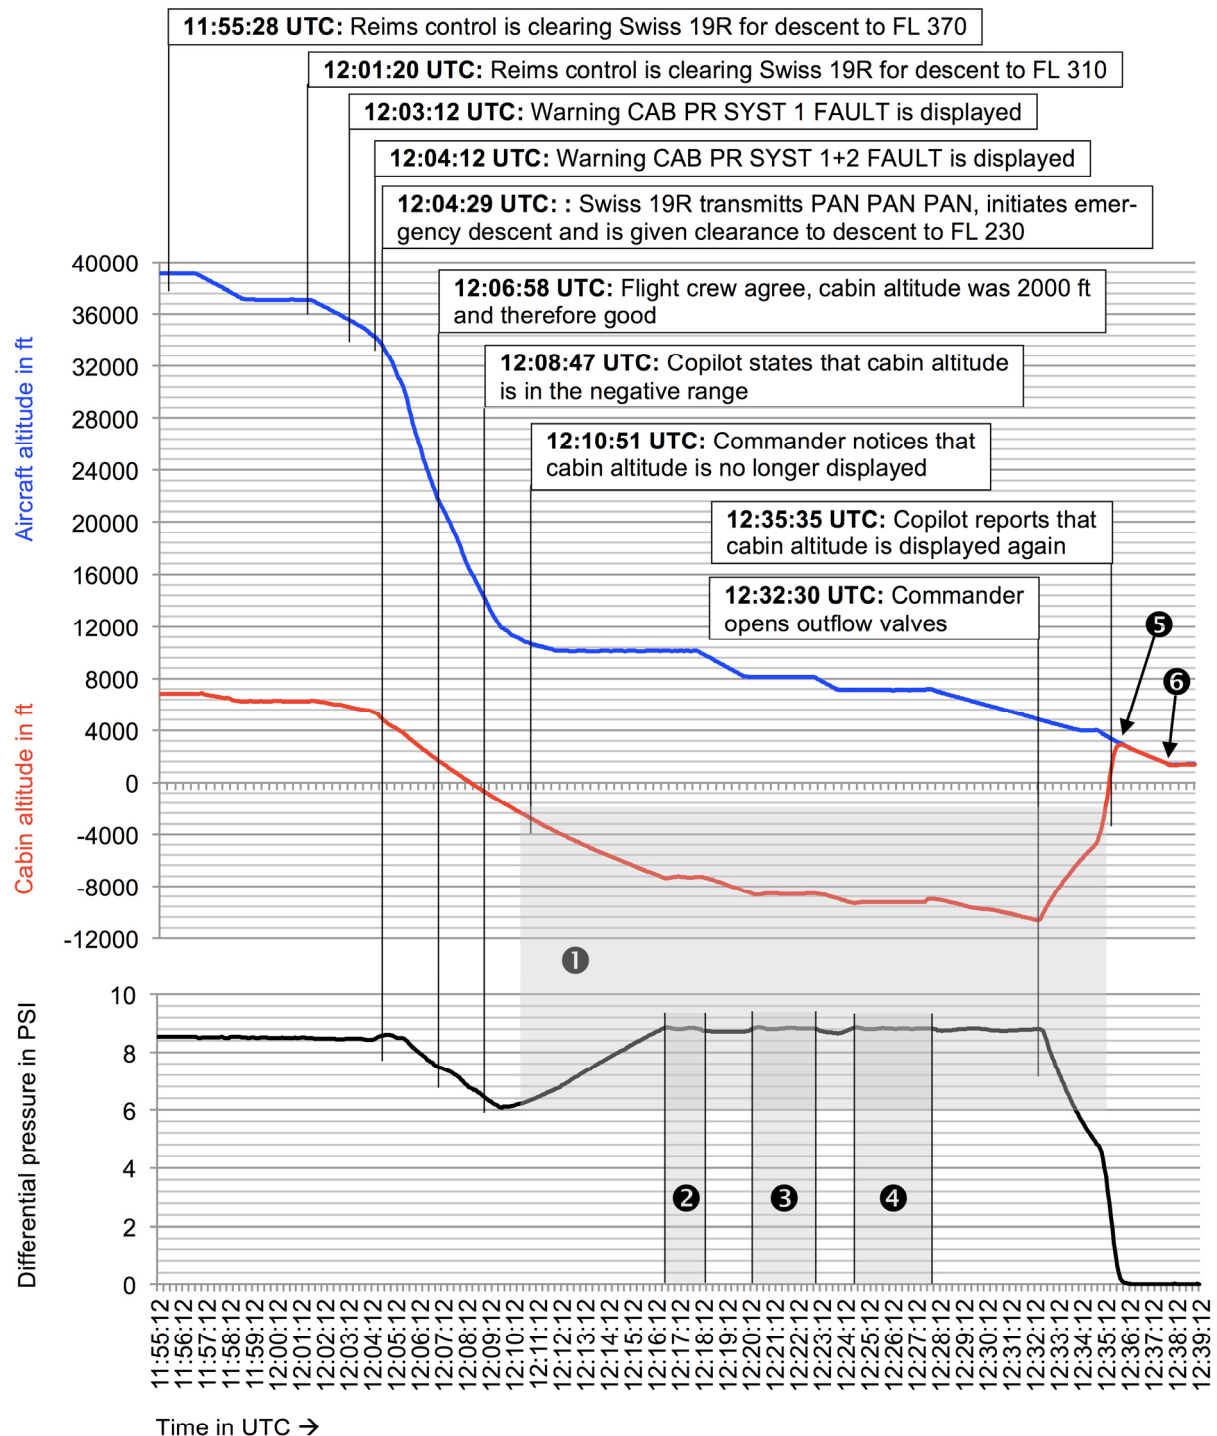
## Annex 1: Sink profile during the serious incident

- ① Cabin altitude and differential pressure displays are replaced by amber crosses
- ② 12:16:43 – 12:18:18 UTC: safety valve 1 is open
- ③ 12:20:38 – 12:23:12 UTC: safety valve 1 is open
- ④ 12:24:47 – 12:28:09 UTC: safety valve 1 is open
- ⑤ Cabin altitude and aircraft altitude are identical and subsequently decrease simultaneously
- ⑥ 12:38:08 UTC: Landing, aircraft touches down on runway 14

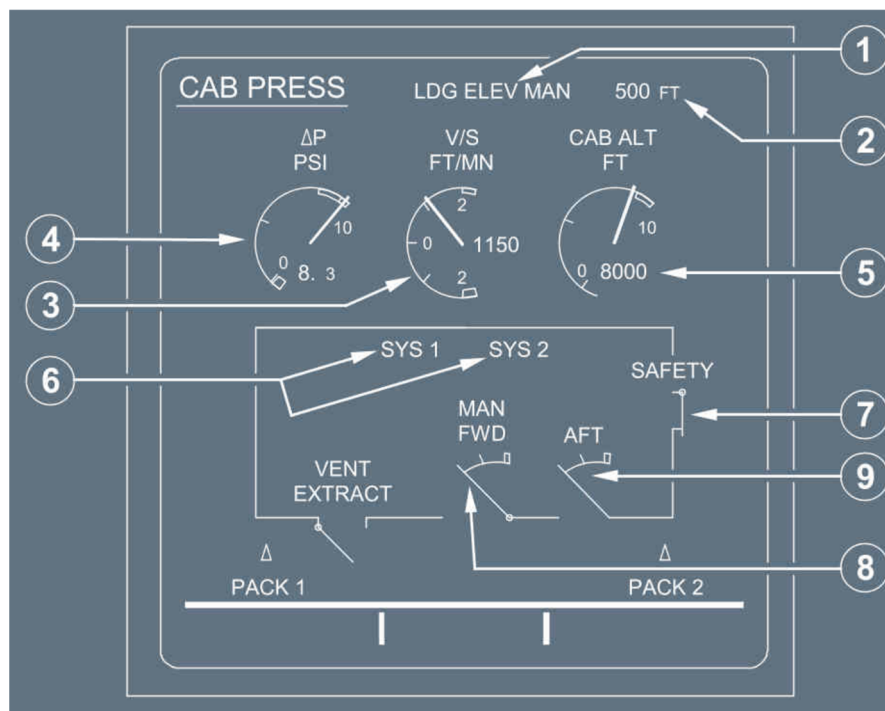
## Annex 8: ECAM system display

By 12:03:12 UTC, the requested position of 3.59° and the actual position of 7.61° of the aft outflow valve created a discrepancy which led to the deactivation of CPC 1 and the activation of CPC 2. Because the corresponding monitoring function in CPC 2 also found a discrepancy (set point = 1.41°, actual value = 7.18°), this also turned itself off at 12:04:12 UTC. Subsequently, the aft outflow valve remained at approximately 7° and the forward outflow valve at approximately 1.5°. This discrepancy is difficult to see on the analogue display on the CAB PRESS page (see annex 8).

- When the cabin altitude reaches a value below -2060 ft, the digital display on the CAB PRESS page is replaced by amber crosses and the analogue display is blanked out. This also applies to the display of the cabin differential pressure.
- The weather had no influence on the serious incident.

The investigation has shown that by design, the cabin altitude digital display on the CAB PRESS page is replaced by amber crosses below -2060 ft and the analogue display is blanked out. This also applies to the display of the cabin differential pressure.
