Final Report No. 2273

concerning the accident involving the
PA-28RT-201T aircraft,
registration HB-PLC,

on 30 May 2015

Grenchen/SO regional airport

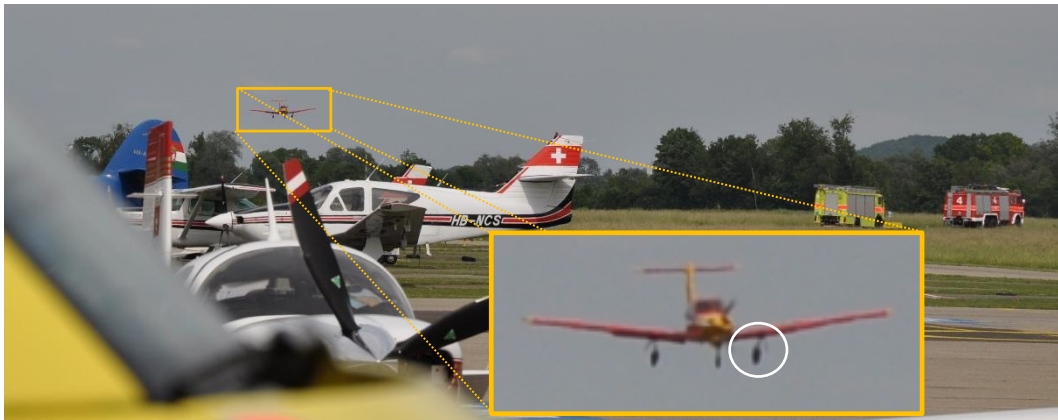
A mechanic from a maintenance company based in Grenchen then called the crew on this frequency. There then followed a brief exchange in dialect, during which in reply to a question the crew confirmed that they had checked every option and were of the opinion that as the gear unsafe light had turned off, the landing gear should be locked. The mechanic indicated to the crew that the left landing gear was not locked. The air traffic controller GRO confirmed on the radio that the left landing gear was extended to approximately 70 degrees according to his estimation (cf. Figure 1).

Figure 1: HB-PLC on final approach to runway 25 (hard surface) at Grenchen regional airport (LSZG) with incompletely extended landing gear (white circle).

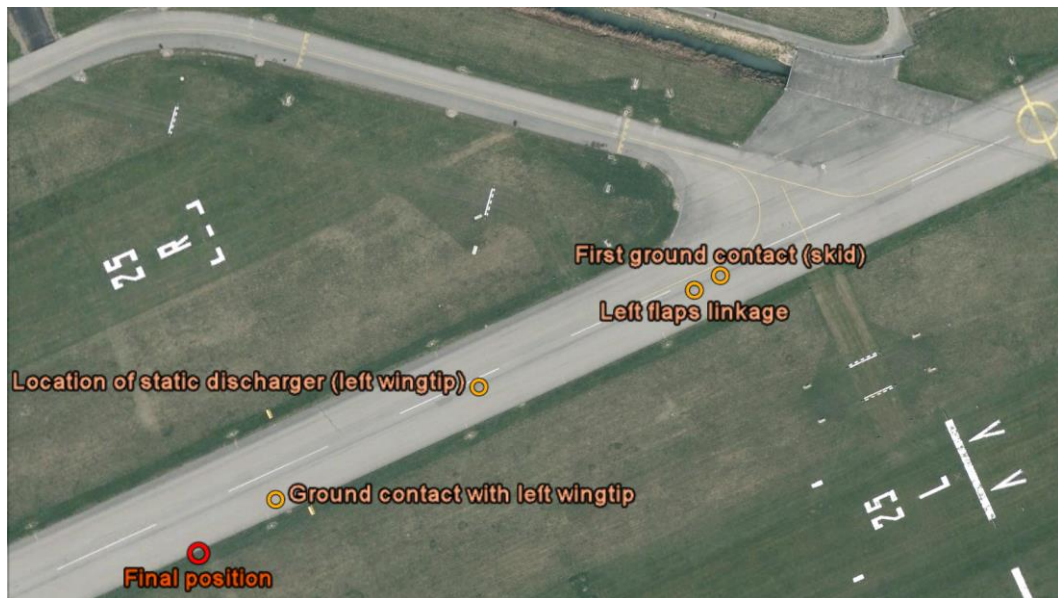
There were clear signs of contact from the tail skid, left landing gear door and the wing tip of HB-PLC along runway 25. A static discharger was also found on the runway.

HB-PLC came to a standstill on the adjacent grass, approximately 260 metres from the touchdown point for single-engine aircraft (cf. yellow circle in upper right corner of Figure 4).

Figure 4: Final position of HB PLC (red) and distinctive features as a result of the landing of HB-PLC on runway 25.

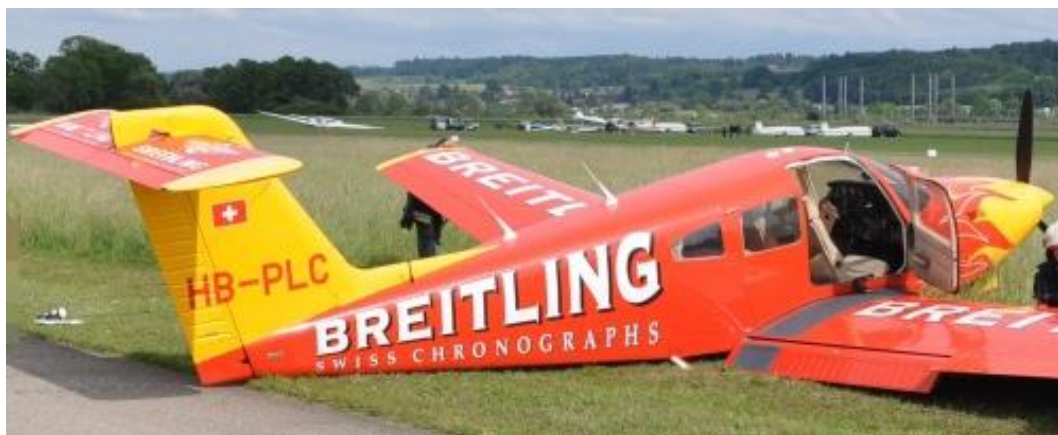
Figure 5: HB-PLC in final position on adjoining grass

- The left wingtip was damaged and the static discharger was missing.
- The pitot tube on the underside of the left wing had been deflected backward.
- The propeller did not exhibit traces of contact.
- There were clear grease marks on the outside of the landing gear link on the left main landing gear.
- The battery and alternator switches and the fuel selector switch were in the “OFF” position.
- The ignition was turned off.
- The landing gear selector lever was in the “DOWN” position.
- Once the battery was switched on, all three landing gear indicators illuminated green.

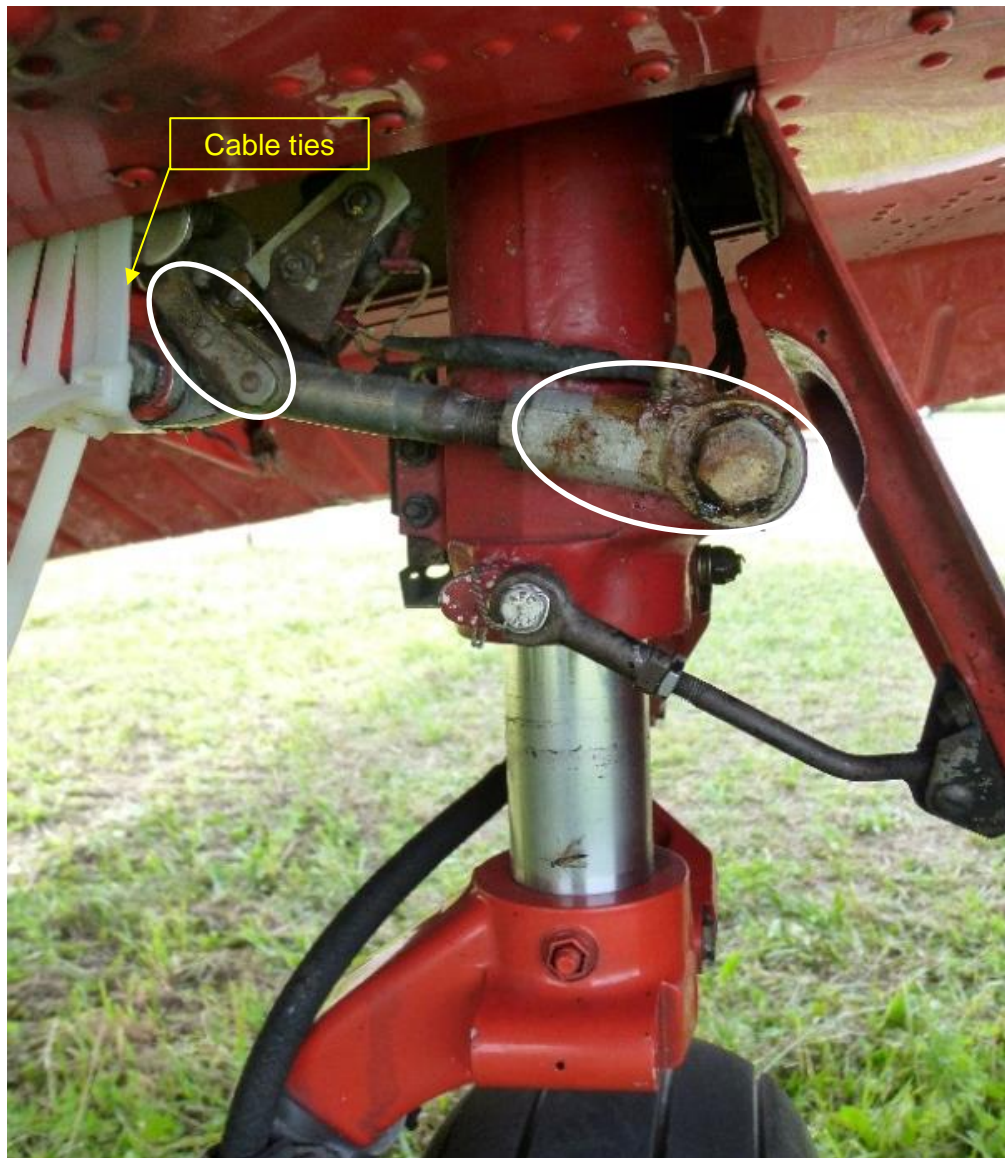
Figure 6: Left main landing gear of HB-PLC with cable ties (yellow arrow) and clear grease marks on the outside of the landing gear link (white frame)

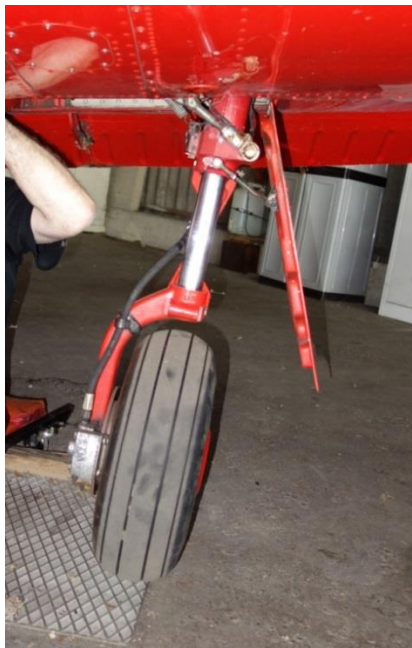
A renewed examination of the landing gear extension revealed that the hydraulic pump turned off too early, i.e. before all three landing gear legs had fully extended and locked.

Figure 7: Left main landing gear of jacked-up HB-PLC in its incompletely extended position

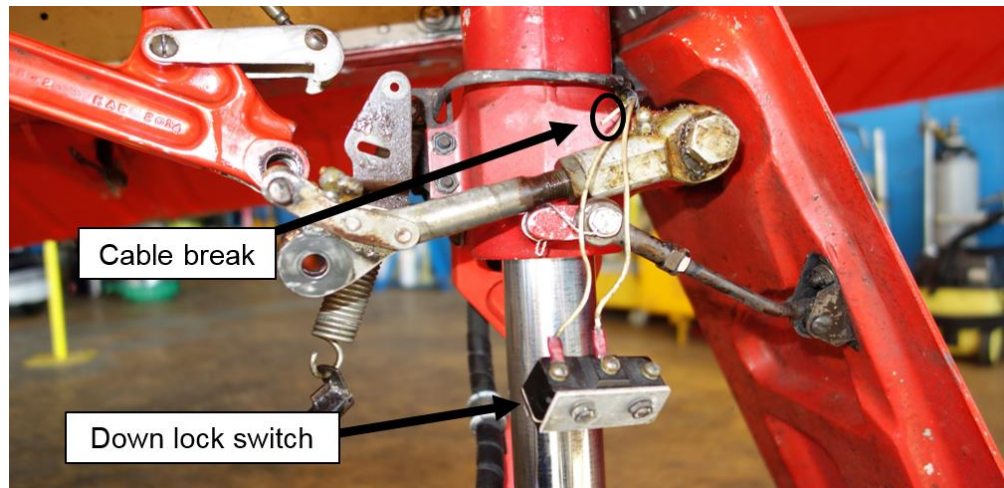
- Upon operation of the down lock switch of both the nose landing gear and the right main landing gear, the pump started immediately.
- Upon operation of the down lock switch of the left main landing gear, the pump did not respond.
- A workshop inspection of the removed down lock switch for the left main landing gear revealed that it was functioning normally.
- Upon further investigation, it was found that there was a fault in an electrical cable leading from the left main landing gear down lock switch to the pump motor which could not be seen from the outside. Electrical power to the hydraulic pump was therefore interrupted even though the left main landing gear was not yet located in the final position and was therefore not locked (cf. Annex 3).

Figure 8: Position of the broken cable on the left main landing gear above the down lock switches after dismantling

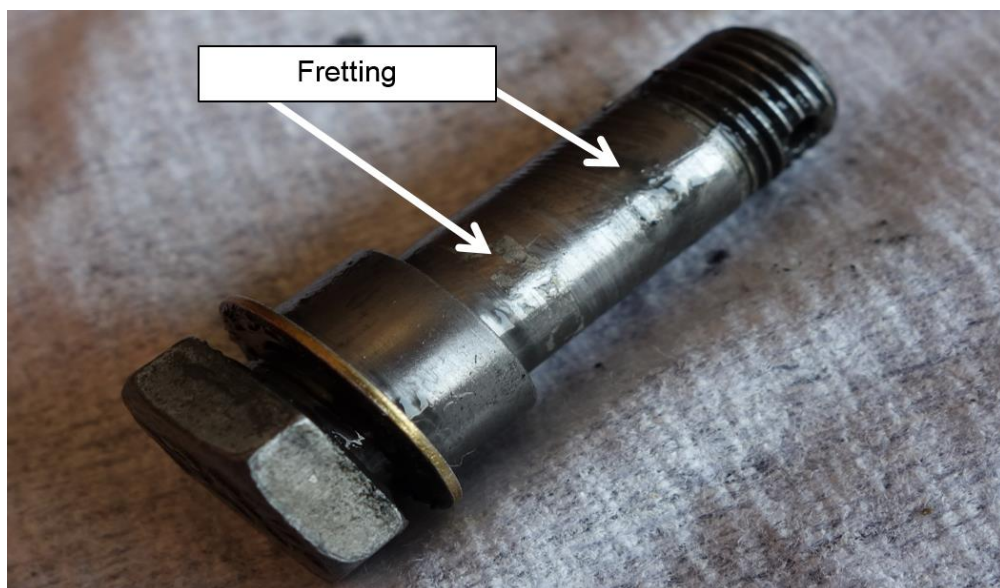
- The left landing gear joints were then treated with penetrating oil, after which the free fall procedures again worked normally.
- After the joints were dismantled, it was determined that both the bolts and bores exhibited evidence of fretting (cf. Annex 2), which is due to dry operation (cf. Figure 9).

Figure 9: Fretting on bolt

The responsible maintenance company did not wish to comment on the fretting on the bolt and bore (cf. Figure 9).

- A cable break on the left main landing gear: such events occur suddenly and cannot be anticipated by an inspection. To be able to land safely in the case of such a fault, the free fall procedure must work. This must be performed and checked during every 100-hour inspection of the aircraft. According to the statement of the maintenance company, this inspection was last performed on 24 December 2014 without any complaints.
- Left main landing gear seizing: fretting on bolt (cf. Figure 9) and bore were probably the result of dry operation. This is due to lack of or inadequate lubrication and leads to surface defects, as were found on the bolt and bore.
