Final Report No. 2275

Concerning the accident involving the Bell
UH-1H helicopter, registration HB-RXC

on 20 December 2012

Alberli Au, municipality Rüthi/SG

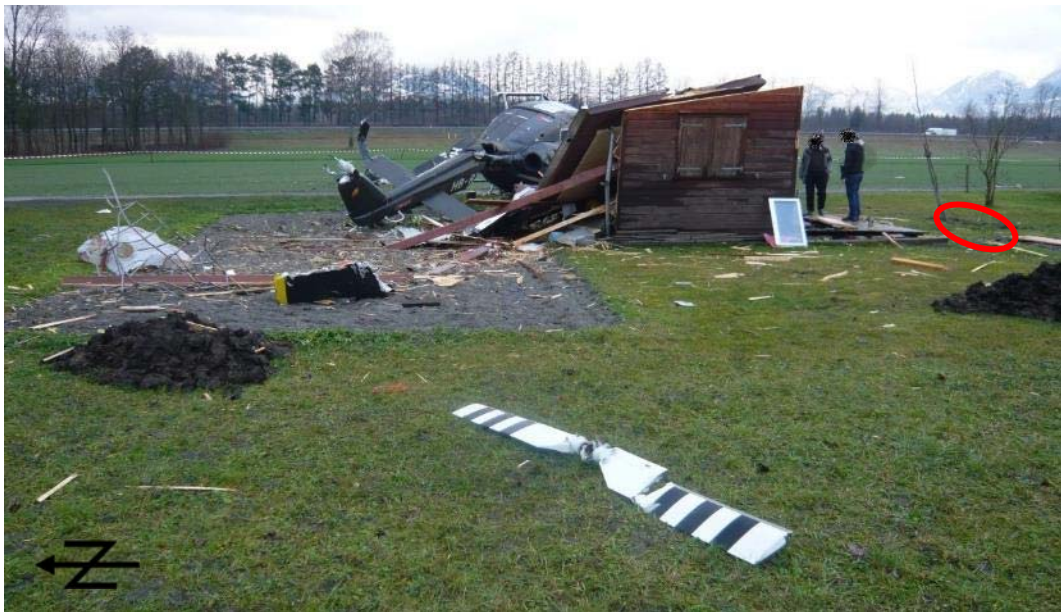
Illustration 10: Final position of the wreckage and tail rotor with crosshead lying underneath. The tail rotor was located on the ground – viewed in the approach direction – approximately 10 metres in front of the helicopter's impact point (circled in red).

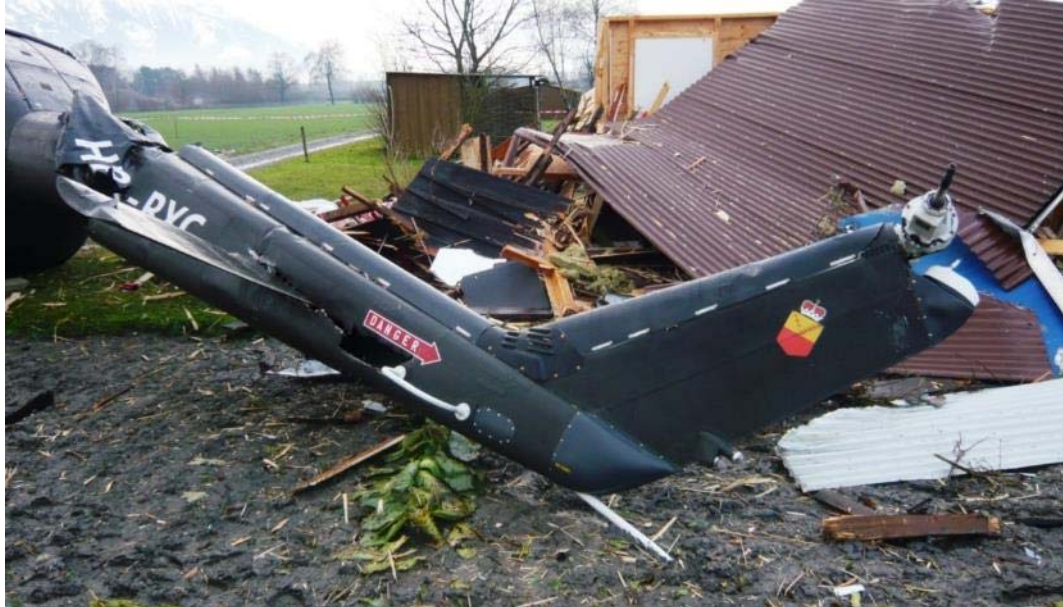
During the initial inspection of the accident site, it was established that the tail rotor transmission had been burst open and the transmission oil had leaked. With regards to the transmission's tail rotor driveshaft, which looked more or less intact, the tail rotor and its associated components were missing. The tail rotor blade pitch mechanism was also completely missing.

No contamination caused by the soil could be found on the tail rotor driveshaft or burst-open transmission.

Illustration 11: Burst-open tail rotor transmission with tail rotor driveshaft.

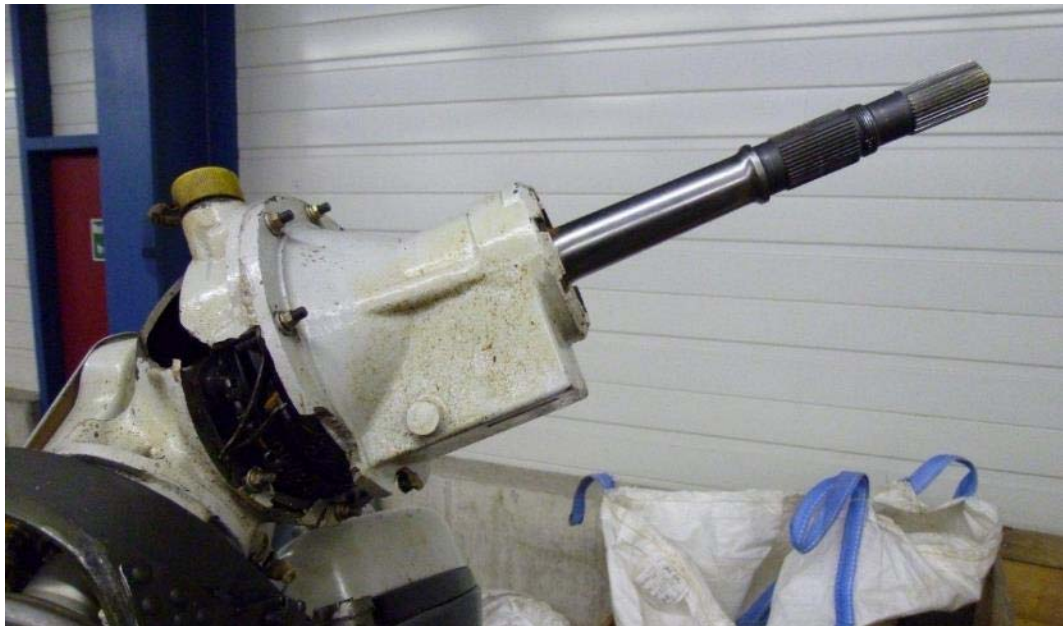
Illustration 12: Burst-open housing of the tail rotor transmission. The fact that the tail rotor driveshaft appears to be intact is remarkable.

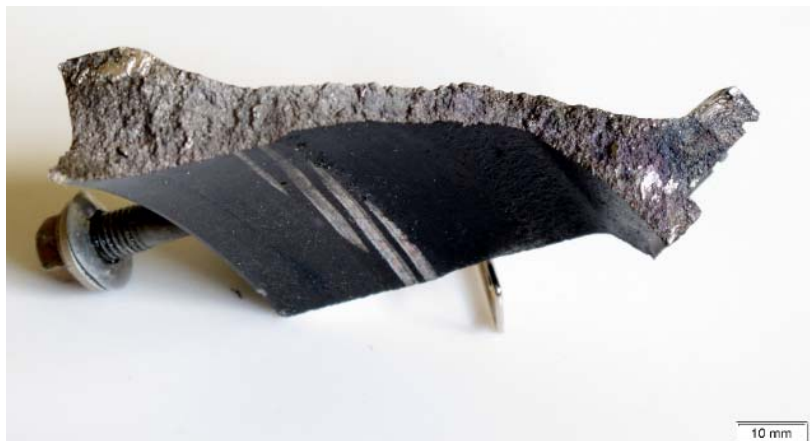
In the area of the burst segment, helical marks were found on the inside of the pinion housing unit. These marks on the surface were metallicly bright.

Illustration 14: Burst segment with helical marks

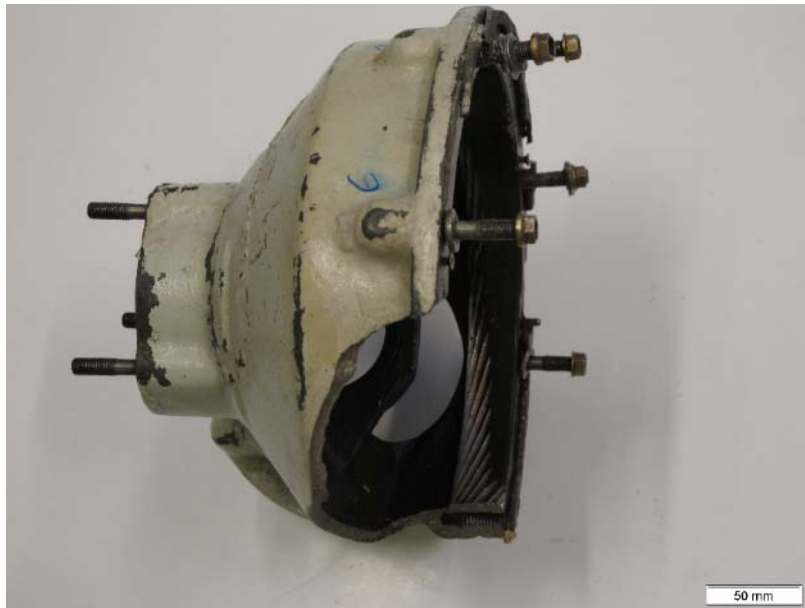
Illustration 15: Pinion housing unit with helical marks and burst segment

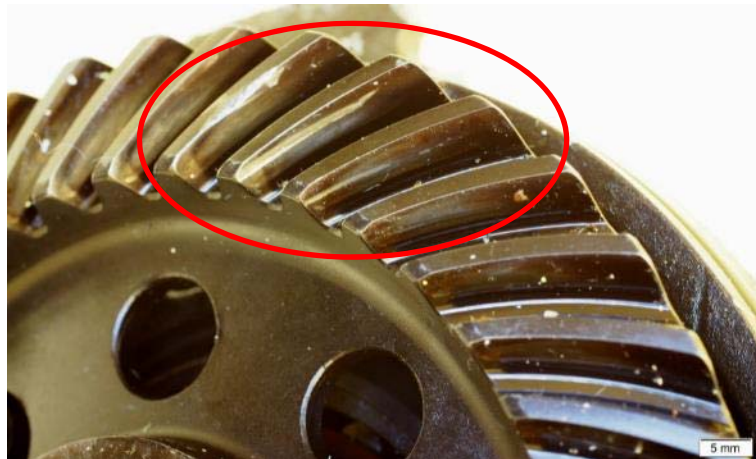
The bevel pinion's tooth flanks as well as those of the bevel gear showed no wear. There were no indications that material had broken off from the tooth flanks. Both bevel gears were in good condition and showed little signs of wear. In terms of the bevel gear, the flanks of three successive teeth were damaged and on the following fourth tooth, the tooth crest edge was damaged. In terms of the bevel pinion, the crest edges of two successive teeth were damaged. All of this was abrasion damage. The type of damage indicates the following: when the transmission housing broke apart, the tooth meshing was no longer aligned, which made the tooth crest edges touch each other causing the damage.

Illustration 16: Damaged tooth flanks of the bevel gear (circled red)

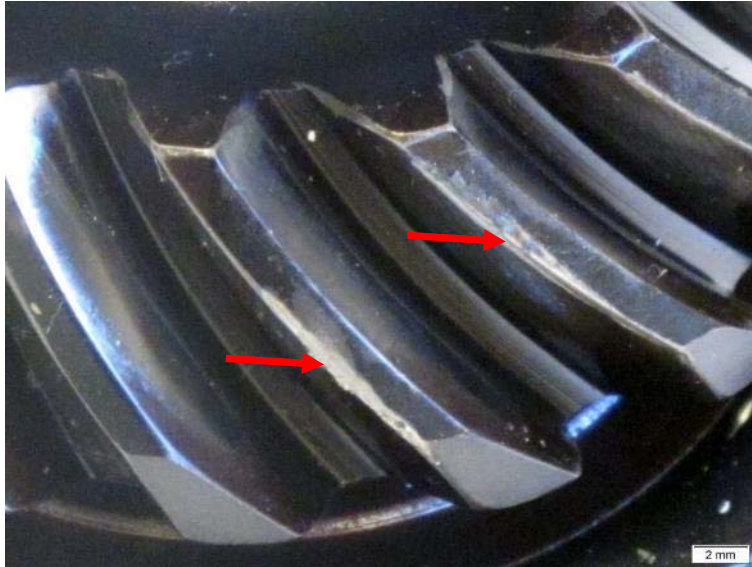
Illustration 17: Damaged tooth crest edges of the bevel pinion (red arrows)

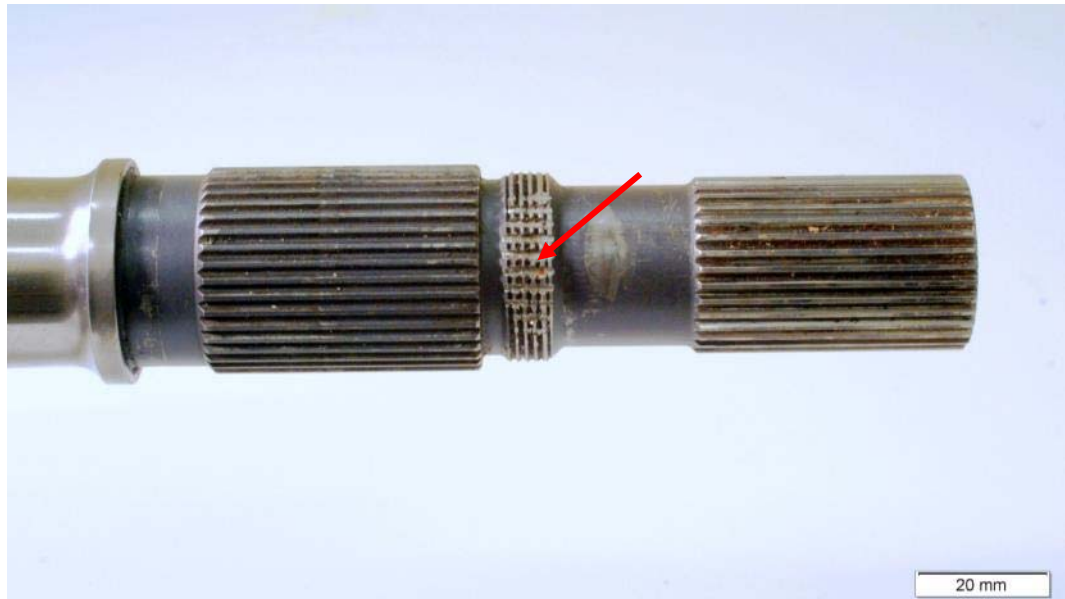
The thread on the outer end of the tail rotor driveshaft was severely damaged. The retaining nut for mounting the tail rotor is screwed onto this thread. The result shows shearing damage, which was caused by a free-moving tail rotor hub that was no longer held in place by the nut. It can be inferred from this kind of damage that the hub jammed on the driveshaft.

Illustration 18: Tail rotor driveshaft with visible notches on the thread for fitting the retaining nut (red arrow)

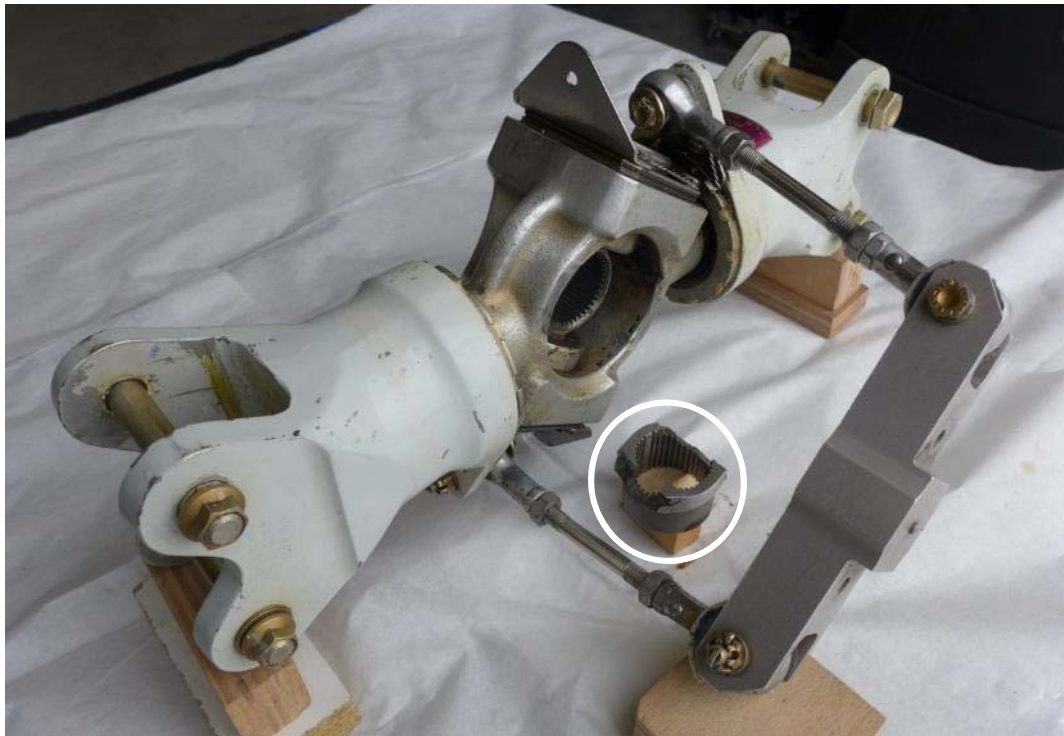
The crosshead is connected to the tail rotor (see annexe 2, pos. 17) by two pitch links. Both of these pitch links were bent.

Illustration 19: Tail rotor hub with pitch links, crosshead and static stop (circled white) with broken-off flanges

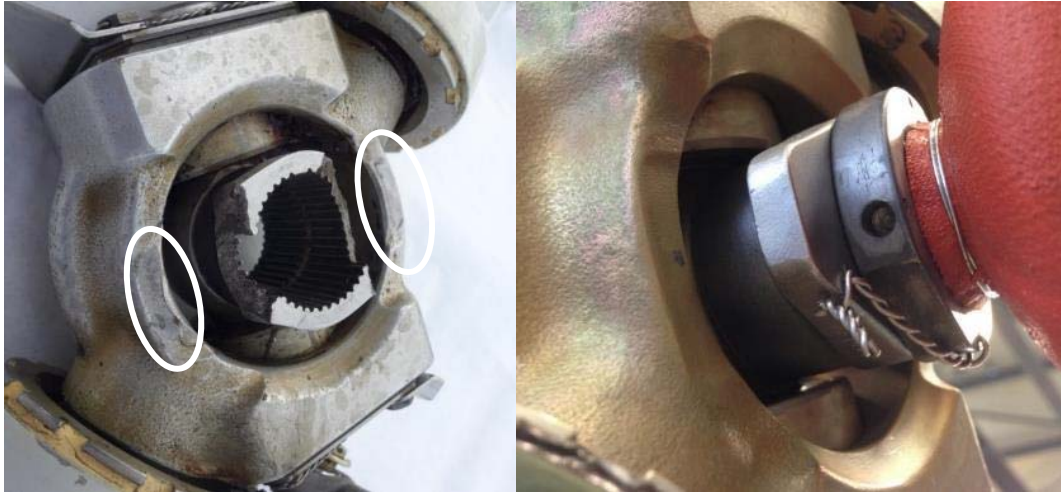
Plastic indentations were found on the front surface of the tail rotor hub. In terms of their shape, this plastic deformation corresponds to the two broken-off flanges of the static stop (see annexe 2, pos.5).

Illustration 20: Plastic indentations on the front surface of the tail rotor hub (circled white) and static stop with the broken-off flanges. The picture on the right shows an intact structurally identical system for comparison.

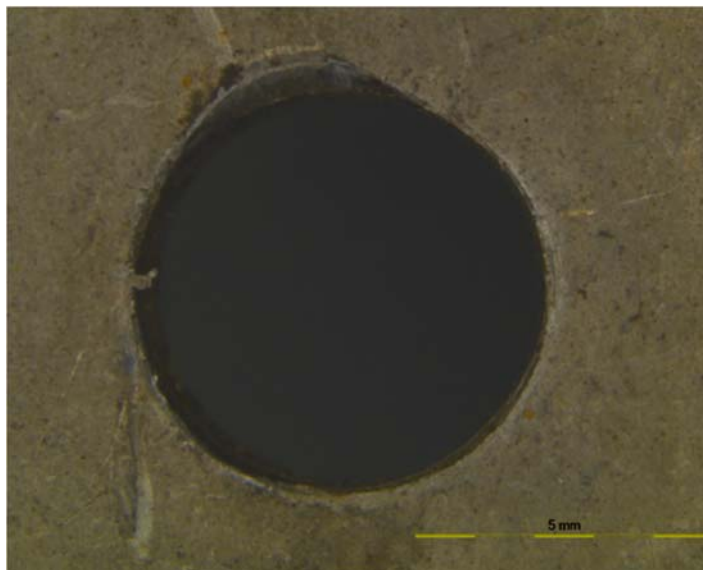
Plastic deformation could be found on one bore hole of the slider, on the side facing the crosshead. It was, in all likelihood, caused by a broken bolt.

Illustration 21: Plastically deformed bore hole on the slider

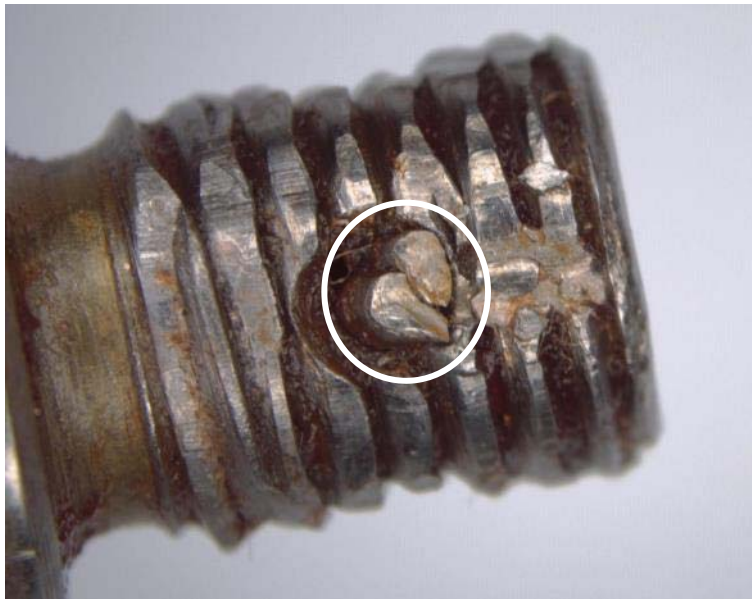
During the examination of the pitch change rod, it was established that the nut, with which the bearing set is attached, as well as the split pin, were sheared off by external blunt force.

Illustration 22: End of the pitch change rod with sheared-off thread and split pin (circled white).
