# Final Report No. 2285 by the Swiss Transportation Safety Investigation Board STSB

concerning the serious incident involving the A319-132 Airbus aircraft, registration YU-APA,

on 17 October 2014

5.5 km north-west of Zurich Airport (LSZH)

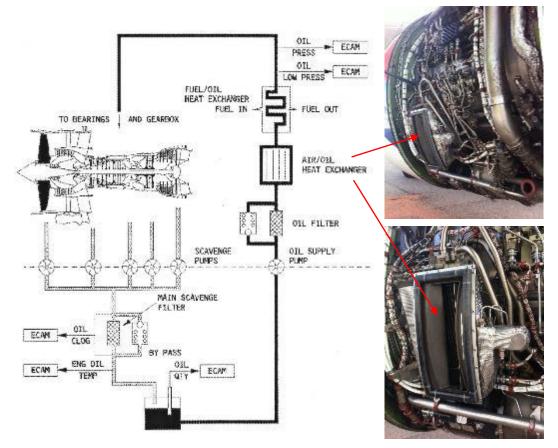
**Figure 2**: The engine's oil circuit (copied from the FCOM), right: engine of the YU-APA photographed after the serious incident

The inspection of the engine, carried out after landing, showed a leak in the ACOC. The defective ACOC with part number (p/n) 50026001-1 and serial number (s/n) 0008 was removed and replaced with the ACOC with s/n 2335.

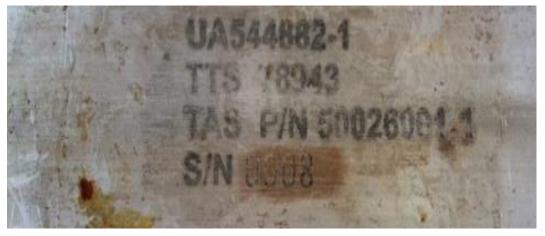
It should be noted that adhesive residue is visible on the defective ACOC at the position where the data plate should be installed and the corresponding numbers had been printed directly on the outer surface of the ACOC (see figure 3).

Figure 3: Photo of the defective ACOC (picture taken on 10 February 2014)

The manufacturer of the ACOC, the *Sumitomo Precision Products Co. Lt.* (OEM) company, confirmed in writing that the defective ACOC was not produced by them, and was therefore not an OEM<sup>14</sup> component. Inquiries revealed that in 2006 the ACOC was sent by SAS as serial number 3427 under repair order 2PIE5605306 to the company Triumph Accessory Services (TAS). The ACOC was repaired in accordance with the component maintenance manual and a new Triumph-designed core assembly, serial number of 0008, was installed. TAS stated that the core assembly is not an OEM part; however, it is manufactured by an approved vendor under the FAA's Designated Engineering Representative authority. Therefore the installed ACOC was a PMA<sup>15</sup> part and not a suspected unapproved part (SUP).

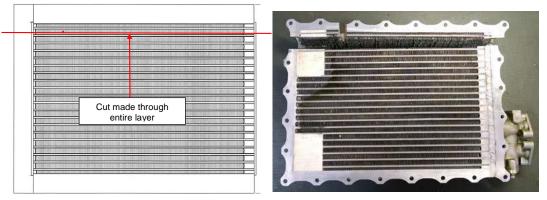
The defective ACOC was thoroughly investigated by a company that specialises in critical thermal fluid management with heat exchangers. The leak could be found and it was possible to limit the search for the cause by cutting across the entire length of the ACOC.

Figure 7: Copied from the respective engineering report (project 5366)

Further investigation of the cause of the leak led to the conclusion that material fatigue of the cooling tubes, caused by movements as a result of broken soldering joints, was the most likely cause. Among other things, the respective report records the following:

"This braze joint, between nosepiece and tubesheet held, had allowed a crack to form and grow through cycling, in the tubesheet itself. The failure is therefore most likely caused by fatigue of the tubesheet, which in turn allowed a crack to form, and ultimately produced a leak in the oil circuit."

According to in-depth investigations, material fatigue of the cooling tubes was most likely the cause of the leak in the air-cooled oil cooler (ACOC) (see chapter 1.16); this defect was the trigger for the serious incident investigated here.
