# **Final Report No. 2290**

## **by the Swiss Transportation Safety Investigation Board (STSB)**

Concerning the accident involving the  
aircraft Maule MX-7-235, HB-KDF,

Münster airfield (LSPU) / VS

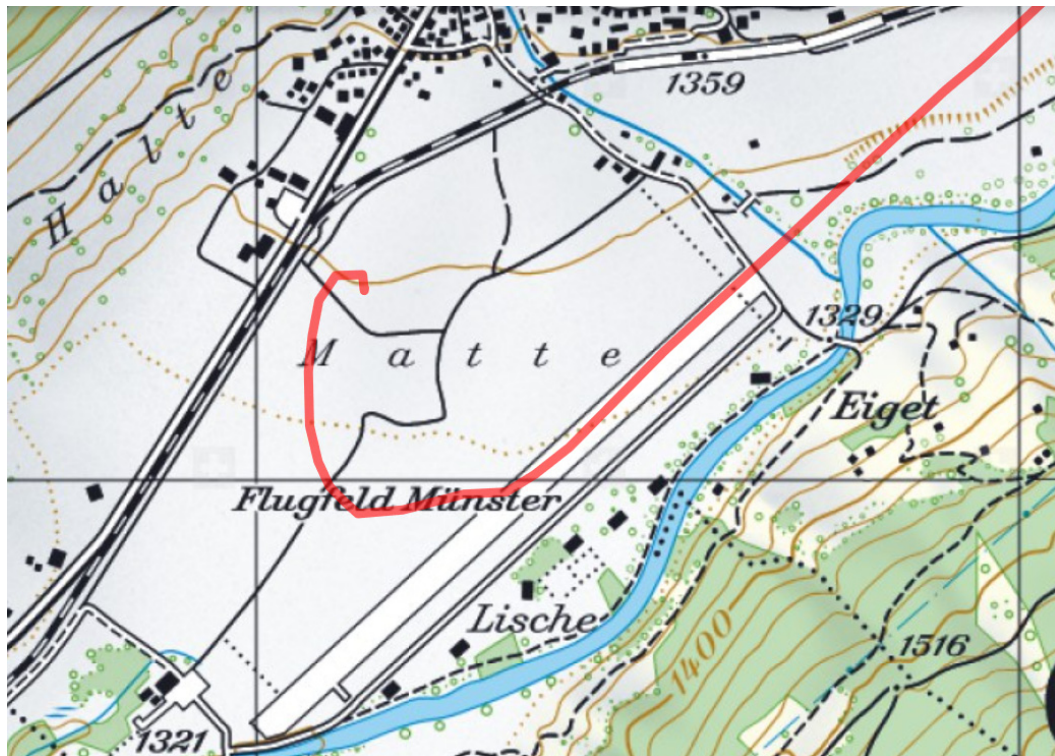
The pilot then applied full throttle and initiated a go-around. According to the pilot, the aircraft was turned further to the right during this phase (see illustration 1). He tried to counteract the turn, but did not succeed. The pilot retracted the flaps by one notch. He did not manage to retract them fully. When the aircraft heading was almost perpendicular to the course of the valley, the tailwind component increased. The aircraft continued to turn further up the valley. The maximum altitude estimated by the pilot was approximately 80 metres above ground. The pilot realised that a collision with the upward-sloping terrain could no longer be avoided and tried to soften the impact as far as possible. In the final moment before impact, he turned off the battery master switch.

**Illustration 1:** The last phase of HB-KDF's flight path (red), as recorded by the Sky-Map software on the pilot's tablet (base map reproduced with permission from the Swiss Federal Office of Topography Swisstopo (JA150149)).

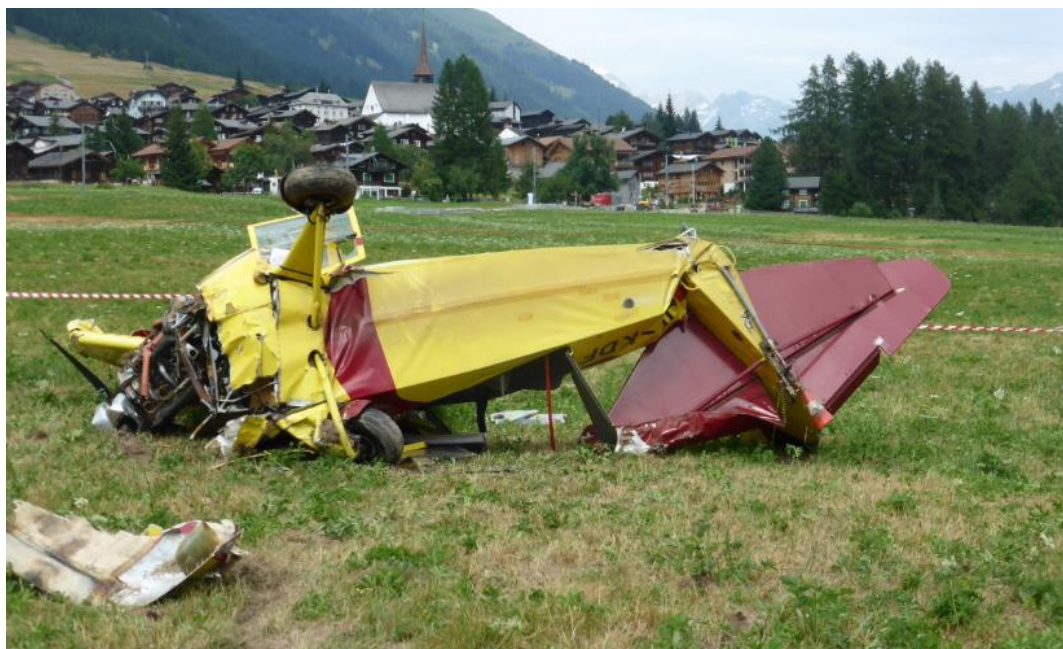
**Illustration 2:** Final position of wreckage

- Both wings were partially separated from the fuselage and laid on top of each other next to the upper side of the fuselage. The flap of the right wing was found in a position of approximately 24°. The flap of the left wing was found at 0°. Marks on the fuselage show that this position had changed during impact.

- The flap control lever was found in the -7° position. This may have been moved into this position when the occupants were rescued.
- The elevator trim indicator was in the 'nose-down' position.

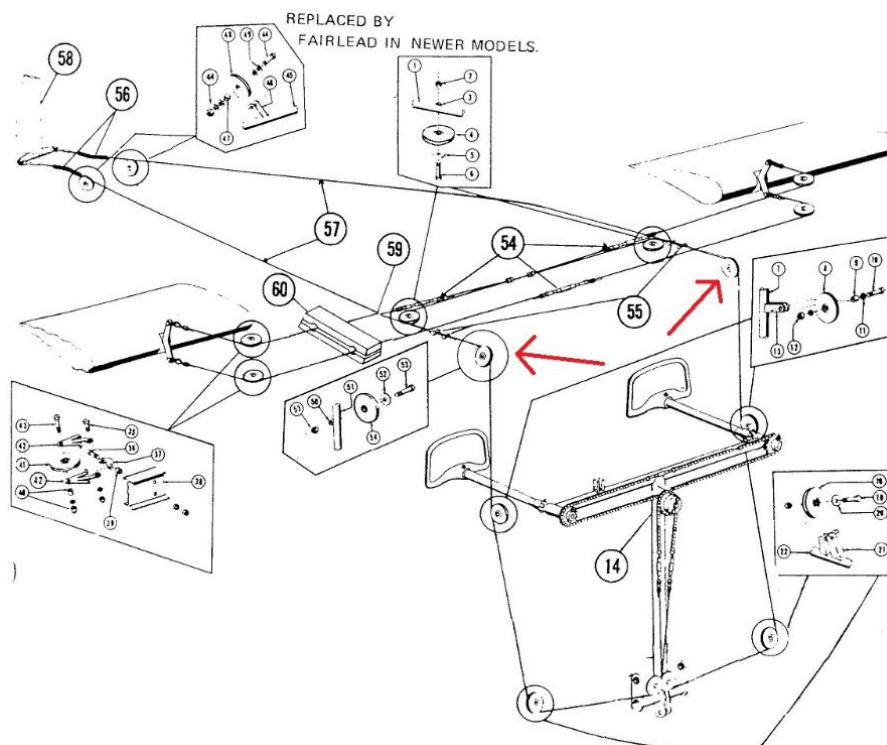
**Illustration 3:** Diagram showing the cable routing. The red arrows indicate the two pulleys where the control cables were incorrectly routed.

After the accident, it was established that the control cables were not routed to run in the groove of the pulley, but between the pulleys (see Illustration 3, illustration 4 and illustration 5) and the fuselage's tubular structure. Abrasion marks on the spacer discs of both pulleys showed that the aileron control cable had been running outside of the pulley's groove for a prolonged period of operation.

According to statements made by the maintenance company, they replaced the control cables during the 100-hour inspection on 18<sup>th</sup> December 2014. The company agrees that the defect found is a result of this maintenance work.

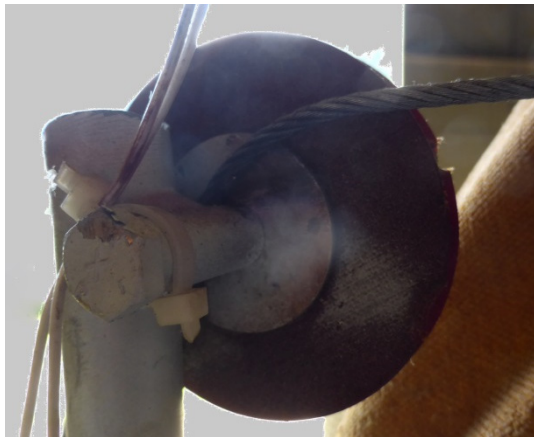
**Illustration 4:** Control cable outside the front top-left pulley's groove

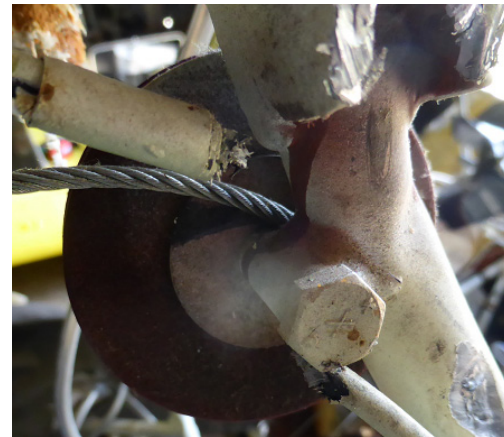
**Illustration 5:** Control cable outside the front top-right pulley's groove

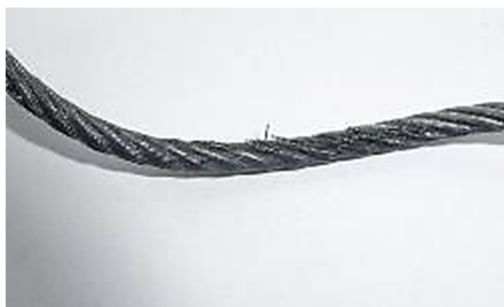
During the last approximately 100 flying hours, the yoke movements moved the control cables over the two tube sleeves, on which the pulleys were mounted. The diameter of these sleeves was approximately 20 mm. A 2-mm-deep groove could be found on both tube sleeves. Both control cables were severely deformed, worn and exhibited wire breaks at this point (see illustration 6 and illustration 7).

**Illustration 6:** Damaged control cable where in contact with the front top-left pulley

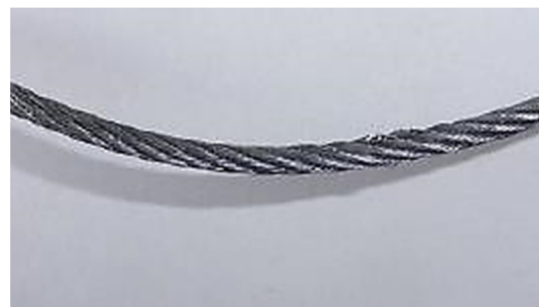
**Illustration 7:** Damaged control cable where in contact with the front top-right pulley
