Final Report No. 2297

concerning the serious incident involving
the Saab 2000 commercial aircraft,
registration HB-IZW,

on 28 November 2013

at FL 110 over Muzzano/TI, east of
Lugano regional aerodrome

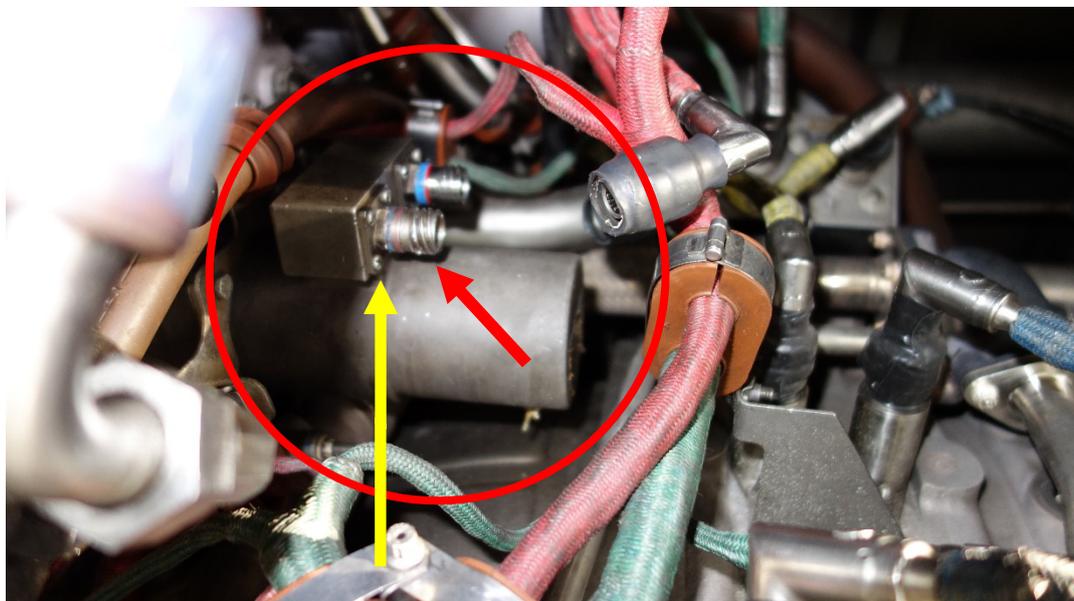
Visual inspection of the BFT unveiled that the left connector was loose and worn out (cf. Figure 6). Damage was found to the four not sufficiently tightened mounting bolts and on the housing. This indicates that unprofessional work had been carried out in this area. A functional test of the BFT was then performed with the connectors removed. This test unveiled that the basic functions of the BFT complied with the specifications.

Figure 6: Beta feedback transducer (BFT) mounted on the right engine on HB-IZW (red circle); the red arrow indicates the worn out thread of the left connector. The yellow arrow indicates the not sufficiently tightened mounting bolts.

As the examination of the BFT unveiled, a short circuit in the left connector between connector pins 3 and 6 existed. Inside the left connector, the plastic guide of the connector pins was spoiled. This defect was presumably caused by vibration. This only became possible by the loose mounting bolts of the connector.

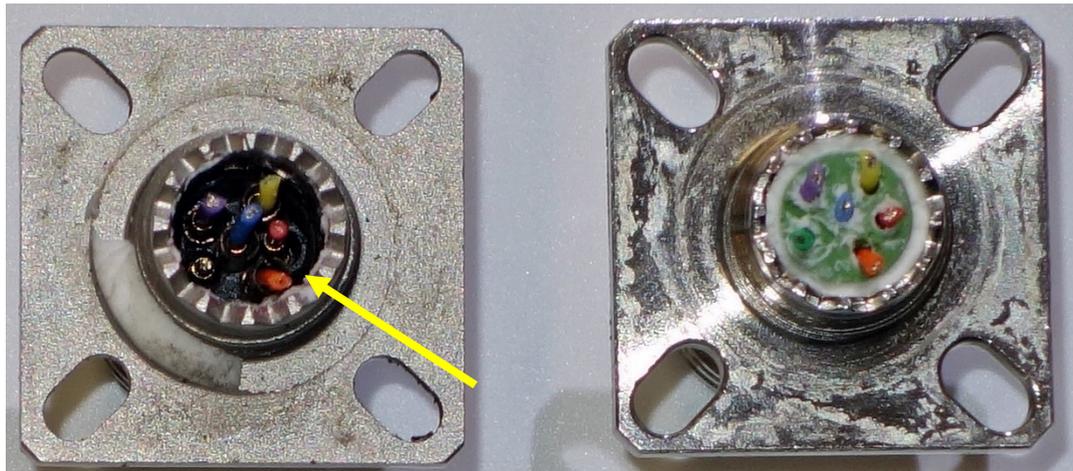
Inside the left connector the plastic guide of the connector pins was spoiled (cf. Figure 7).

Figure 7: Rear view of the two connectors in disassembled state. The yellow arrow indicates the worn out connection with the area of the spoiled plastic guide. The intact right connector is shown next to it for comparison.

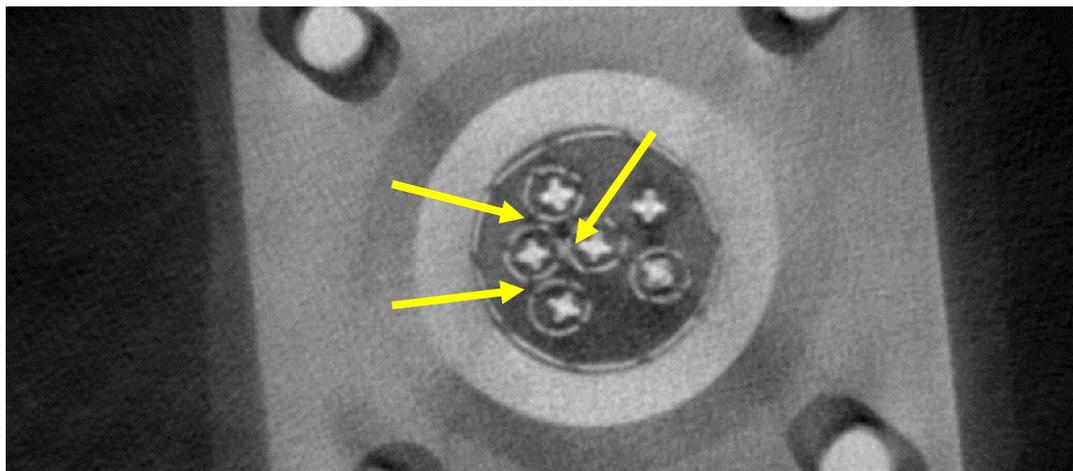
Before disassembly the BFT was examined using computer tomography. It was possible to visualize the areas in the left connector where short-circuits between the connector pins could have occurred.

Figure 8: Visualization of the left connector. The yellow arrows indicate the areas in which short-circuits occurred.

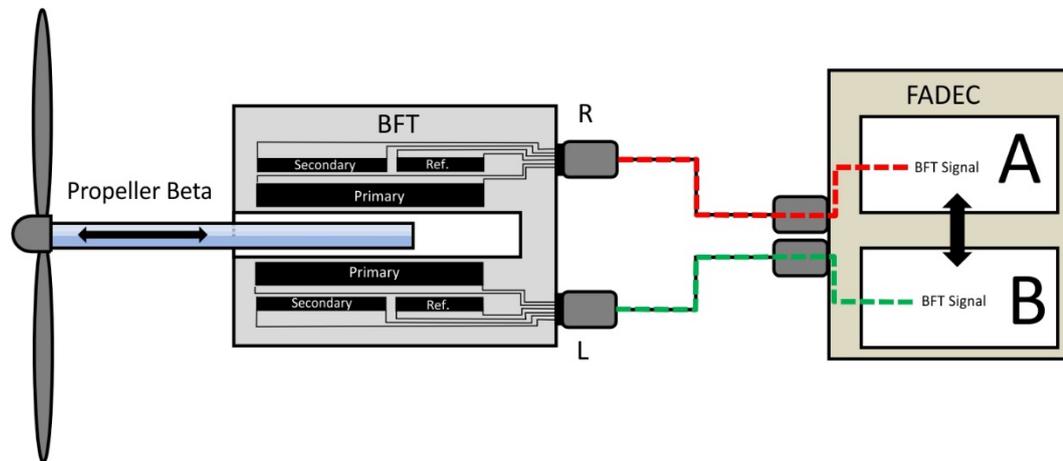
- The channel of the right connector (R) functioned electrically without any faults.
- The channel of the left connector (L) failed the electrical tests, due to an electrical resistance between connector pins 3 and 6 (primary winding) of 0.4 Ω at room temperature, corresponding to a short circuit. The resistance at room temperature should be 60 Ω.
- Testing on the insulation of the left connector revealed that the resistance between the primary and secondary winding was only 20 kΩ. In addition, the resistance in the left channel, between the primary and the reference winding was also only 20 kΩ. The same measurement on the right connector yielded a value of 100 GΩ, whilst 22 GΩ was measured on the right channel.
