# **Final Report No. 2303**

## **by the Swiss Transportation Safety Investigation Board STSB**

concerning the accident involving the  
ATR 72-202 commercial aircraft,  
registration D-ANFE,

on 4 December 2014

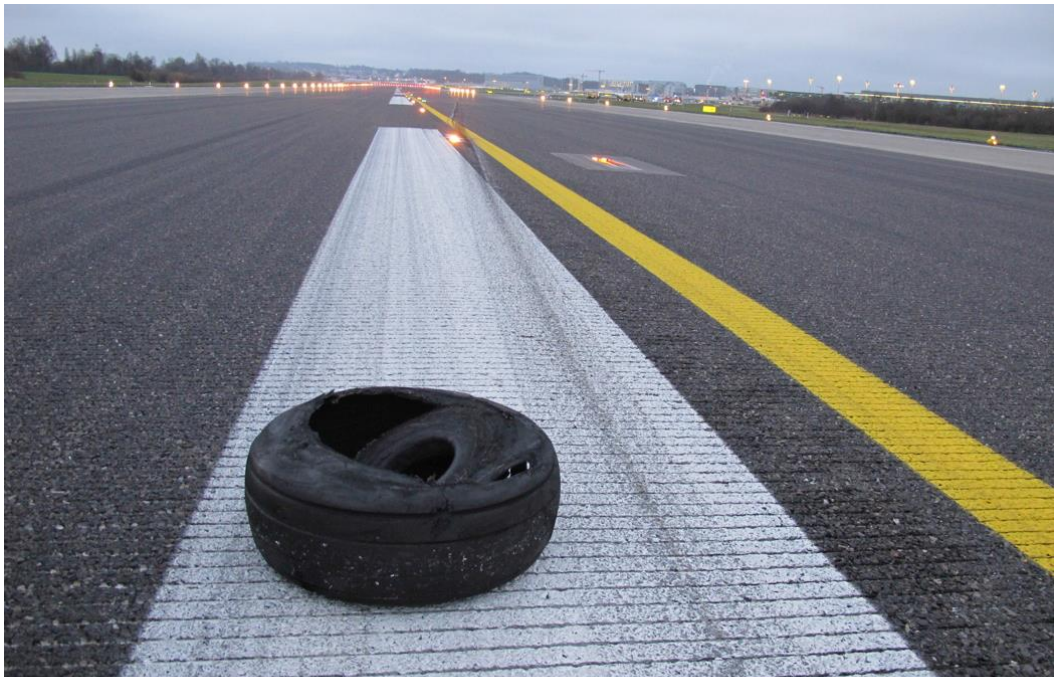
**Figure 5:** During the inspection of runway 14 after the landing of D-ANFE the tyre of the right nose wheel was found approximately 2080 m from the runway threshold. Beside it, white and black traces are visible.

According to the statement of the Airport Manager, who performed this inspection, he was unable to find any other parts of the nose landing gear at the location where the tyre was found. After he had recovered the tyre, he continued the inspection until the end of runway 14, turned and - again slightly offset to the right of the centreline - drove back along the centre line of runway 14 towards the starting position. As he did so, he noticed black rubber traces, which later turned to white and black traces (cf. Figure 5). According to his statements, he did not assess the traces as restrictive for flight operations.

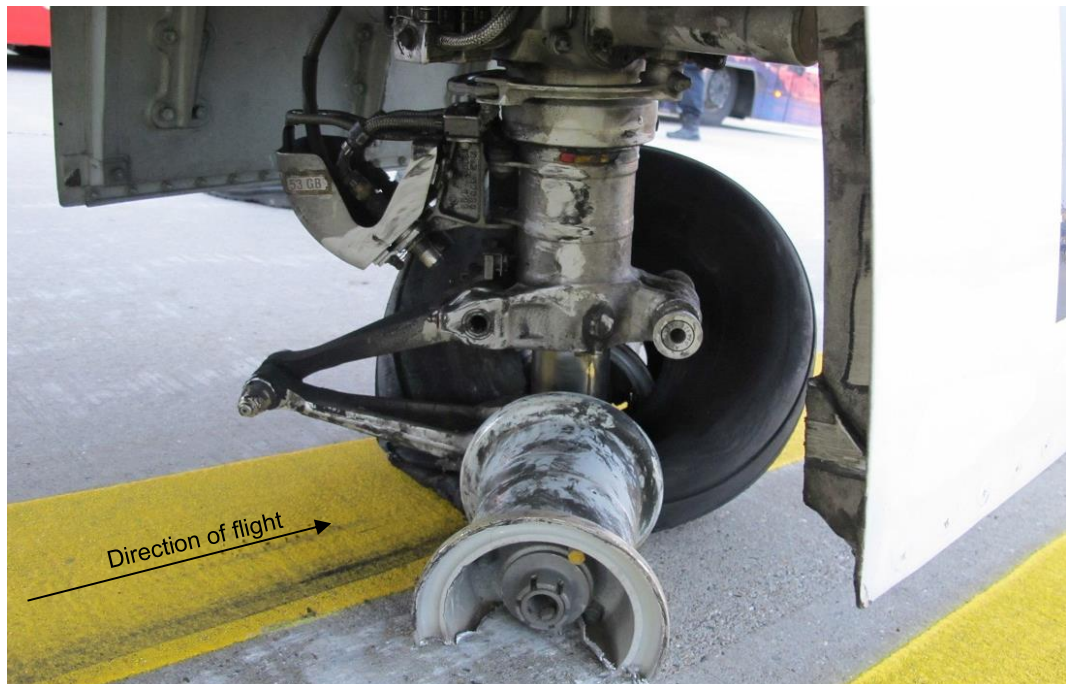
An initial inspection of the aircraft revealed, in addition to the damage to the nose landing gear, other damage to the right main landing gear door and a crack on a taxi light.

**Figure 7:** Damage to the nose gear of D-ANFE after landing; the left tyre got blocked between wheel rim, landing gear strut and axle.

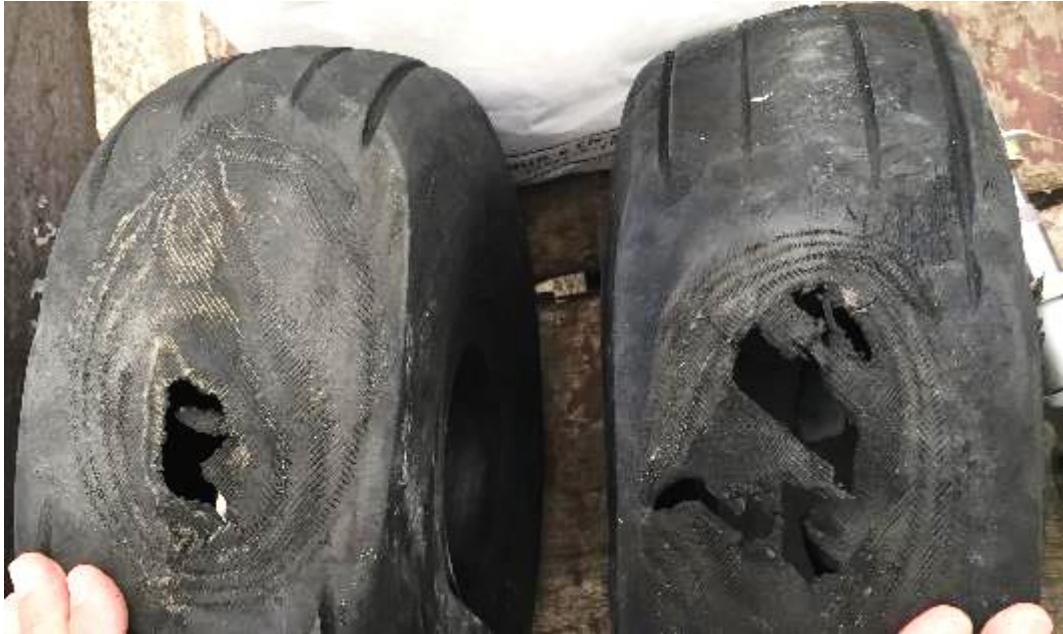
The nose wheel tyres showed only one distinct abrasion mark on each of the running surfaces (cf. Figure 8).

**Figure 8:** Abrasion mark on each of both nose wheel tyres of D-ANFE

Within the framework of the investigation it was not possible to reconstruct the sequence of events of the accident in detail. The apparent damage to the tyres of both nose wheels however clearly indicates local overstressing (cf. Figure 8), leading to the conclusion that during the landing the nose landing gear was not centered and so the nose wheels were unable to rotate freely.

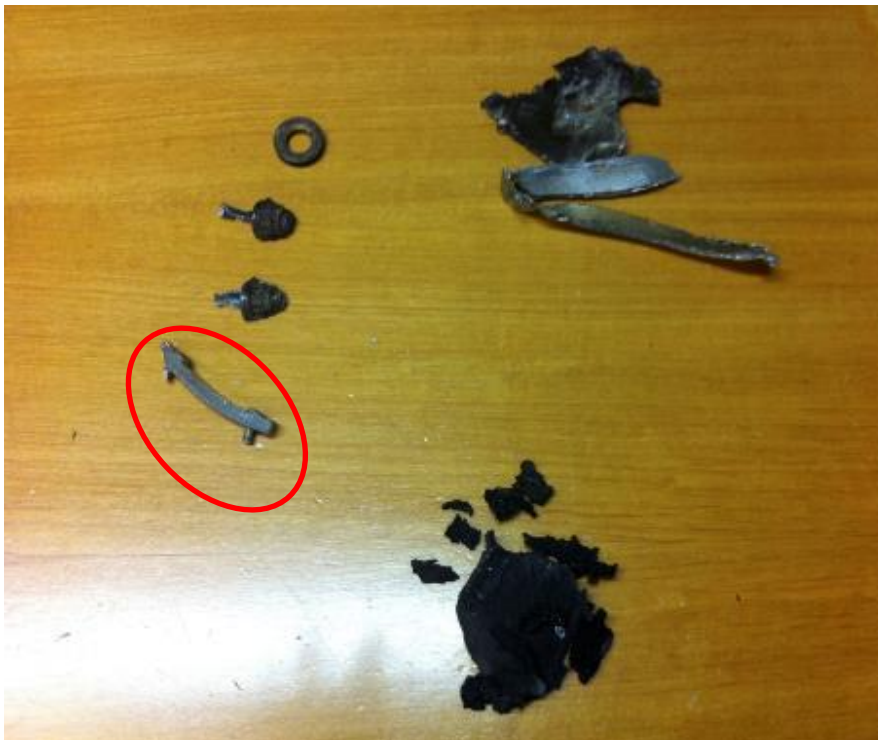
During the second runway inspection (cf. Section 1.10.4), parts of the tyres, metal pieces and a balance weight (cf. red ellipse in Figure 9) from the nose landing gear of D-ANFE were found.

**Figure 9:** Small parts of the nose gear found on runway 14

During the runway inspection on the afternoon of the day on which the accident occurred (cf. Section 1.10.4) more small parts belonging to the nose landing gear of D-ANFE were found (cf. Figure 9). Even though the occurrence and history of the present accident were not affected by this, such small parts represent a safety risk for aircraft landing afterwards (factor to risk).

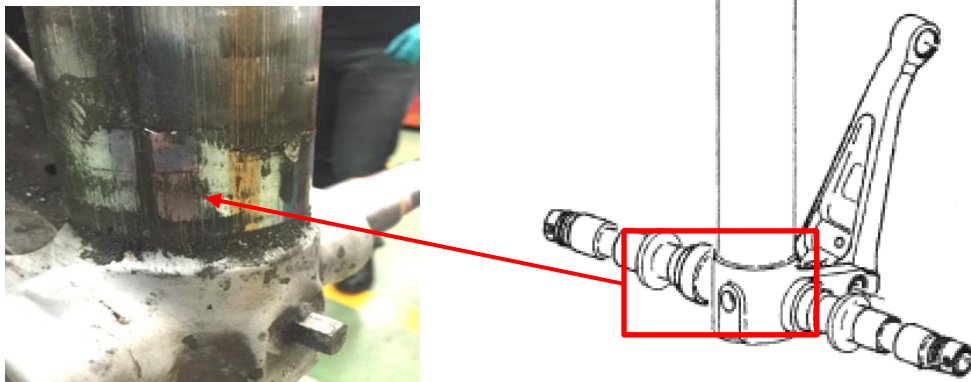
The lower part of the sliding rod had damage which was attributable to inadequate lubrication.

**Figure 10:** Damage to the lower part the nose landing gear sliding rod

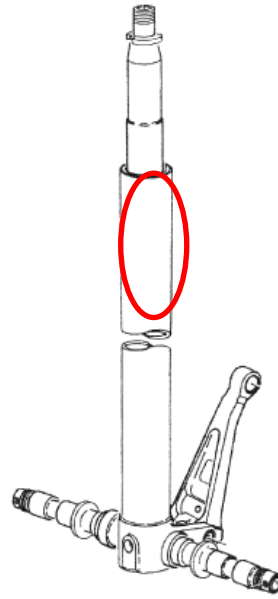
The sliding rod of the NLG assembly exhibited markings which likewise indicated inadequate lubrication (cf. Figure 11).

**Figure 11:** Markings on the sliding rod of the NLG assembly

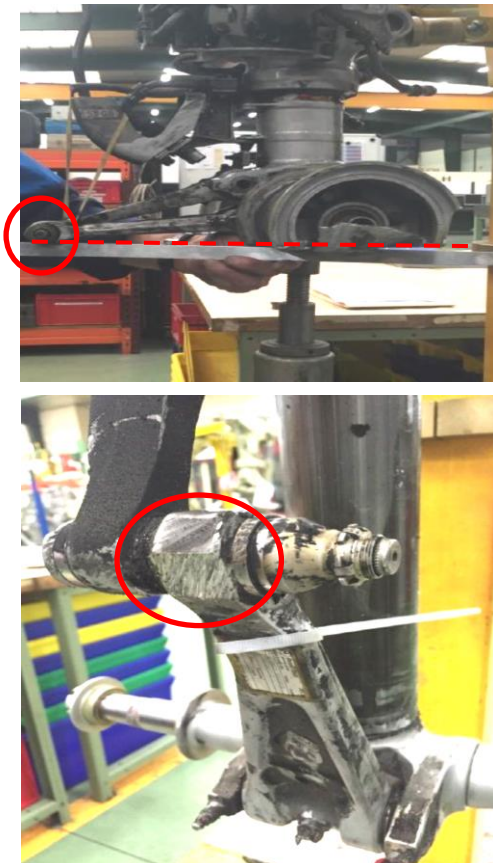
The abrasion marks on the lower sides of the rod end bearings of the upper and lower torque link were a consequence of the nose gear sliding during the landing roll (cf. Figure 12).

**Figure 12:** At the linkage between the upper and lower torque link both rod end bearings exhibited abrasion marks on the lower side.

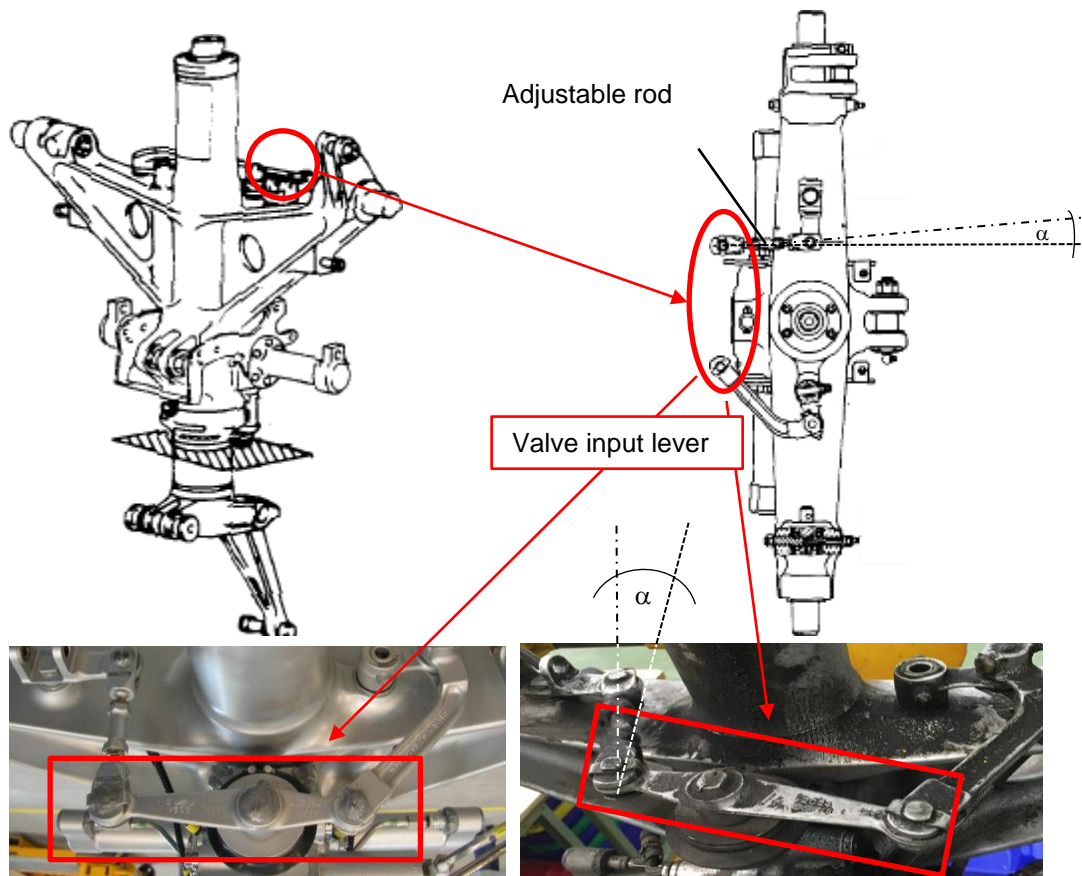
The valve input lever of the steering system was found to be installed in an inverted state (rotated through 180° about the longitudinal axis - cf. Figure 13).

**Figure 13:** Correct (left image) valve input lever of the steering system (framed in red) and valve input lever with inverted installation (rotated through 180° in the longitudinal axis - right image)

This meant that the angle  $\alpha$  (cf. Figure 13) of the adjustable rod was misaligned and was subject to mechanical strain.

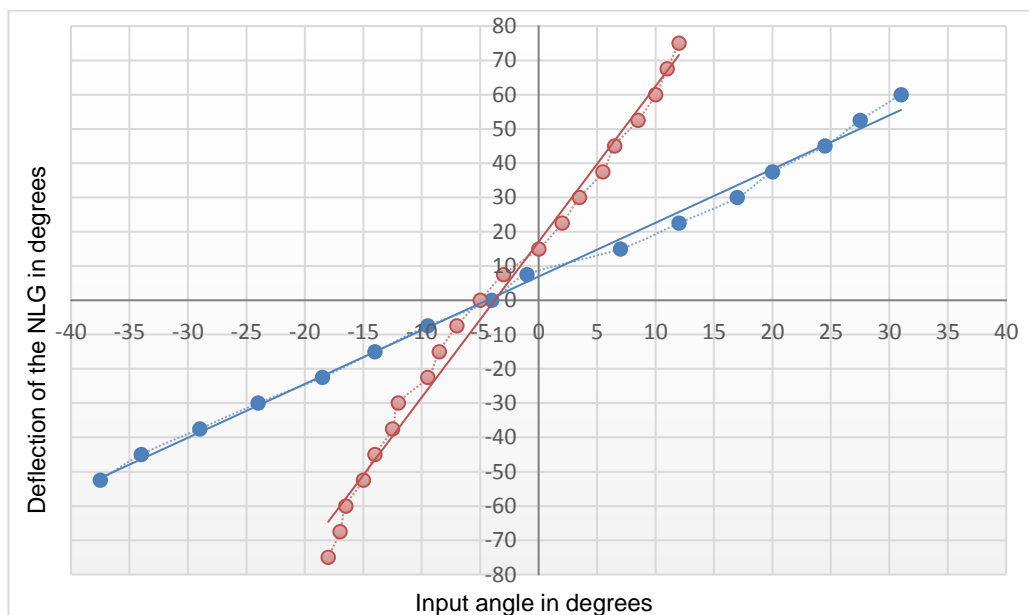
**Figure 14:** Illustration of the measured deflections of the nose landing gear (NLG) as a function of the input angle ( $X$ ) over the full range from  $-36^\circ$  to  $+36^\circ$  (cf. Figure 3 in Section 1.6.2.6.1), with valve input lever in the normal position (blue points) and with valve input lever inverted (rotated through  $180^\circ$  - red points).

Subsequently a test series indicated that the transmission ratio between the inputs and actual deflections of the nose landing gear for a valve input lever which had been attached rotated through 180° was approximately three times higher than for a valve input lever which was correctly attached (cf. Figure 14).
