Final Report No. 2308

concerning the accident involving the
Fairchild 24R46A “Argus III” aircraft,
registration HB-ERO,

on 23 August 2016

Oberhöhnwilen, municipality of
Ermatingen/TG

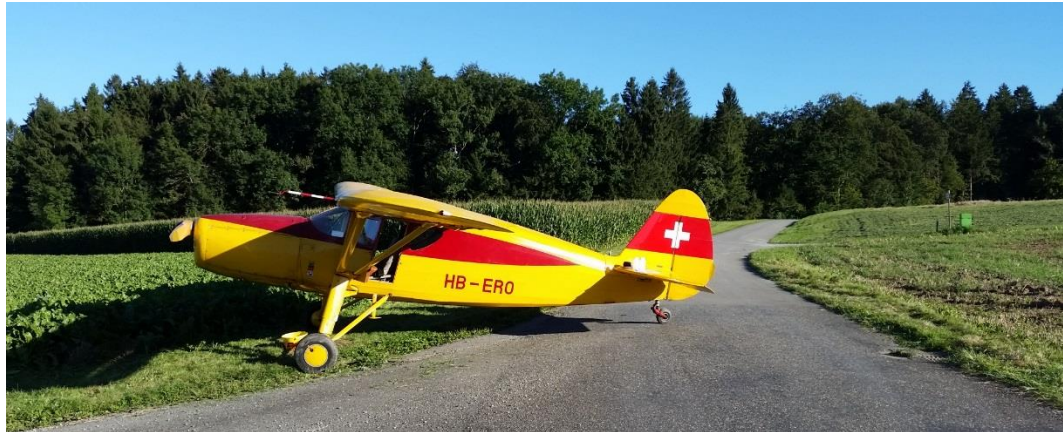
The pilot immediately searched for a suitable forced landing site and decided to land HB-ERO on uncultivated farmland near Weiler Oberhöhnwilen in a south-easterly direction. The two occupants were uninjured during the landing and the aircraft was not further damaged.

Figure 2: Aircraft HB-ERO after the forced landing near Oberhöhnwilen

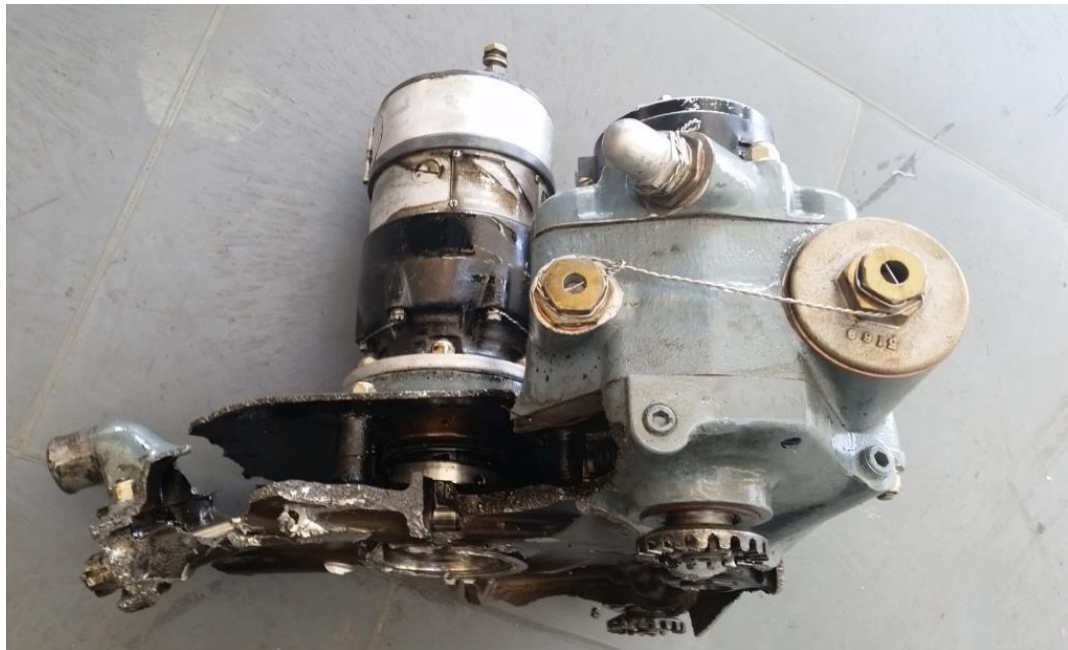
- The aircraft did not exhibit any signs of external damage and the controls functioned perfectly.
- The flaps were retracted.
- All electrical switches and the magnetos were switched off and the fuel cocks were closed.
- Engine oil was dripping out at the transition from the lower engine cowling to the airframe. The right and lower engine cowling as well as the front half of the underside of the aircraft were heavily contaminated with oil.
- After disassembly of the lateral engine covers, it was found that the crankcase was fractured towards the rear of the engine.
- Various components were found on the lower engine cover, among other things crankshaft counterweights and fragments of the engine housing.
- The accessory section as well as the two magnetos had become separated from the engine (cf. Figure 3).

Figure 3: The accessory section and the two magnetos were separated from the engine of HB-ERO.

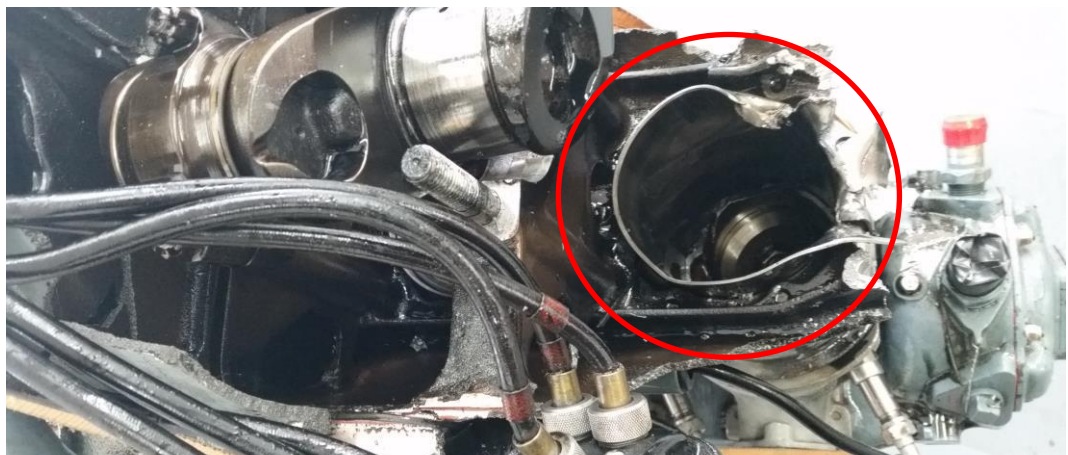
- The rearmost cylinder no. 1, viewed in the direction of flight, as well as its piston and the associated part of the housing, were destroyed; the crankshaft was broken and the camshaft was bent.
- The piston rod was bent through approximately 160 degrees.
- The crankcase was destroyed as far as cylinder no. 3.
- Except for the front right engine mount, all mounts were separated from the engine housing.

Figure 4: The components of cylinder no. 1 (marked in red), the rearmost cylinder viewed in the direction of flight, were destroyed.

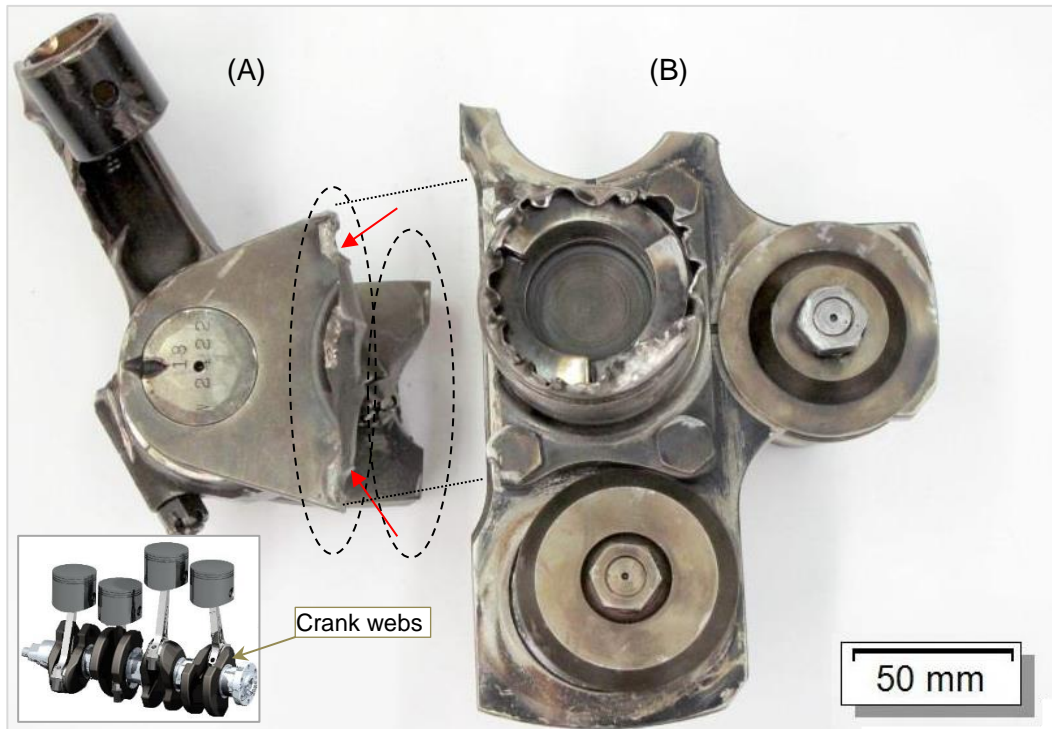
- Crankpin no. 1 with piston rod and broken-off crankshaft webs (A);
- Separated section of the crankshaft (B).

Figure 5: Part (A) with the two broken-off crankshaft webs (marked by broken lines) and part (B) of the engine of HB-ERO for metallographic investigation of the fracture surfaces (red arrows)

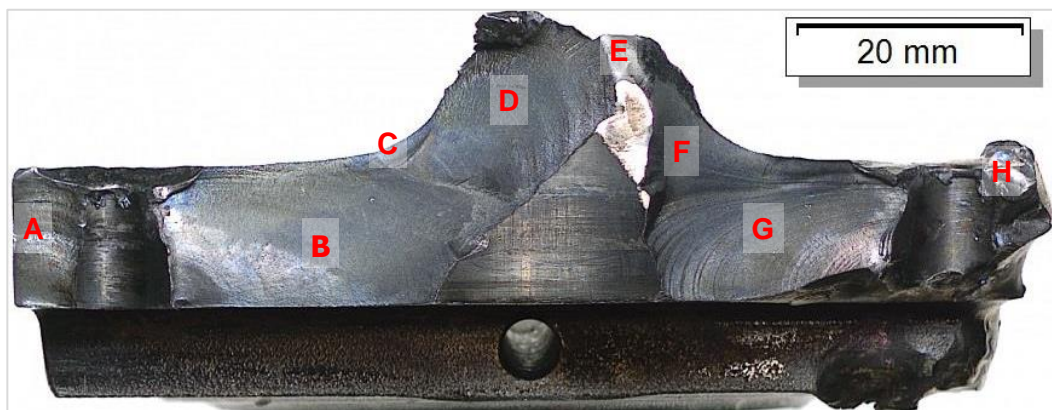
In terms of the material, no characteristics relating to the cause of the fracture were found. Owing to the secondary damage caused by the reciprocal friction of the fracture surfaces, the fractures could no longer be clearly interpreted microfractographically. Nevertheless, there were indications of various fatigue failure zones (cf. Figure 6 Zones A, B, C, D and G are fatigue fracture surfaces which exhibit clear striations. It was not possible to analyse fracture zone H due to mechanical damage.

Figure 6: Fracture surface of the crankshaft web with the fatigue fracture surfaces in zones A, B, C, D and G (from left to right); it was not possible to analyse fracture zone H.

The fatigue fractures found by metallographic examination (cf. section 1.5.2) were initiated over a fairly long time at different points on a crankshaft web of rear cylinder no. 1. The residual fracture surface was small, which in normal operation suggests a low load on the crankshaft web.

It cannot therefore be completely excluded that the cracking at the crankshaft occurred since the engine was first put into service. It can be assumed with a high degree of probability that a crack was present at the time of the last total overhaul of the engine in 2005 at 2716:39 hours TSN. Such cracks usually are detected on the occasion of a crack test as part of a total overhaul.

This pre-existing weakening was the cause of the sudden fracture of the crankshaft webs of the rearmost cylinder, viewed in the direction of flight, whilst cruising with a normal load on the engine, leading to the engine immediately seizing up and to serious damage to the engine. The slightly increased oil temperature when cruising, as well as the engine's increased oil consumption, do not provide a plausible explanation in respect of an existing connection with the pre-existing damage at the crankshaft.
