Final Report No. 2309

by the Swiss Transportation Safety Investigation Board STSB

concerning the accident involving
the Airbus Helicopters AS 350 B3
helicopter, registration HB-ZIS,

on 14 July 2015

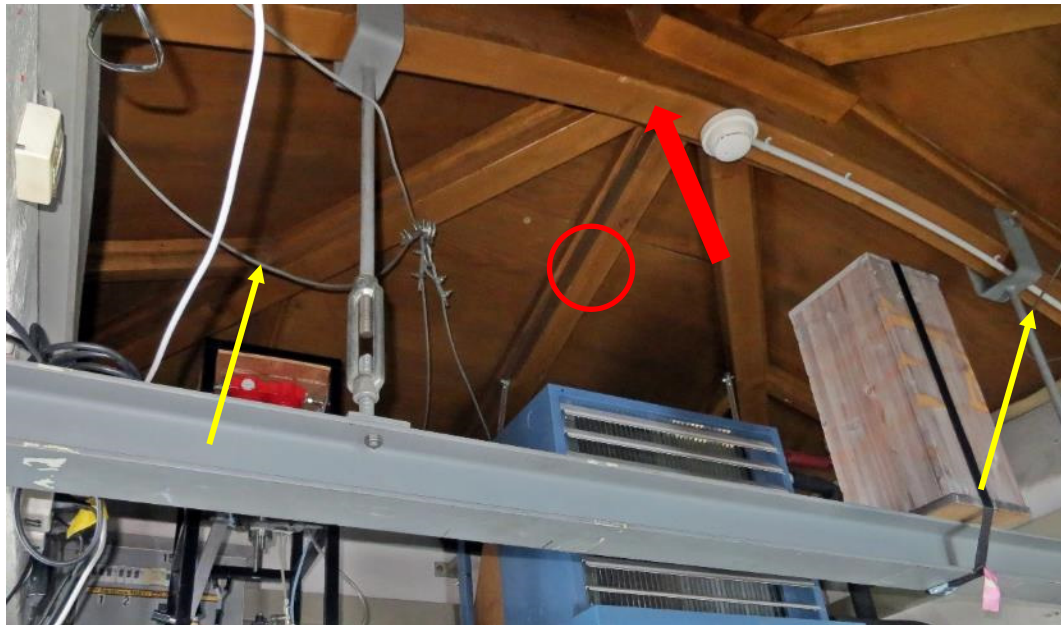
Figure 6: Interior view of the roof. The thick red arrow indicates the main beam. The red circle marks one of the two roof rafters. The yellow arrows indicate the two pre-mounted wire rope slings in the main beam.

The wire ropes which were pulled into the holes act under load on the rafters and main beam as a split wedge. In this situation a danger of a fibre fracture of these structural elements exists. From the statics of the roof structure it is evident that when the roof is lifted respectively transported, the two fixing points on the glulam beam ultimately sustain the total load of the roof. The load on the two slings, which are attached to the roof rafters, is low; they stabilise the roof when it is lifted respectively transported.

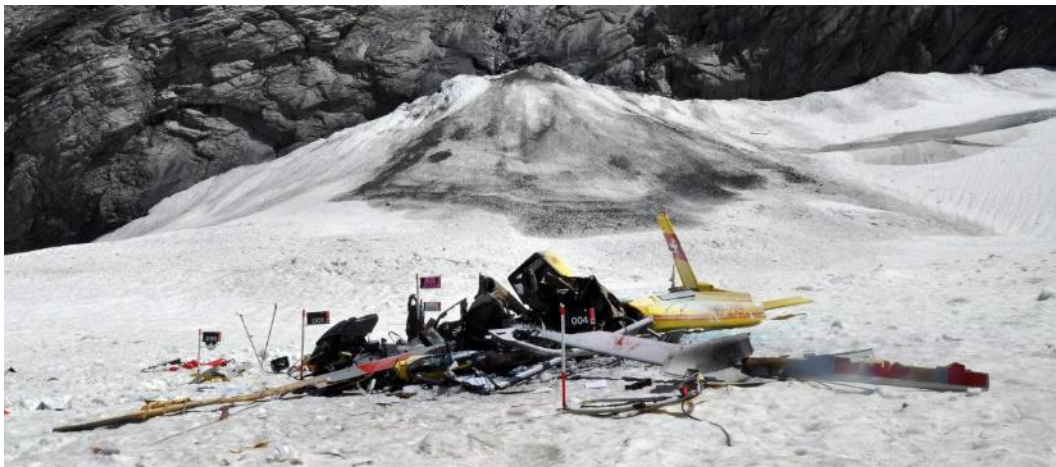
The helicopter crashed in its normal attitude on the glacier with a high vertical speed and a very low forward speed.

Figure 9: Final position of the wreckage

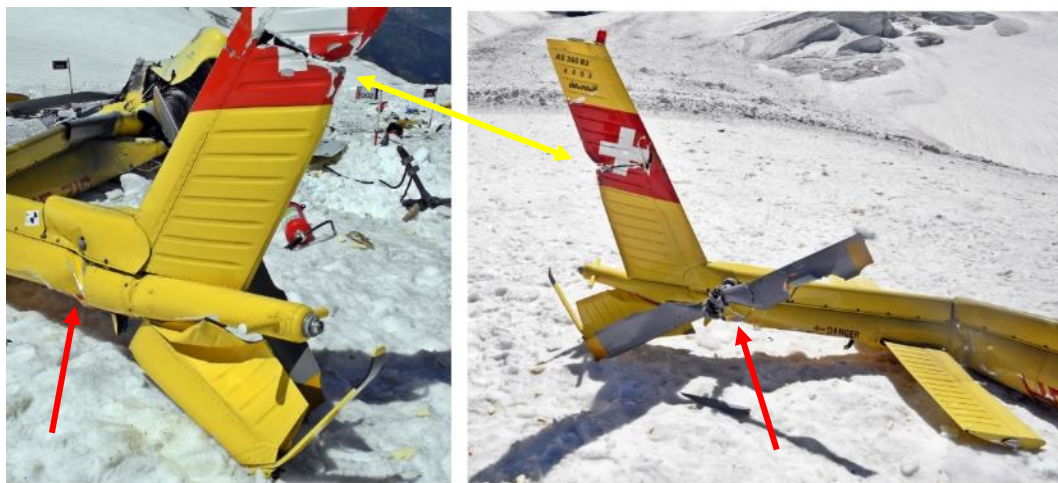
Figure 10: Detail photo of tail boom. The red arrows point to the twisted area. The yellow arrow points to the incision in the vertical stabiliser.

- On the tail boom, as well as on the rotor blades, distinct marks of the longline could be identified.
- In total, three segments of the 30 m longline were found. Approximately 5 m of the longline are missing.

whether the amber FUEL warning, which illuminates at a fuel level of 60 l, played a role here. It is certain that this speed, in combination with the inappropriate suspension of the load, led to the external load becoming unstable. The longline subsequently then was thrown over, leaving many traces on HB-ZIS. In the tail boom area, this led to damage to the vertical stabilizer and then to the deformation of the tail boom. As a result, the tail rotor drive shaft was separated just in front of its gearbox. It can be assumed up to the severing of the longline that the entire load was now suspended from the tail of the helicopter, which explains the observed uncontrolled flight attitude.

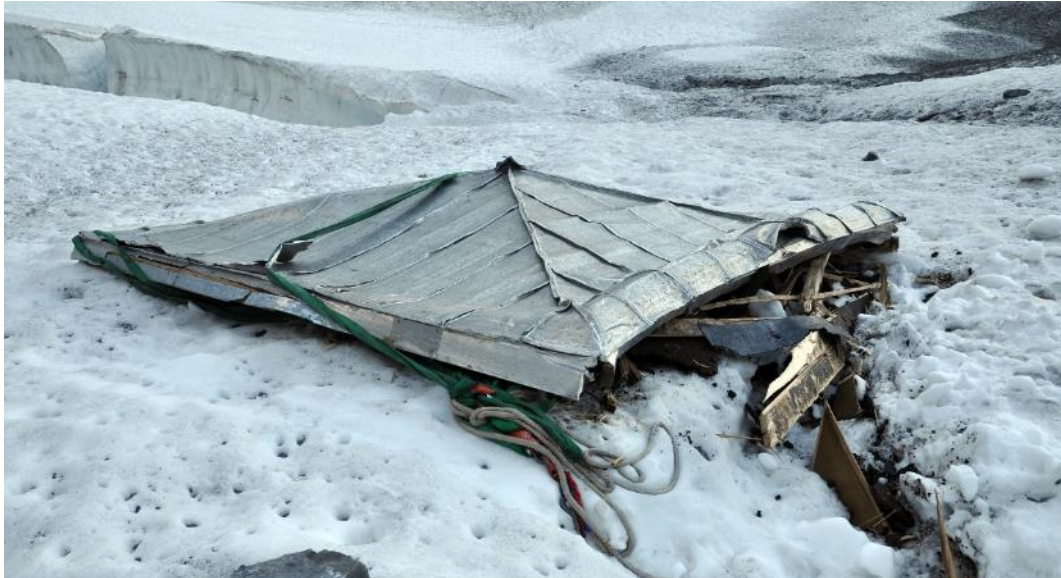
The sheet metal roof cladding exhibited plastic deformation and the roof was badly damaged on one side. All four textile loop slings and the wire rope slings fastened to them by round shackles were found in the vicinity of the roof. The 14.6 m long separated end segment of the longline also lay near to the four textile loop slings, which were still hanging in the cargo hook. After the roof was lifted off the ice surface, the following findings, among other things, were made:

- The roof structure was damaged in various places.
- One roof rafter was loose under the roof, with the nails pulled out.
- One roof rafter was still connected to the roof structure by its nails.
- The glulam beam was torn off lengthwise, to a large extent along the glued joints.

Figure 11: Final position of the external load

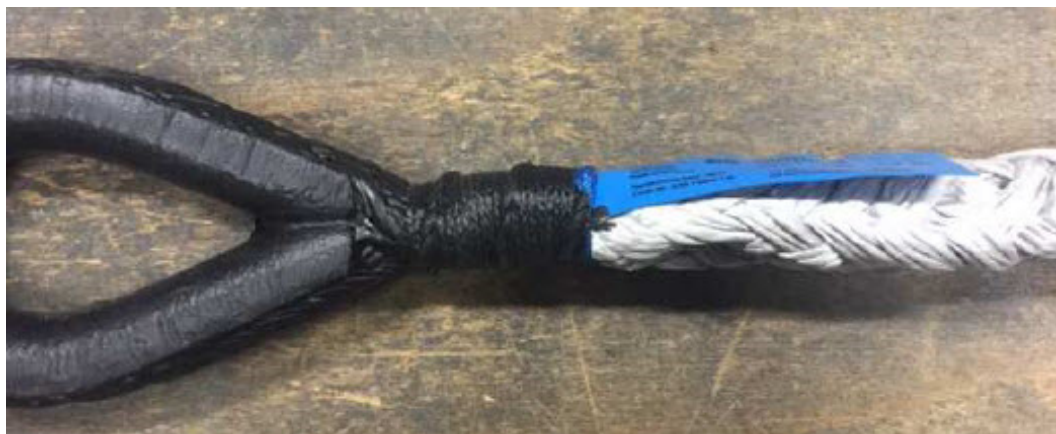
According to information from the operator, at least on one end of the longline labelling can be found for identification. No labels with crucial data, as required for such longlines, could be found.

Figure 12: Example of an end of a longline with thimble and label. This longline also does not have a protective cover.

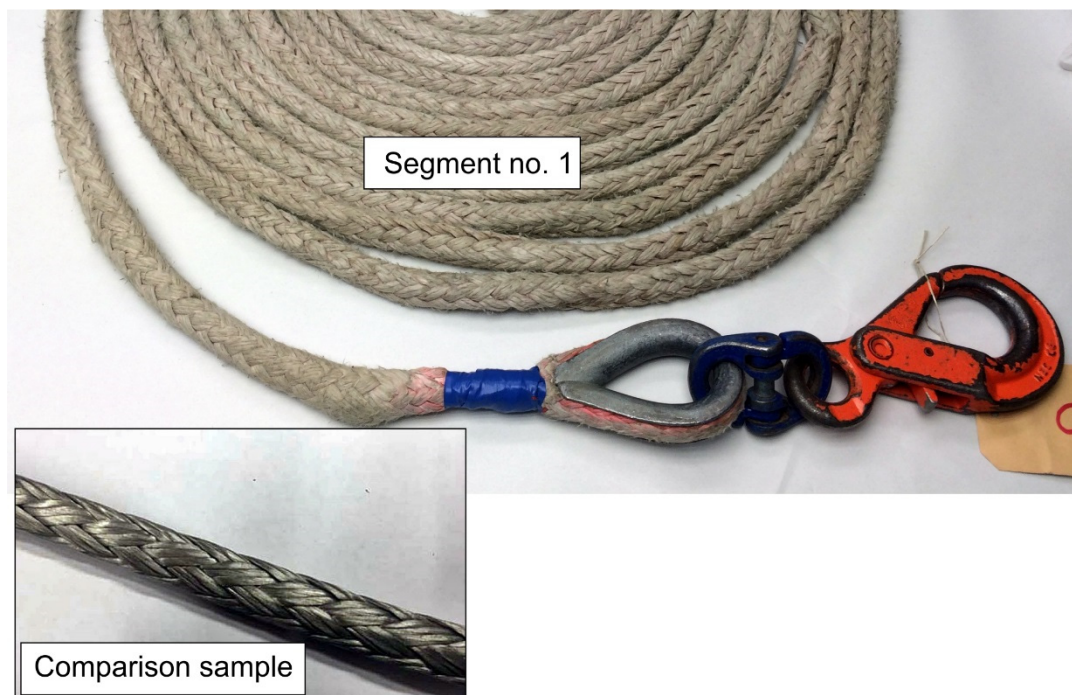
The remainder of the longline used were assessed by the manufacturer. In the process, the incorrect maintenance of the splice and the join was evident. From this point of view, this rope should no longer have been used in flight service. In view of the range of uses, this longline had reached a point where it should have been discarded. This is substantiated by the loosening and chamfering in the area of the splice and at some points on the free length.

A new longline has a diameter of 12 mm. Through its use the diameter had increased up to 16 mm (see Fig. 13).

Figure 13: Segment no. 1 of the 30 m longline with the incorrectly spliced end. The sample for comparison shows the condition of a Dyneema longline fresh from the factory.
