Final Report No. 2313

Concerning the accident involving the
DynAero MCR-ULC aircraft, HB-WAR,

on 13 December 2015

at Locarno Airport / TI (LSZL)

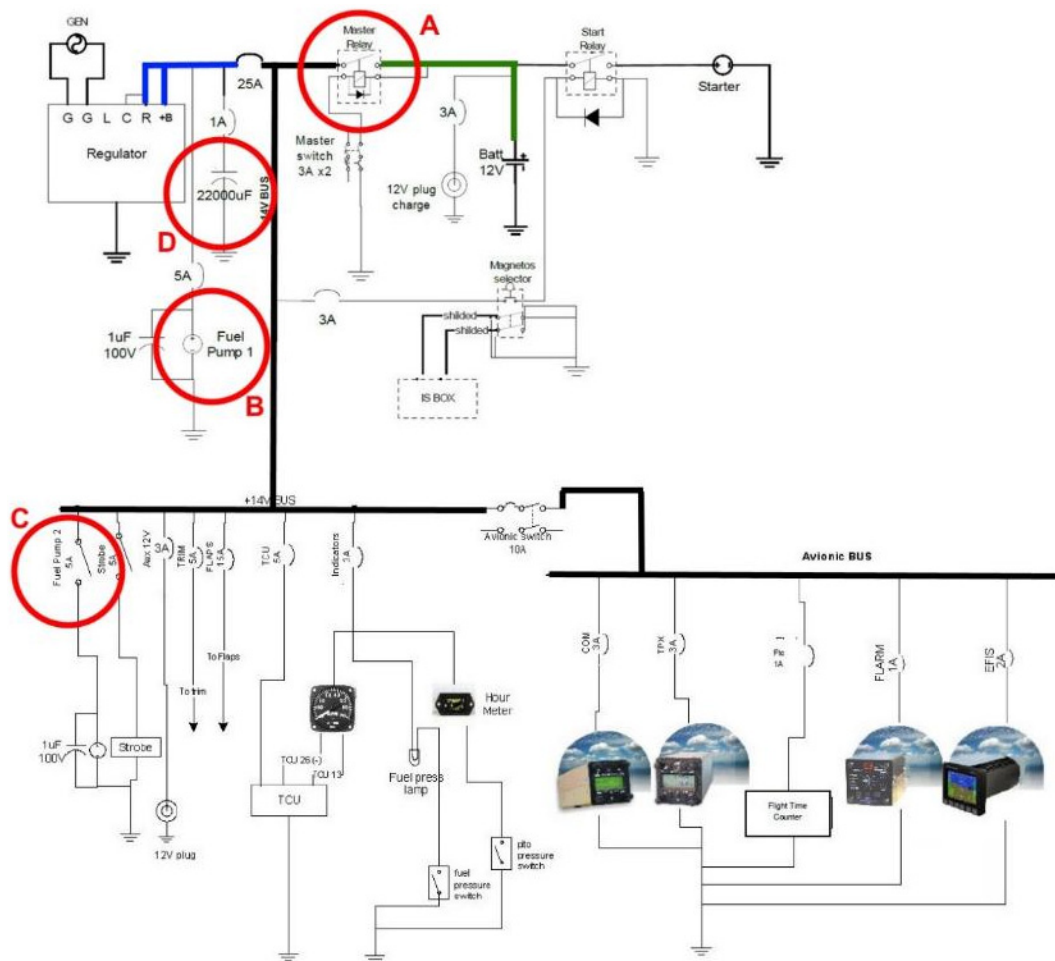
The electrical system supplies, amongst other things, the two electrical fuel pumps: fuel pump 1 is permanently connected to the main power distributor (+14 V bus); fuel pump 2 is activated via a switch on the instrument panel (see illustration 2). According to the AFM, this ensures that at least one pump can be operated at all times, even if one of the two power sources fails.

No charge indicator lamp for the rectifier regulator is fitted in the DynAero MCR-ULC, which is why a failure of the generator or of the rectifier regulator can only be identified from a low voltage notification on the voltage indicator and the low voltage light.

Illustration 2: Electrical system of the MCR-ULC (taken from the AFM) with A: master relay, B: fuel pump 1, C: fuel pump 2 and D: capacitor

In addition, provision is also made in the design diagram for a warning light for the rectifier regulator at output L (see illustration 1), which informs the pilot of a rectifier regulator failure. No such warning light is installed in the MCR-ULC and an electrical problem is only indicated by the low voltage light and the voltmeter in the event of a low battery voltage. A rectifier regulator failure therefore remains undetected, which was identified as a contributory factor.

The European Aviation Safety Agency (EASA) and the Federal Office of Civil Aviation (FOCA) should take appropriate measures to ensure that a failure of the rectifier regulator or generator and the discharging of the battery can be detected at any early stage in all aircraft with a Rotax 914 engine.

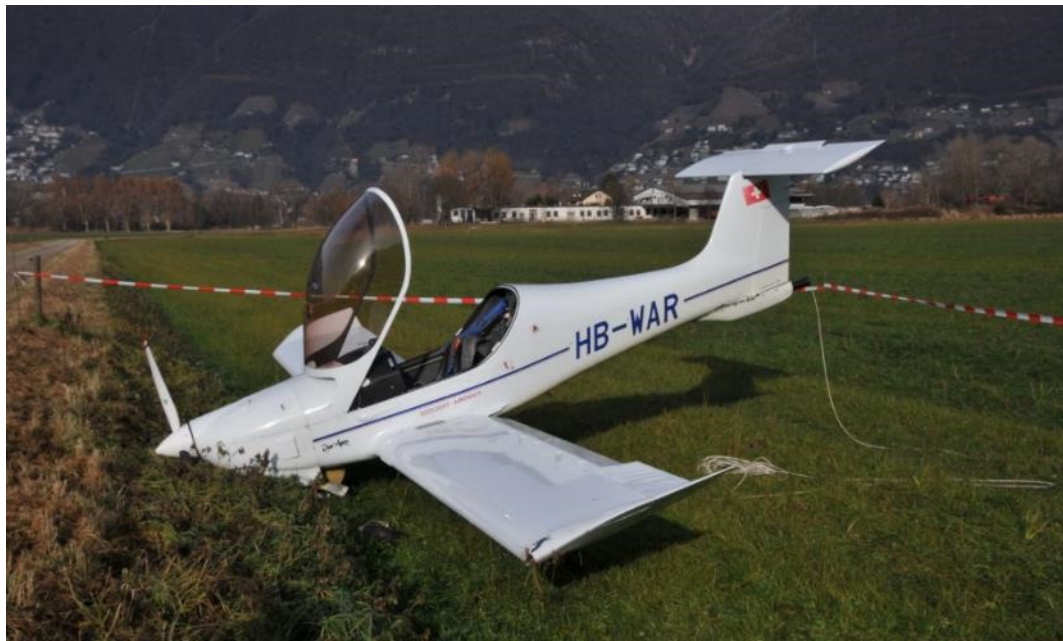
Illustration 3: Final position of HB-WAR

The final position of the aircraft was 365 m after the end of runway 26L. The wreckage lay in the direction of flight against the bank of a farm track. As a result of the impact with the bank, the nose landing gear was broken off, the two propeller blades at the bottom were bent and the two wing tips were damaged (see illustration 3).

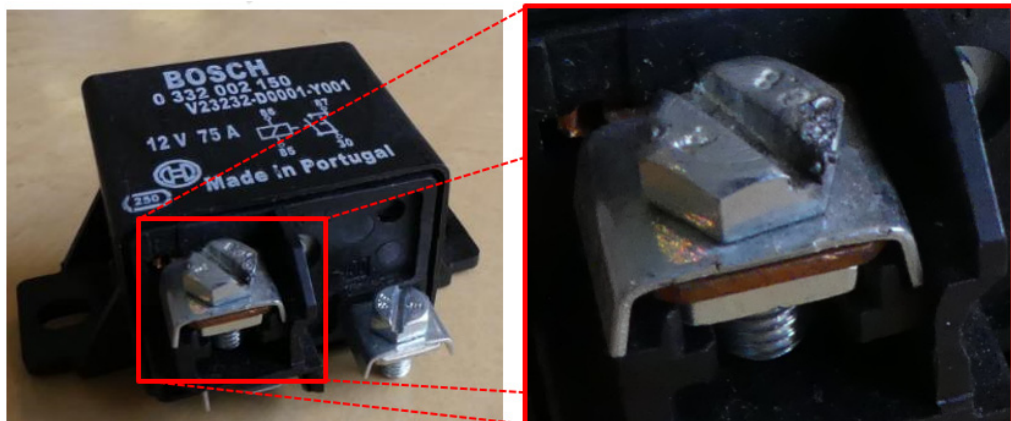
- The transponder was electrically damaged and could not be operated.
- All other devices were in working order.
- The master relay, which separates the main power distributor (+14 V bus) from the battery supply, showed signs of burns on one electrical connection due to a short circuit, but was still functioning (see illustrations 4 and 5).

Illustrations 4 and 5: Master relay, following removal, with scorch marks on one of the electrical connections

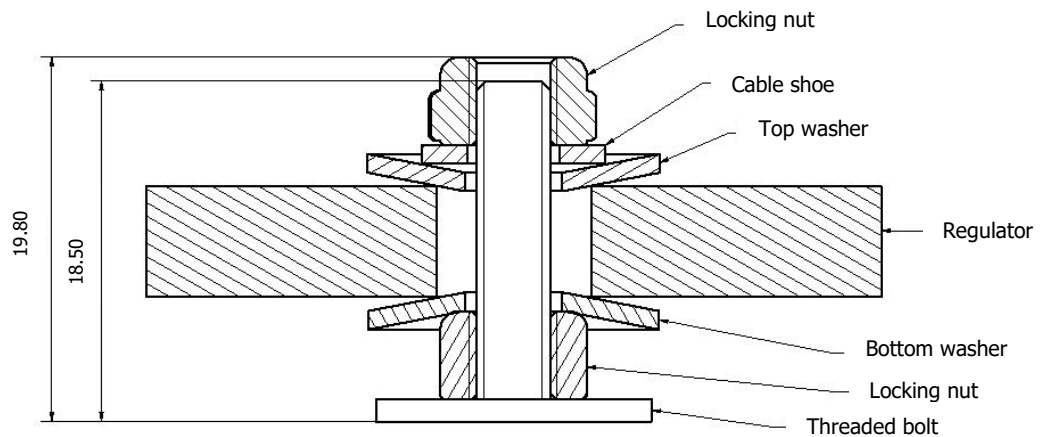
- The threaded bolt, which had been set into the fuselage structure and was used to mount the rectifier regulator and the ground cables on the cabin floor behind the fire bulkhead, had a total length of 18.50 mm (see illustration 6). The following components were fixed on this (from bottom to top): bottom washer (1.01 mm), fixing flange for the rectifier regulator (6 mm), top washer (1.01 mm), cable shoe of the ground cable (0.96 mm) and locking nut (4.8 mm). With all of the components, this gave a total length of 19.80 mm, which meant that the clamping part (plastic insert) of the self-locking nut could not grip the threaded bolt.

Illustration 6: The composition of the threaded bolt for fixing the rectifier regulator and the ground cable (cable shoe)

- The two threaded bolts with which the rectifier regulator and the ground cable were mounted on the cabin floor behind the fire bulkhead were too short, which meant that the locking nut could not be tightened enough to enable its self-securing effect. It is therefore probable that vibrations loosened the locking nut slightly over time and that the electrical contact between the ground cable and the rectifier regulator was interrupted in the process, which leads to the same behaviour as that described above: the power supply from the battery to input C of the rectifier regulator drops with a subsequent total loss of the power supply.

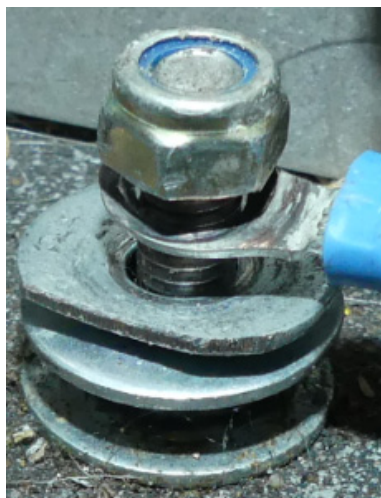
- The locking nut on the threaded bolt with the cable shoe of the ground cable was not tightened. Illustration 7 shows the threaded bolt with the two washers, the cable shoe of the ground cable and the locking nut after the rectifier regulator had been removed.

- Both washers exhibited marks on their surfaces that typically occur with a poor electrical connection.

Illustration 7: The threaded bolt with the damaged washers and the cable shoe of the ground cable after the rectifier regulator had been removed

The accident can be attributed to an emergency landing following engine failure due to an interruption in the fuel supply because the non-redundant power supply to both electrical fuel pumps cut out. It is highly likely that the power cut was caused by an interruption in the ground connection at the regulator.
