Final Report No. 2319

concerning the serious incident involving
the Robinson R22 Beta II helicopter
HB-ZGO

on 6th April 2016

1 km south-east of Worb, canton of Bern

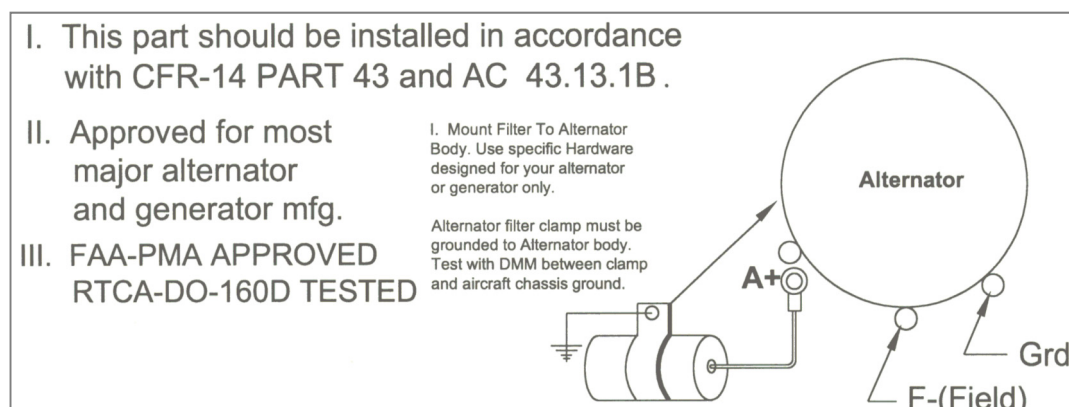
Illustration 3: Installation instruction for the alternator filter from its manufacturer

As the alternator filter is not approved for installation in a Robinson R22 helicopter, there were no relevant type-specific installation instructions. The documentation from the manufacturer of the alternator filter only provides a schematic installation note, which was followed when the alternator filter was installed in HB-ZGO (see section 1.3.5). Based on a PMA granted by the FAA, it is however permissible to fit this kind of alternator filter to various small aircraft (e.g. Cessna C172). Because installation using only one mounting bolt is not explicitly defined, the installation of

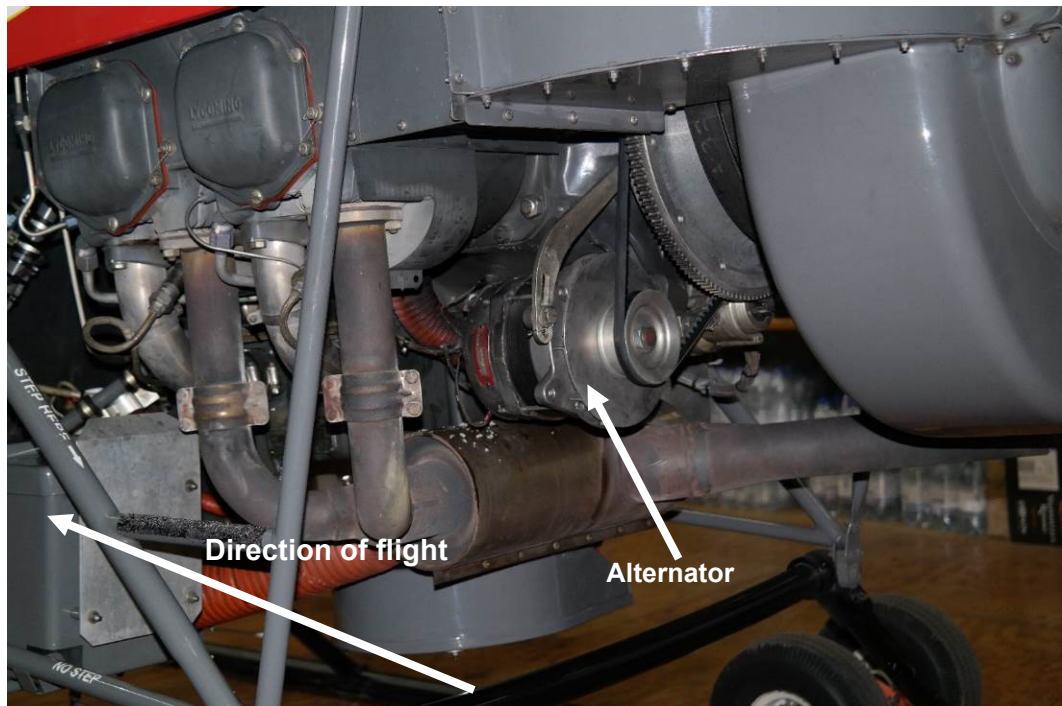
The engine bay was inspected after landing. Burn marks were found in the lower left part of the engine bay around the alternator and significant traces of soot were found on all components nearby (see illustration 4).

Illustration 4: The lower left part of the engine bay; burn marks and traces of soot around the alternator

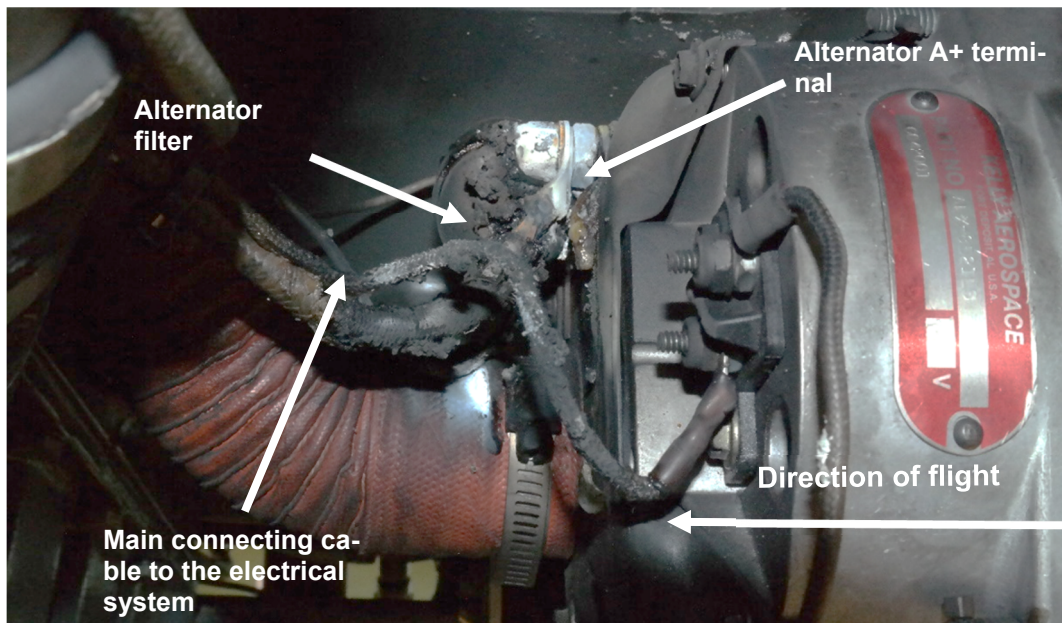
The most severe burn marks occurred around the alternator's electrical connections closest to the alternator filter (see illustration 5).

Illustration 5: The alternator with the alternator A+ terminal, the main connecting cable to the electrical system and the alternator filter

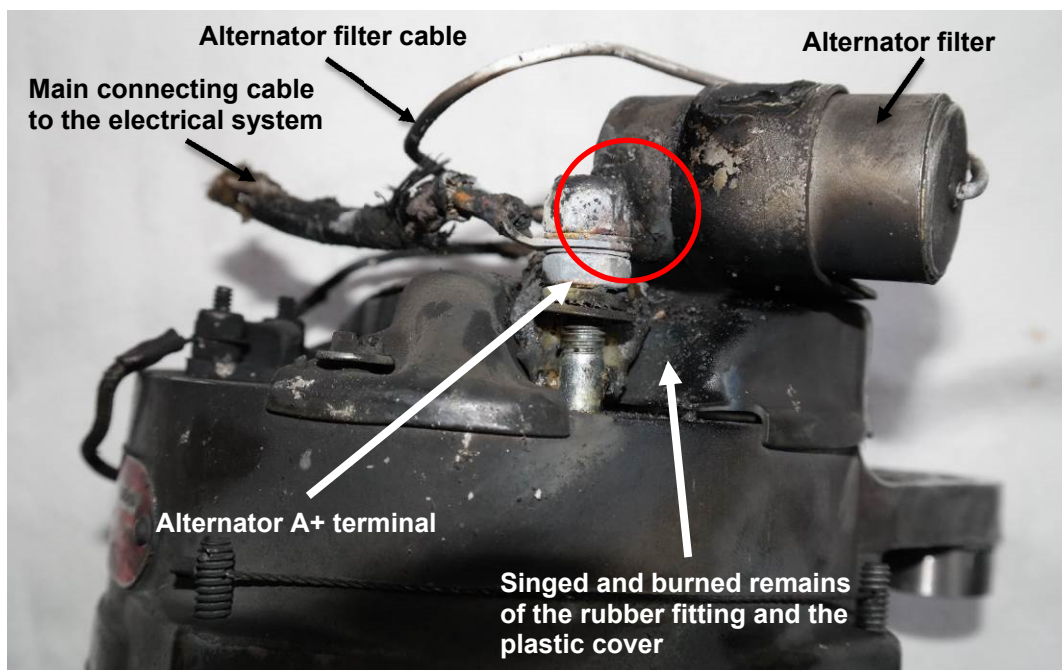
As can be seen in illustration 6, the greatest amount of heat had developed around the alternator's A+ terminal. Both the alternator's plastic cover and the rubber terminal cover (rubber fitting), which had covered the A+ terminal before the fire, were melted and singed. It is remarkable that the gap between the upper locking nut on the alternator's A+ terminal and the alternator filter housing only measures a few millimetres.

Illustration 6: The alternator after removal, with A+ terminal, main connecting cable to the electrical system, cable to the alternator filter, alternator filter and the singed and melted remains of the rubber fitting and plastic cover respectively. The small distance between the alternator's A+ terminal and the alternator filter housing can be seen in the red circle.

The alternator filter was mounted on the alternator in such a way that the distance between the earthed alternator filter housing and the alternator's A+ terminal only measured a few millimetres. The rubber terminal cover (rubber fitting) for the A+ terminal, which isolated against a short-circuit in the alternator and/or the battery, was therefore jammed between the A+ terminal and the alternator filter and it is highly likely that, over time, engine vibrations caused mechanical wear of the cover. Because of that, electrical isolation was no longer ensured and electrical sparks were produced between the earthed alternator filter housing and the alternator terminal.

The serious incident can be attributed to a short circuit between the alternator terminal and the housing of a retrofitted alternator filter. The short circuit caused sparks which led to a fire in the engine bay.

In all aircraft that have been retrofitted with an alternator filter mounted on the alternator subject to a PMA granted by the FAA, it should be ensured that no short circuit can occur between the earthed alternator filter housing and the electrical system.

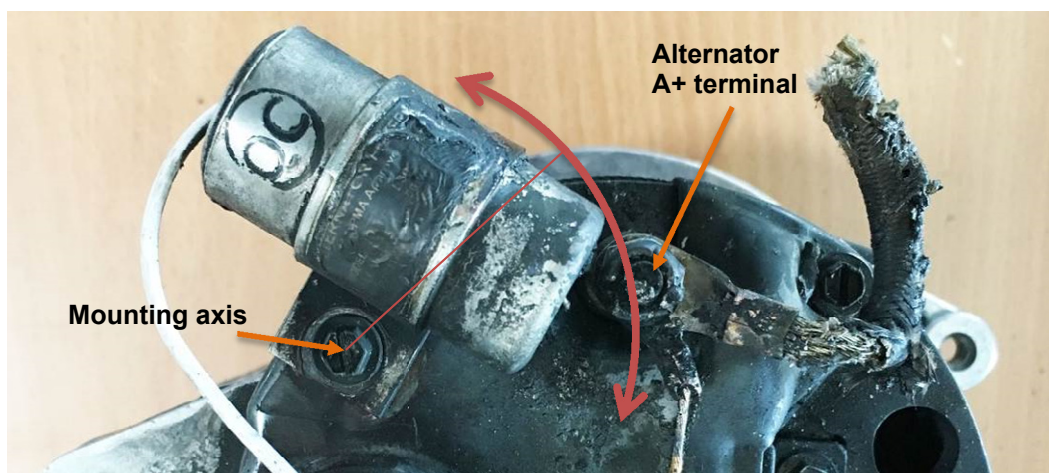
The alternator filter's mounting bracket had only one hole and was therefore fixed to the alternator with just a single bolt (see illustration 7). The alternator filter's position in relation to this mounting axis was therefore not clearly defined. It is likely that, over time, the alternator filter rotated around its mounting axis due to vibrations and that the distance between the alternator's A+ terminal and the alternator filter housing decreased even further.

Illustration 7: Mounting of the alternator filter to the alternator housing using one bolt; the position of the alternator filter when rotated around the mounting axis is indicated by the circular arrow in dark red.

- The installation of the alternator filter had been inappropriate, resulting in mechanical damage to the insulating rubber fitting on the alternator terminal. Because of this, a short circuit with the earthed alternator filter housing was able to form.
