Final Report No. 2320

concerning the accident involving the
Bell 206B helicopter HB-XSL

on 9th June 2016

400 m north-west of Heimeneegg,
municipality of Buchholterberg
in the canton of Bern

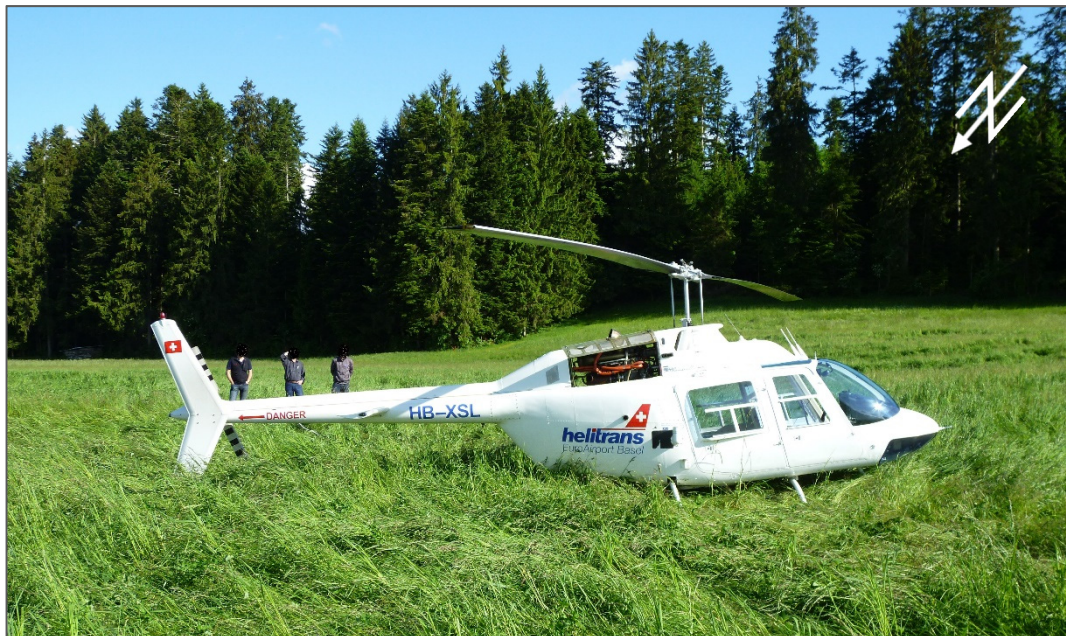
Illustration 2: The helicopter HB-XSL having landed in the long grass; the people behind the helicopter in the photo were on the road.

The marks in the grass indicated that the helicopter had touched down without any forward speed. The tail skid did not touch the ground.

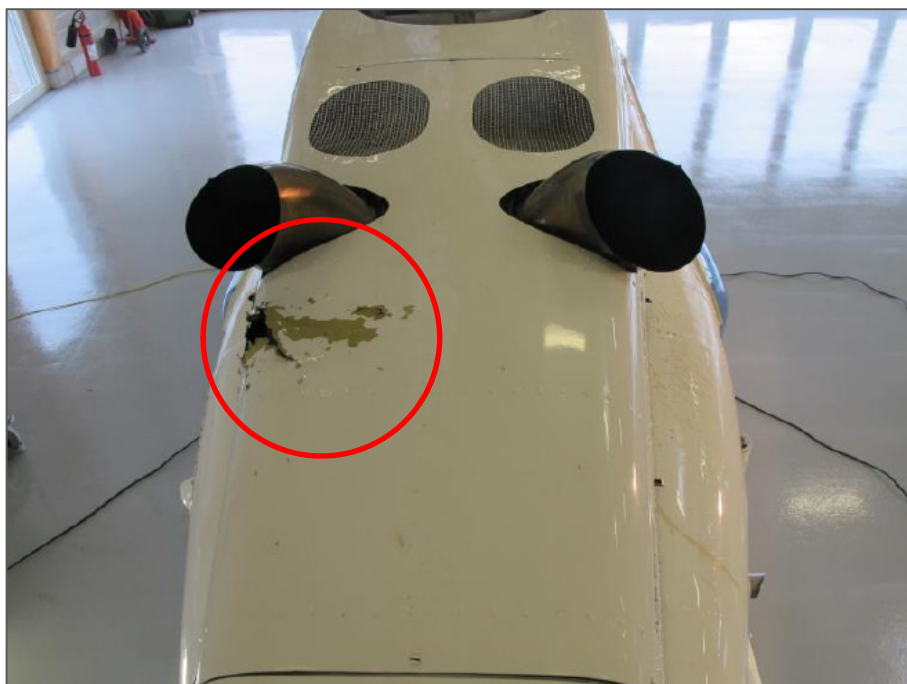
Several punctures were evident in the left engine cowling of HB-XSL level with the turbine, which were the result of turbine components being ejected. The underside of one of the main rotor blades had also been damaged by turbine components which had been catapulted out. The landing skids were deformed slightly. No other damage to the outer airframe of the helicopter was evident.

Illustration 3: View of the airframe of HB-XSL in the area of the engine looking in the direction of flight; the punctures are evident in the left engine cowling (red circle).

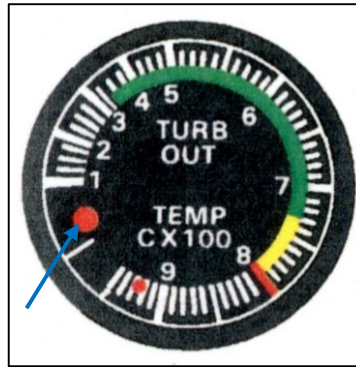
Illustration 5: The TOT indicator instrument installed in HB-XSL includes a red warning light (blue arrow) on the left-hand side, which permanently lights up once the respective limit has been exceeded.

When the battery master switch was switched on, the warning light illuminated due to an excessively high TOT (see section 1.4.6).

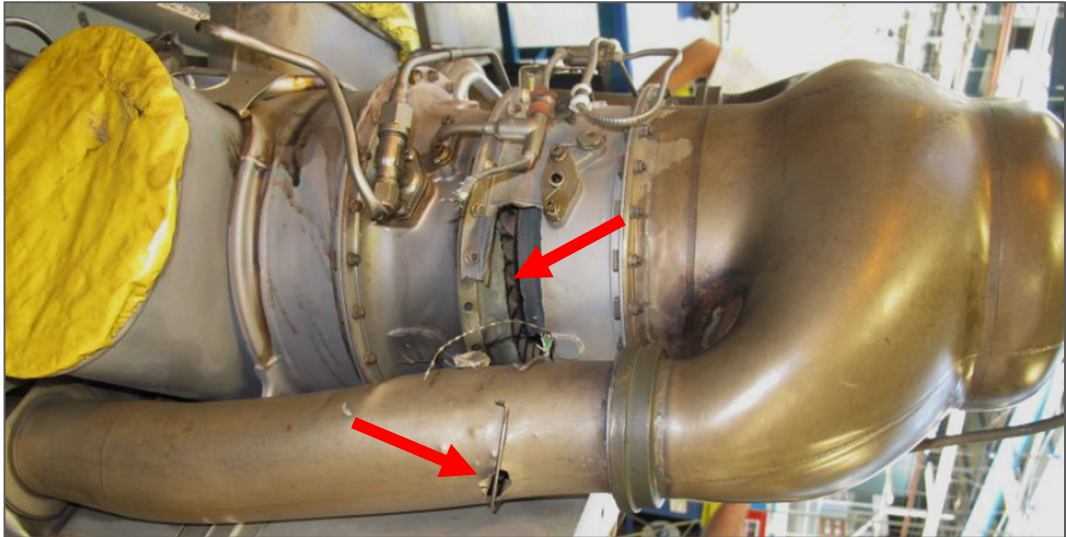
Part of the gas generator turbine support had been torn open, exposing part of the damaged first-stage turbine wheel (see illustration 6).

In the left-hand discharge tube, punctures were evident level with the first-stage turbine wheel which were caused by metal parts that had been ejected. The discharge tube was dislodged from the outer combustion case (OCC) and the snap ring was loose on the tube.

Illustration 6: Removed engine of HB-XSL with destroyed turbine module and damaged discharge tube (red arrows)

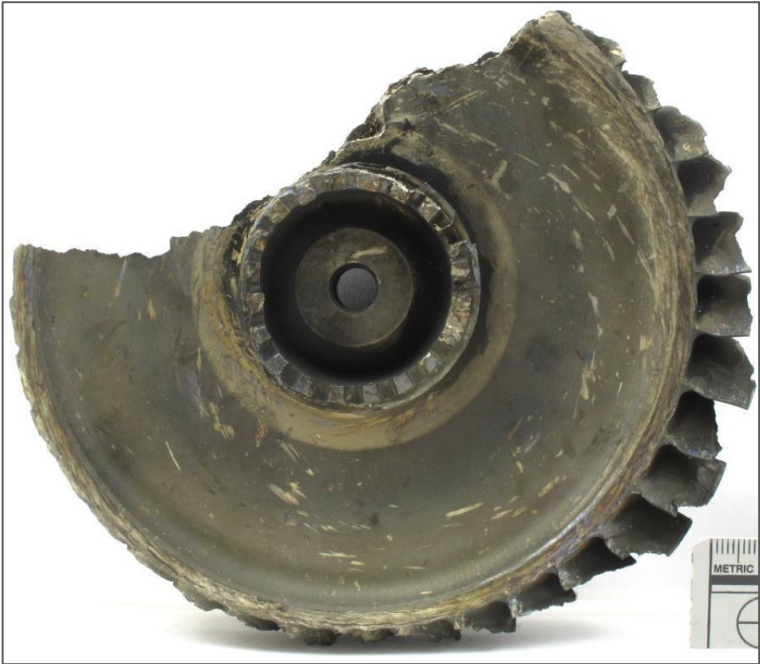
- The temperature sensors were undamaged and had taken on a dark colour.
- The couplings between the free power turbine (FPT) and the drive gear as well as between the gas producer turbine (GPT) and compressor were intact.
- The bearings rotated smoothly; the no. 8 bearing was fractured.
- The turbine tie bolt was fractured into three pieces and its aft end had pierced the sump cover of the no. 8 bearing.
- A free flow was guaranteed for all engine oil lines.
- A relatively large segment of the first-stage turbine wheel had broken off and was no longer present on the wheel (see illustration 7).
- All of the airfoils on this turbine wheel were largely broken off and the gas outlet side exhibited noticeable dark discolouration.

Illustration 7: Gas outlet side of the first-stage turbine wheel

- One segment of the turbine wheel, consisting of wheel rim, web and 13 airfoils, was torn off the wheel. The crack began as the result of thermal fatigue on the wheel rim and spread radially inwards as an interdendritic fracture⁶. This damage was the cause of the subsequent, segment-like overload fracture of the wheel. The damage to the fracture surface on the opposite side to where the fracture originated was consequential damage. The stub shaft fractured due to the overload of the turbine wheel, with all of the airfoils on the wheel breaking off in the process.

The fractured first-stage turbine wheel consists of a nickel-based high-performance alloy. The examination of the material's microstructure showed that the turbine was subjected to a thermal overload at least once some time before the event. From the structural examination, it can be concluded that the outer area and the trailing edges of the airfoils on the first-stage turbine wheel were exposed to a temperature of at least 1,150°C, which was well above the maximum permissible TOT specified by the manufacturer (see section 1.4.6). This excessive temperature changed the material properties and in particular reduced the strength, resulting in the formation of cracks due to thermal fatigue.

The failure of the engine can be attributed to the first-stage turbine wheel breaking apart due to the aforementioned crack formation as a result of previous thermal overload on one or multiple occasions.

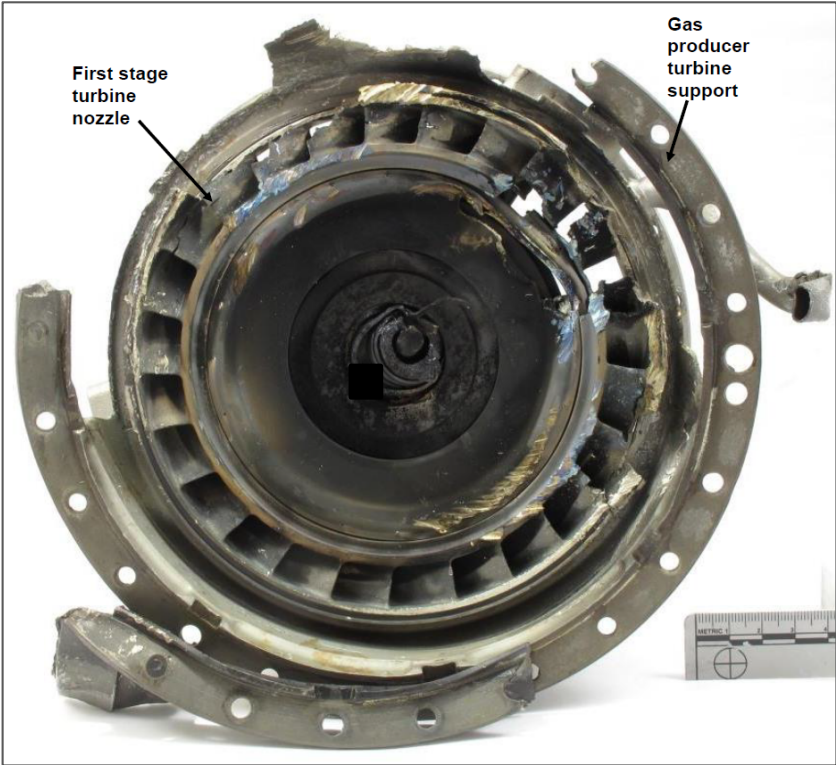
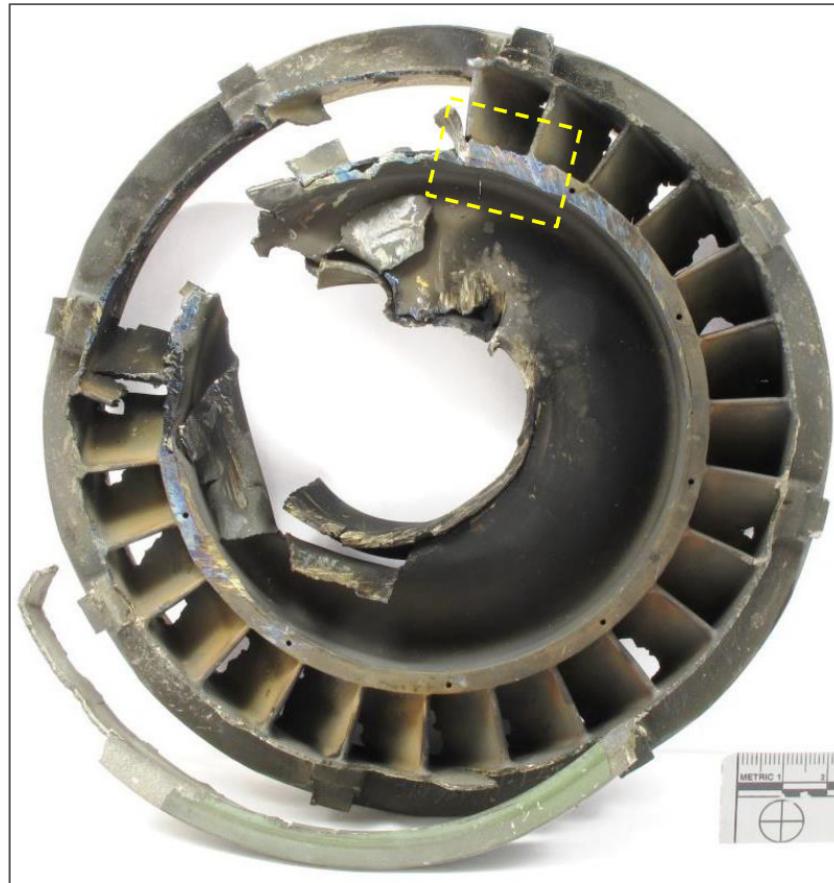
- The first and second-stage turbine nozzles (see illustration 8 and illustration 9) had been severely damaged by the debris from the ruptured first-stage turbine wheel.

Illustration 8: Gas inlet side of the first-stage turbine nozzles with gas producer turbine support

Illustration 9: Gas inlet side of the second-stage turbine nozzles

- The second-stage turbine nozzle ring, consisting of the inner- and outer-vane band, the diaphragm and the airfoils, was severely damaged due to the failure of the first-stage turbine wheel. On the turbine nozzle ring, transverse cracks were also discovered on the leading edge of two adjacent airfoils. One crack extended approx. 0.85 cm transversely through the airfoil, with the other, radial crack running around 1.42 cm from the transverse crack inwards through the inner-vane band and into the diaphragm. The airfoil exhibited an overload fracture due to tensile stress and the outer part of the inner-vane band showed a heavily oxidised surface with interdendritic features. The radial crack, which resulted from fatigue, ran inwards through the inner-vane band into the diaphragm and effected an overload fracture.

The second-stage turbine nozzle ring was severely damaged by parts of the first-stage turbine wheel as it broke apart. The pronounced oxidation damage on the turbine nozzle ring and the fatigue cracks which were found were caused by the excessive temperature that has been verified. The damage to the turbine nozzle ring did not cause the engine failure.
