Final Report No. 2325

by the Swiss Transportation Safety Investigation Board STSB

Concerning the serious incident (near-collision)
involving the commercial aircraft Fokker 50, OO-VLF,
operated by Vlaamse Luchttransportmaatschappij N.V.
(VLM) under the flight plan call sign VLM 22TX
and the Piper PA-28RT-201T aircraft, OK-ELL,
on 21 April 2016
approximately 10 NM north-east of
Friedrichshafen airport (EDNY), Germany

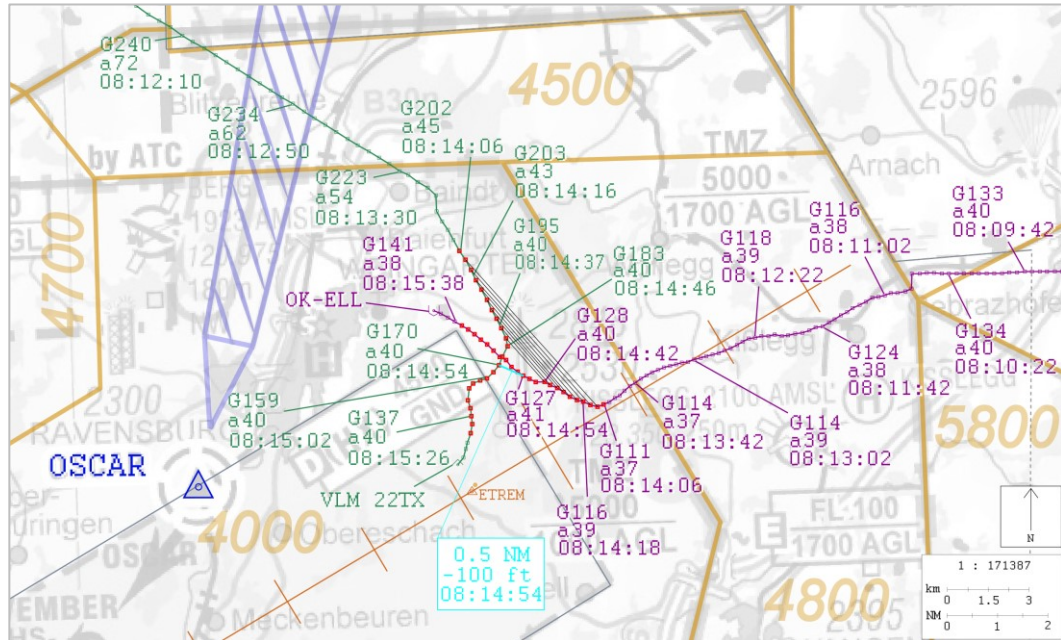
Figure 1: Flight paths of VLM 22TX (green) and OK-ELL (magenta) during the dangerous convergence according to the recorded radar data, with information of speed (G) relative to the ground in knots, altitudes (a) in hundreds of feet QNH and time in UTC. All positions during the STCA from 08:14:06 UTC until 08:15:34 UTC are illustrated in red, the closest point of approach having taken place at 08:14:54 UTC (cyan). In the period of time between 08:14:18 UTC and 08:15:38 UTC, the altitude readings of OK-ELL increased from 3900 ft to 4100 ft and then decreased again to 3800 ft. The following superimposed information are shown: the areas with the respective minimum vectoring altitudes (MVA) (orange), the VFR approach corridor to the reporting point OSCAR (blue) and the connecting lines (black) between the positions of the two aircraft with a constant angle (constant bearing).

At 08:14:42 UTC, the radar plot indicated a first change of course of VLM 22TX to the right. At the same time, OK-ELL changed his own course to the left, followed by another change of course to the right four seconds later. The RE air traffic controller later declared that he had been surprised by the left turn of the VFR traffic, because the speed vector had pointed shortly and unexpectedly towards VLM 22TX. Based on the observed altitude and heading fluctuations of the VFR traffic involved (cf. figure 1), the RE air traffic controller determined that neither a reliable heading instruction nor a descent clearance were possible, as the aircraft was already flying at the minimum vectoring altitude (MVA) of 4000 ft AMSL.

Adding to the unfavourable visual conditions for all pilots, both aircraft were approaching each other with a constant angle (constant bearing) between 08:14:10 UTC and 08:14:42 UTC, meaning that the respective position of the other aircraft remained unchanged from the perspective of the pilots, as shown by the black narrow parallel connecting lines in Figure 1. It is, therefore, not surprising that the pilot of OK-ELL saw the large silhouette of the Fokker 50 only late as he initiated a right turn, thereby altering the constant convergence bearing. This indicates that the traffic information given by the PL Main aerodrome controller at 08:14:50 UTC, only four seconds before the closest point of approach, came too late.

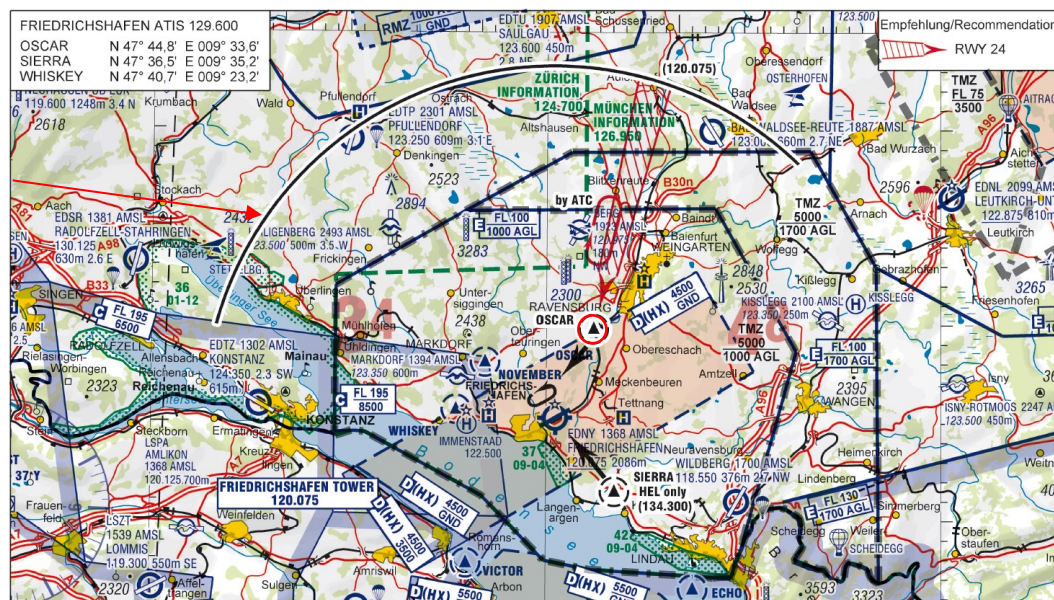
These documents show that when runway 24 is in use, the flights on approach to the paved runway are to proceed via the compulsory reporting point OSCAR and recommend following the red shaded arrival corridor (cf. figure 7). The radio contact with the aerodrome control is to be established latest ten minutes before reaching OSCAR, in any case no later than when overflying the 18 NM radius line around the airport reference point as shown on the chart. The CTR must be avoided when approaching the compulsory reporting points.

Figure 7: VFR chart pursuant to the publication AIP SUP VFR 07/16 of 14 April 2016, valid from 18 April to 24 April 2016, with the circular arc plotted at 18 NM around EDNY (red arrow) and the VFR arrival corridor to the compulsory reporting point OSCAR (red circle highlighted by the STSB)

According to the visual approach chart published on the occasion of the aviation exhibition, the flights on approach for the concrete runway 24 must proceed over the compulsory reporting point OSCAR, whereby the recommended approach corridor, crosshatched in red, must be followed (cf. figure 7). As a consequence, the VFR traffic is indeed channeled on an arrival route that must, however, cross the approach axis when approaching from the south. The approach altitude of not more than 4000 ft AMSL when flying to the compulsory reporting points constitutes a recommendation and corresponds to the MVA in this sector (cf. figure 1). In view of the lack of a flight altitude limit in the arrival corridor, as well as outside the CTR, an increased concentration of mixed traffic can be expected, especially in the right hand base leg for runway 24 when conducting IFR approaches, representing a systemic safety deficit.

According to the guidelines of the visual approach chart, published specifically for the trade fair, approaches for the paved runway 24 are carried out via the mandatory reporting waypoint OSCAR, north of the airport, with a recommendation to follow the approach corridor at an altitude no higher than 4000 ft AMSL. As a consequence, the VFR traffic approaching from the south-east must cross the runway axis.

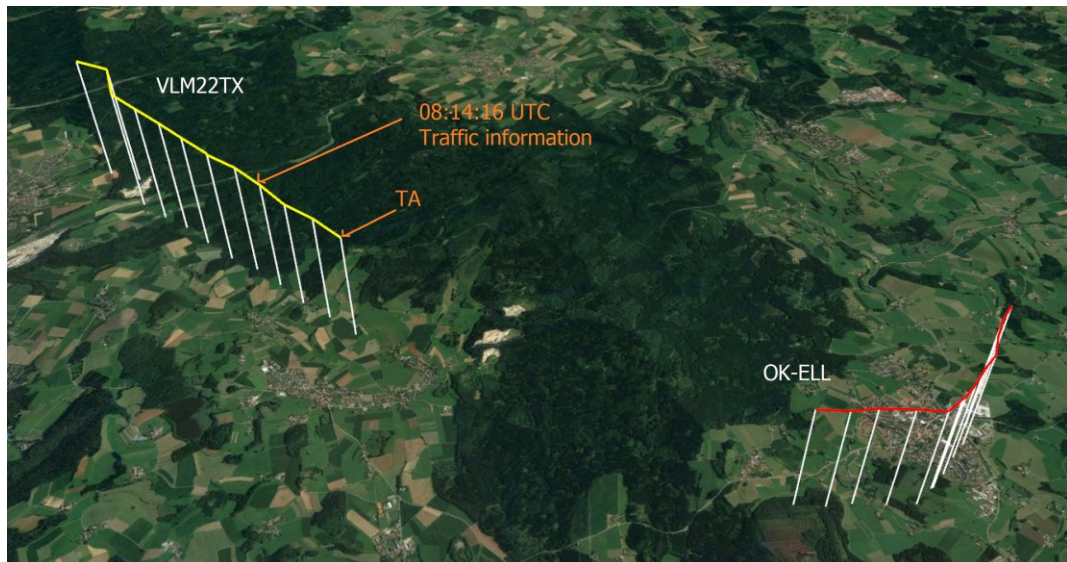
Figure 8: Convergence of the two aircraft based on the recordings of the MRT every 4 seconds and activation of a traffic advisory (TA) at approximately 08:14:27 UTC (orange), featured in Google-Earth

- Consequently, in terms of prediction time to CPA, the conditions on board VLM 22TX were satisfied for the activation of a TA between 08:14:27 UTC and 08:14:55 UTC, respectively for a RA between 08:14:41 UTC and 08:14:54 UTC.

The analysis of the MRT readings (cf. chapter 1.9.1) show that the conditions for the emission by the traffic alert and collision avoidance system (TCAS) on board VLM 22TX of a traffic advisory (TA) between 08:14:27 UTC and 08:14:55 UTC as well as of a resolution advisory (RA) between 08:14:41 UTC and 08:14:54 UTC were satisfied.

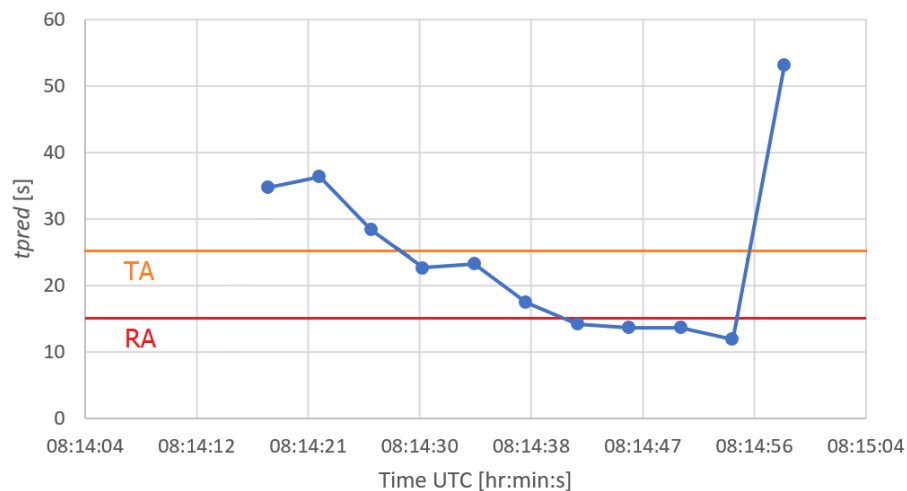
Figure 9: Prediction time (t_{pred}) to the CPA in the horizontal dimension during the convergence between the two aircraft with the two threshold values (TAU) for a traffic advisory (TA) (orange horizontal line), respectively for a resolution advisory (RA) (red horizontal line)

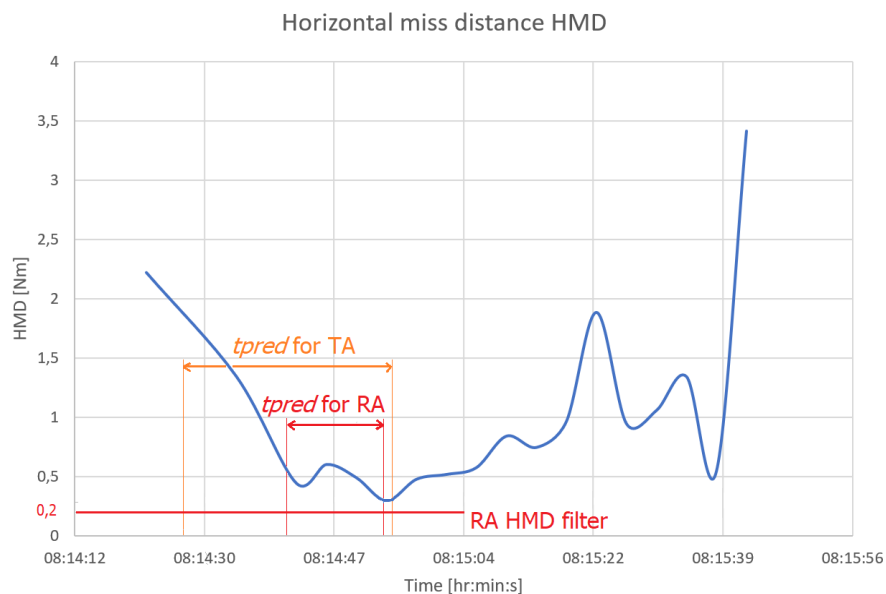
- The CPA occurred at 08:14:54 UTC, as both aircraft were already on divergent trajectories. The separation was 0.5 NM horizontally and 100 ft vertically.

Figure 10: Horizontal miss distance (HMD) during the convergence between the two aircraft with the threshold value for a resolution advisory (RA) (red horizontal line) of 0.2 NM as well as the period of time during which the conditions were satisfied for the activation of a TA (t_{pred} for TA), respectively for a RA (t_{pred} for RA).
