# **Final Report no. 2329**

concerning the serious incident  
involving the aircraft PA-28RT-201T,  
registration HB-PGF,

on 22 October 2016

over Lenzerheide/GR

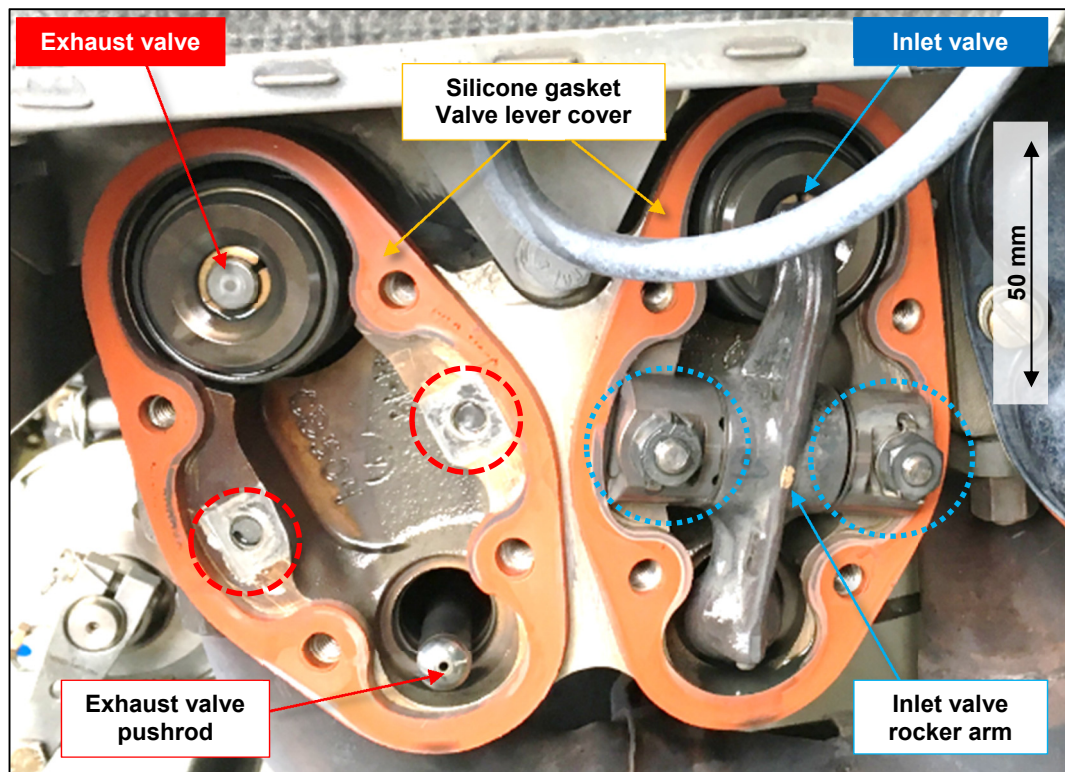
**Figure 2:** Cylinder no. 6 after dismantling the valve lever cover; inlet valve (right) with installed rocker arm, the axis of which is secured at both ends by a retainer, a tab washer and a hex nut on the stud bolts (dashed blue circles); exhaust valve (left) with sheared stud bolts (dashed red circles)

After the landing, the engine in HB-PGF, which had not seized, was examined. During disassembly of the cylinder no. 6 valve covers, it was found that both studs on the exhaust valve had fractured. The rocker arm is mounted on the cylinder head using these stud bolts. As a consequence of this failure, the exhaust valve could no longer be opened, so the engine disproportionately lost power, vibrated and stopped running smoothly.

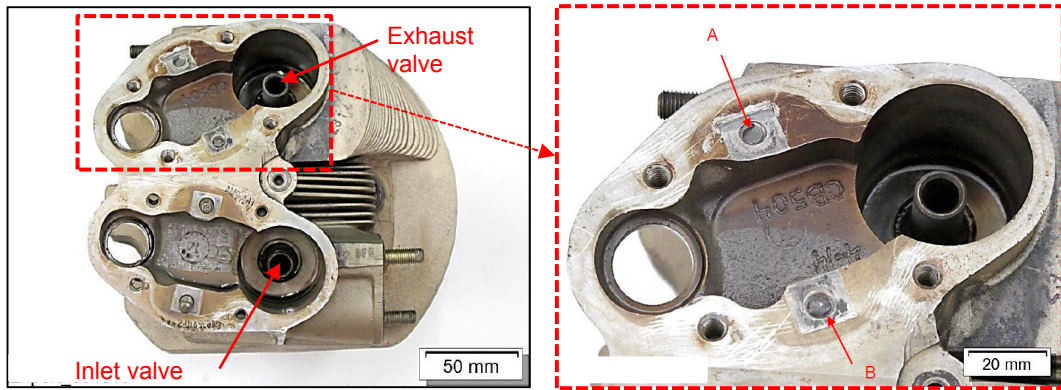
- The two studs for the assembly of the rocker shaft for the exhaust valve were broken (Figure 3).
- The fracture occurred at the end of the fully screwed-in threaded part, at a point where the studs exhibit the smallest cross-section and the greatest notch sensitivity.
- No loosening was detectable on the remaining sheared-off sections of these studs, which were still mounted in the threads in the aluminium cylinder head.
- On the inside of the valve cover (rocker arm cover) and on various parts of the mechanism of the exhaust valve, various types of contact damage were found (Figure 4).
- The inlet valve pushrod was bent.
- The exhaust valve pushrod was undamaged.

**Figure 3:** View of cylinder no. 6, from the valve side; the area bordered in red with the two sheared studs A (outside) and B (inside) of the exhaust valve is shown on the right, enlarged.

The fracture of the inside stud is clearly a fatigue failure. The retaining or contact areas of this bolted connection exhibited impact wear, cavitation wear, tribooxidation and some adhesive deposits, all of which suggest micro-movements in this area. Such micromovements occur in the event of insufficient clamping force of a bolted connection and dynamic load. The surface damage to the thread of the sheared inside stud was caused by the oscillating counterpart, i.e. one end of the rocker arm. This and the bent tab of the washer used in the assembly also indicates that the bolted connection was loose before the stud fractured.

The cause of the failure of the inside stud was insufficient tightening of the nut during assembly of the rocker. This assembly error resulted in insufficient gripping force of this bolted connection. It came loose in operation and the bolted connection then fractured.

The fracture of the outside stud was a forced rupture. There were no indications of any fatigue. After the failure of the inside stud, the rocker was bolted to the cylinder head only at the outside end. This resulted in extreme stress on this bolted connection, due to the lever effect which occurred. The outside stud then fractured. The outermost part of the bearing surface of the rocker arm was pressed plastically and obliquely into the cylinder head. The fracture of the outside stud is attributable to the failure of the inside stud.

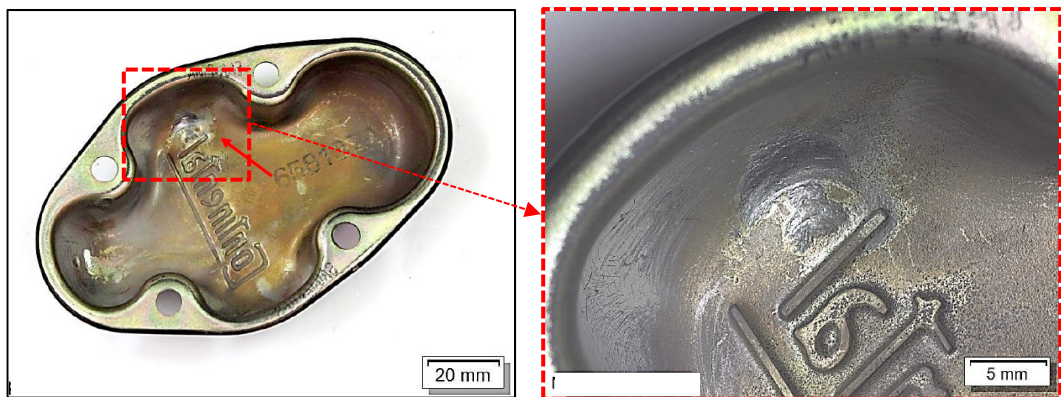
**Figure 4:** Inside of the exhaust valve cover with contact damage (red arrow); the area outlined in red is shown on the right, enlarged.

- The valve/rocker cover exhibited a plastic deformation indentation caused by the front surface of the inside stud (cf. Figure 4). The indentation was clearly visible and is congruent with this front surface.

After the fracture of the two studs, the rocker arm together with the rocker was moved back and forth over the pushrod by the cams on the camshaft. This caused the indentations found on the inside of the valve cover and on the rocker. This process was perceived by the pilot as a rattling engine noise.

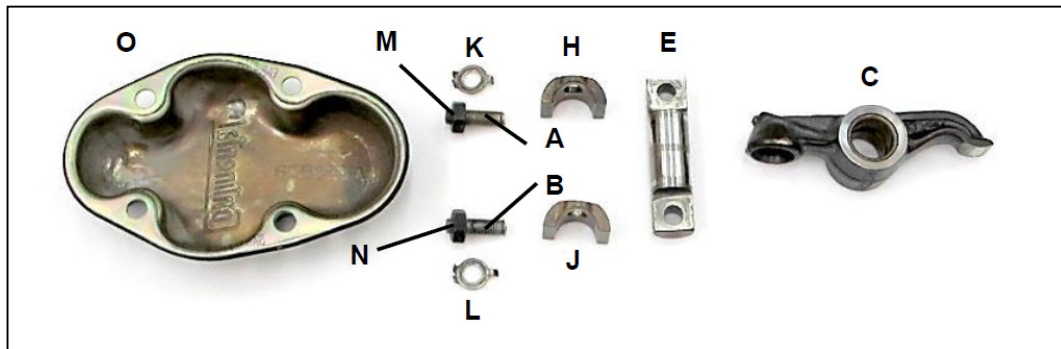
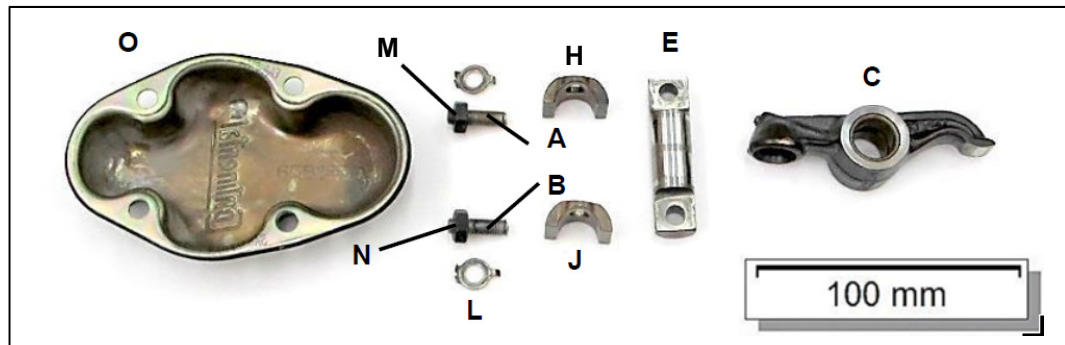
**Figure 5:** Exhaust valve cover with rocker and individual components of cylinder no. 6

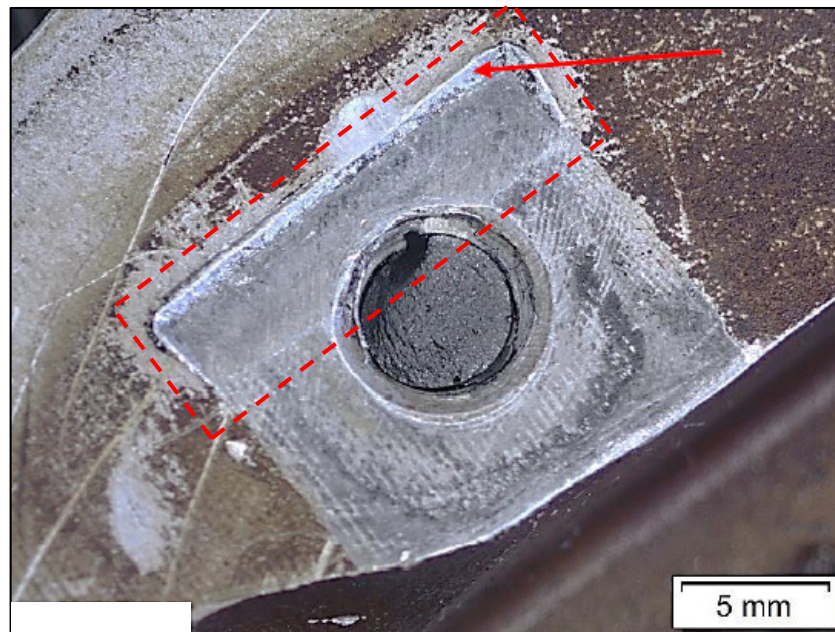
- The tab washer for the rocker shaft assembly with the inside stud was bent off. This tab prevents the washer from rotating during assembly.
- Marks on the inside of the valve/rocker cover are congruent with the marks on the end of the rocker.
- In the immediate vicinity of the clamping area of the outside stud, the contact area of the cylinder head had oblique indentations (cf. Figure 6). This oblique indentation came from a rocker shaft which was positioned accordingly.
- In the case of the fixing of the rocker shaft, the clamping and contact surfaces exhibited impact wear, cavitation wear, tribooxidation (reaction layer wear) and some adhesive deposits.
- The inside sheared-off part of the stud exhibited pronounced surface damage (cf. Figure 7). Such damage is caused by an oscillating counterpart.

**Figure 6:** Contact surface of the cylinder head in the retention area of the outside stud with the oblique indentation (red arrow and border)

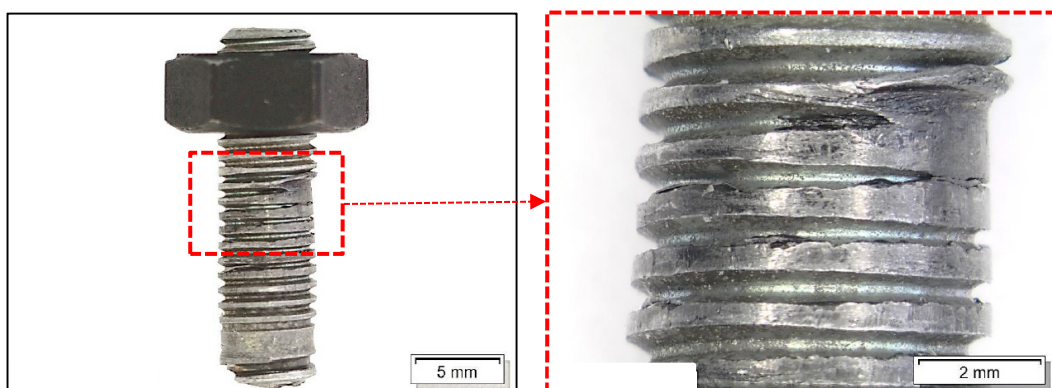
**Figure 7:** Inside sheared part of the stud bolt exhibiting pronounced surface damage
