Final Report No. 2332

concerning the accident involving the
Enstrom 280C helicopter, HB-XLS,

on 22nd January 2016

at Buttwil Airport (LSZU) / AG

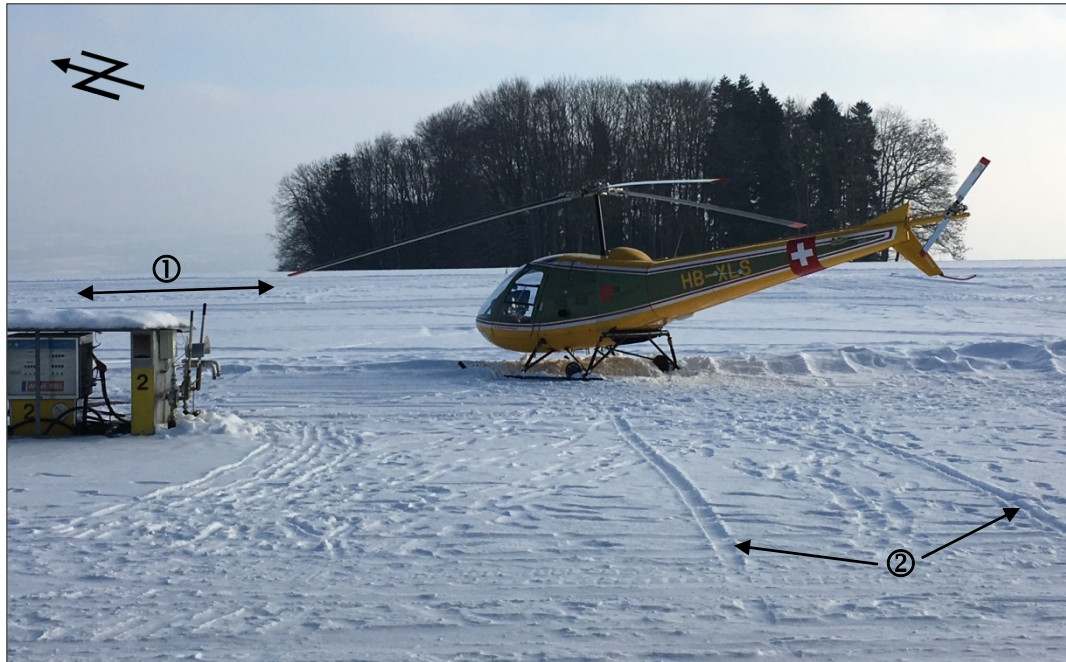
No snow had been cleared from the entire airport area. The tracks made by the rotating helicopter, i.e. by the skids, were clearly visible in the snow; as were the tracks which had been created when rolling the helicopter from the hangar to the take-off area (see illustration 1). The take-off area was approximately 17 m from the hangar and approximately 4 m from the fuel station.

Illustration 1: The final position of the helicopter HB-XLS, looking towards the runway ①. The fuel station can be seen on the left. The rolling tracks ② ran from the hangar to the take-off area.

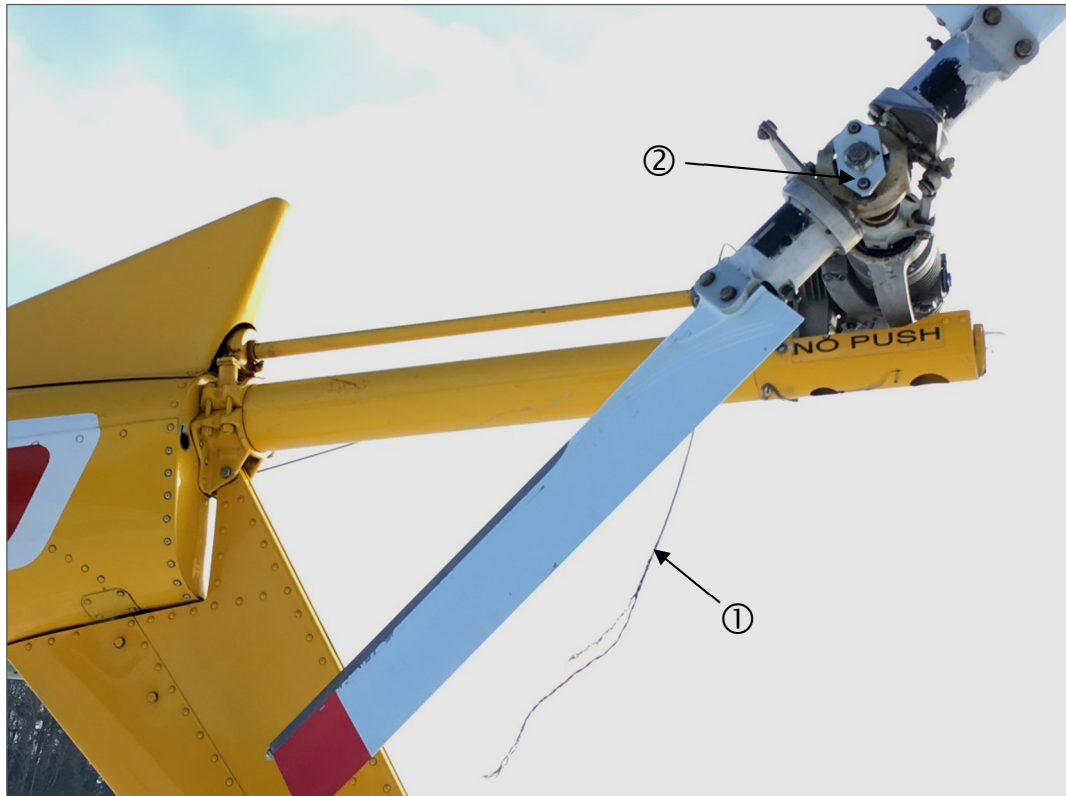
Immediately after the incident, it could be established that the left tail rotor control cable had snapped (see illustration 2). In addition, there were marks visible on both tail rotor blades indicating contact with the control cable.

Illustration 2: The condition of the tail rotor assembly of HB-XLS on the day of the accident: the snapped left control cable ① and the static stop ② that limits the tail rotor's wobbling motion (see section 1.4.) can be seen.

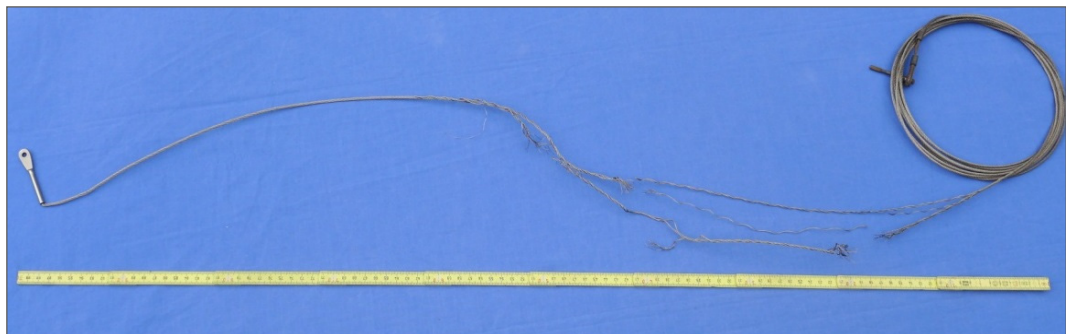
Initial investigations showed that the tail rotor's left control cable had snapped in two different places near the cable pulley that guides and deflects the cable and is mounted furthest back in the tail boom (see illustration 3).

Illustration 3: The snapped left tail rotor control cable after removal from the helicopter. The fitting to the tail rotor control can be seen on the left.

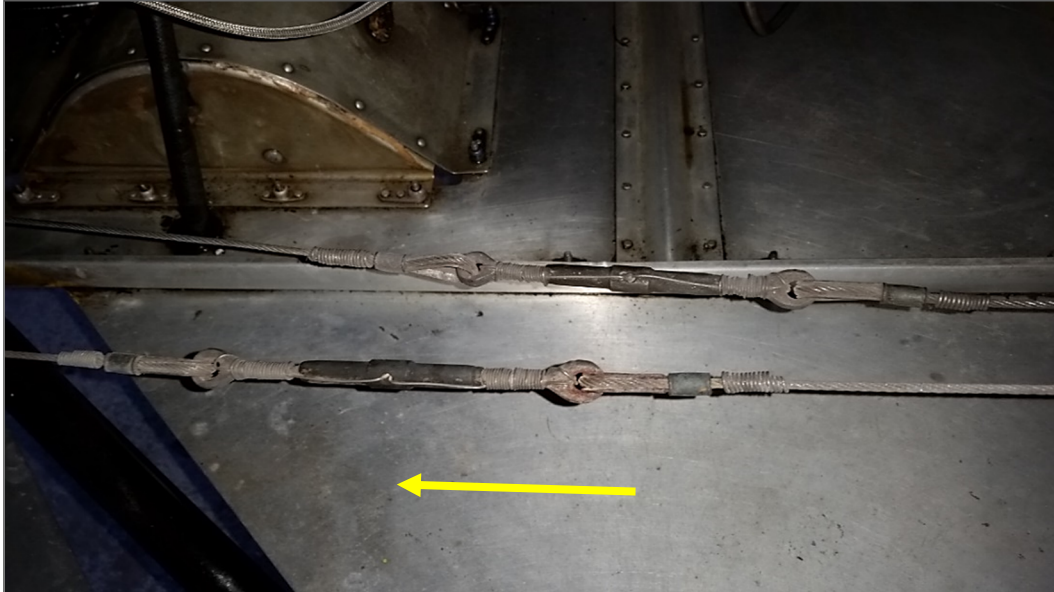
The turnbuckles were corroded and deposits were present on their safety wires. No signs of inspection or adjustments could be found (see illustration 4).

Illustration 4: The turnbuckles of the right and left tail rotor control cables with safety wire to prevent undesired loosening. In HB-XLS, they are located near the engine. The yellow arrow indicates the direction of flight.

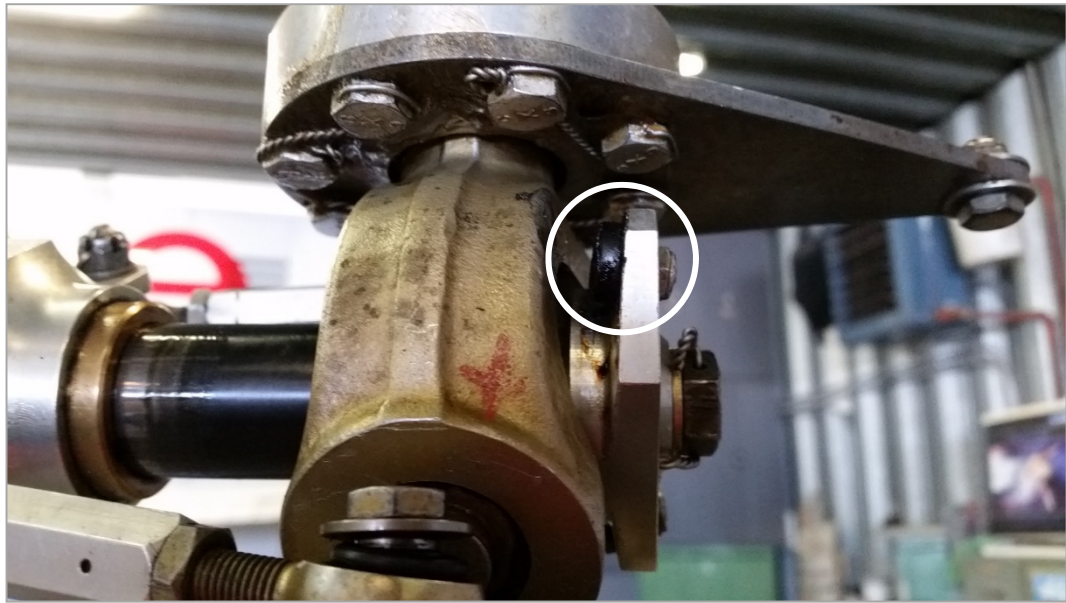
At the time of the accident, both rubber teeter stop bumpers were worn and soft. It was not evident from the technical files when the rubber teeter stop bumpers were last replaced.

Illustration 5: The tail rotor driveshaft of HB-XLS with hub and static stop showing a defective rubber teeter stop bumper (circled in white). This photograph was taken on the day of the accident.

The condition of the two rubber teeter stop bumpers on the static stop of the tail rotor was poor (see section 1.4.2.4). They should have been replaced during the last inspection at the latest.

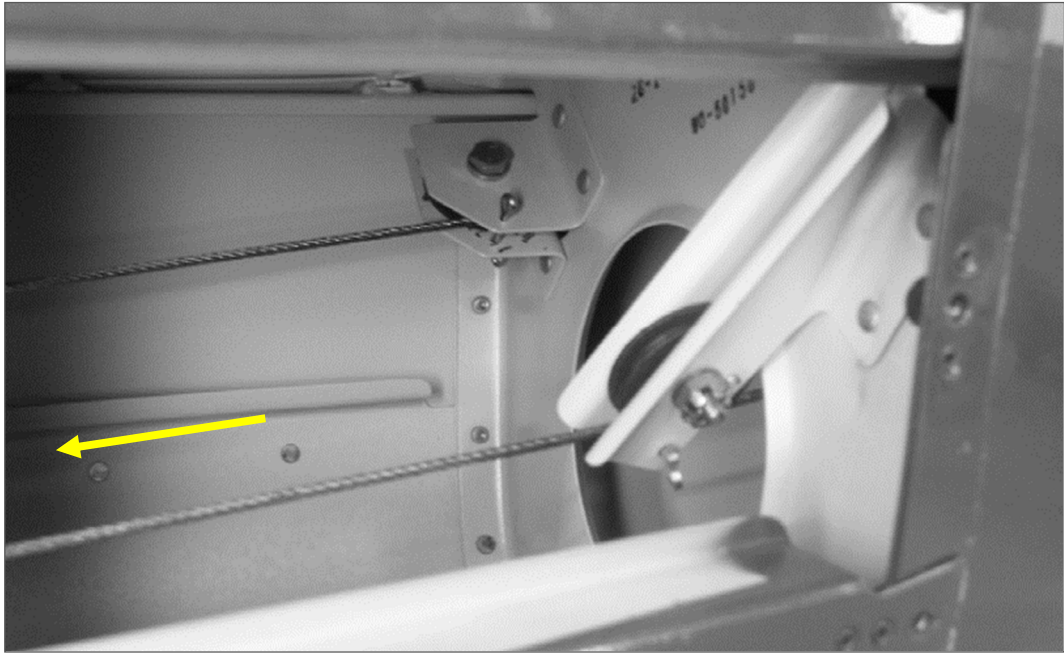
Illustration 6: The layout of the left cable pulley in the rear area of the tail boom, as displayed in the manufacturer's service directive bulletin. The yellow arrow indicates the direction of flight.

Illustration 6 was taken from the SDB and shows a modified version of the installed left cable pulley mount. The left fairlead is located approximately 20 mm towards the tail boom's centre and approximately 60 mm lower (see illustration 7). This increases the distance between the tail rotor blade tip and the control cable.

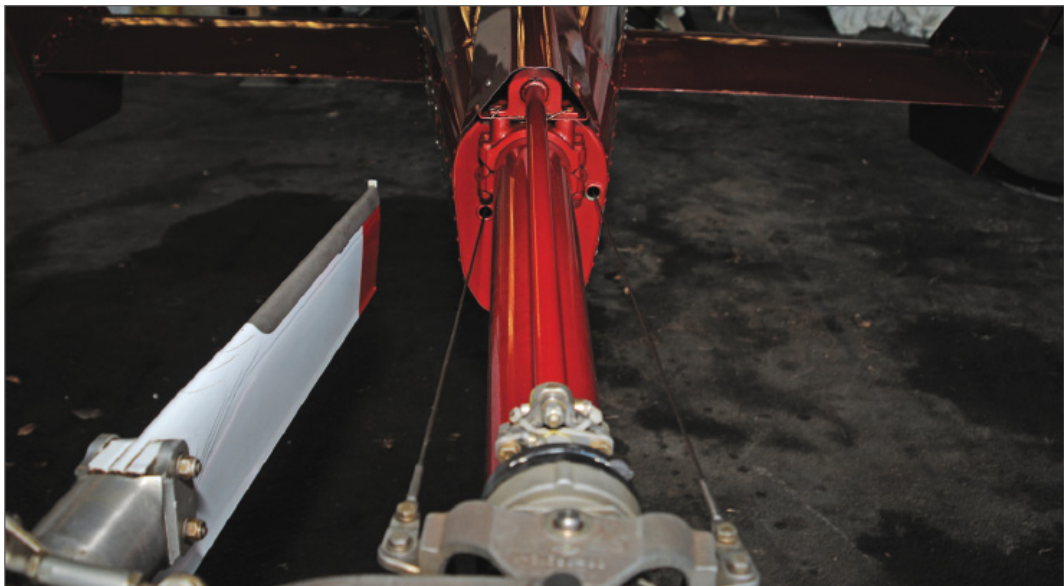
Illustration 7: A modified fairlead in a helicopter of the same type.

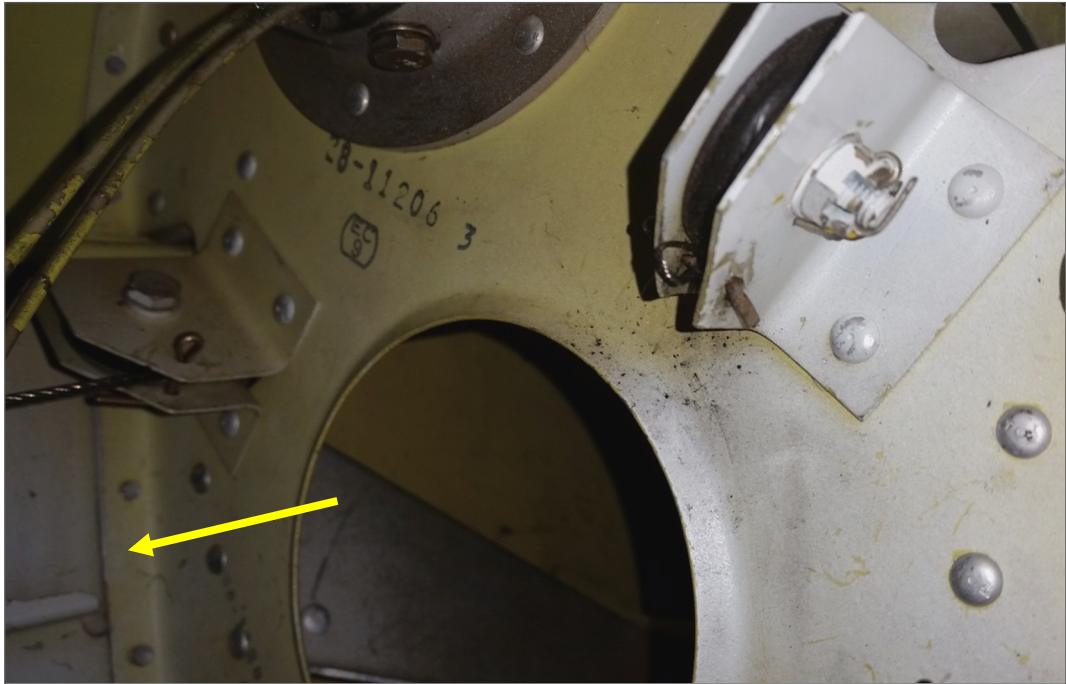
In HB-XLS, the left and right cable guide systems were mounted identically and symmetrically (see illustration 8).

Illustration 8: The symmetrical cable guide system in HB-XLS. The yellow arrow indicates the direction of flight.

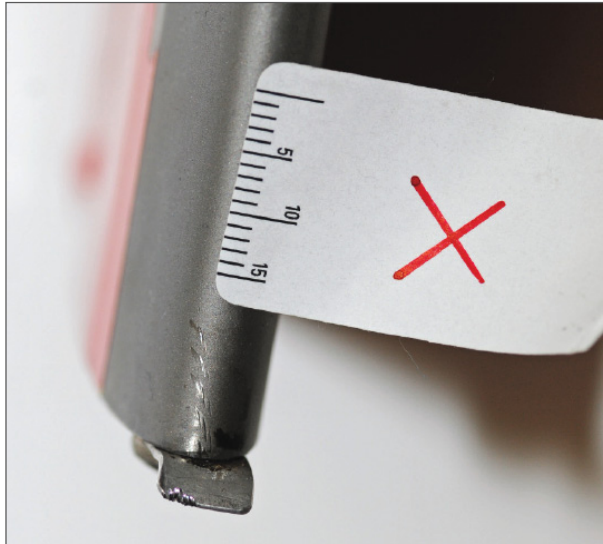
The metal plates mounted on the rotor blade tips as strike indicators showed substantial indentations indicating hard contact with the control cable (see illustration 9). In addition, one indicator was bent outwards and backwards in the tail rotor's direction of rotation. In the outer area of both rotor blades, contact marks from the control cable could be detected in the form of scratch marks. On one blade, the marks run 370 mm along the leading edge towards the blade hub. On the other blade, they run 160 mm in the same direction (see illustration 10). These marks were caused by the snapped control cable.

Illustration 9: The indentation on the strike indicator and contact mark on the tail rotor blade's leading edge (no. 1).

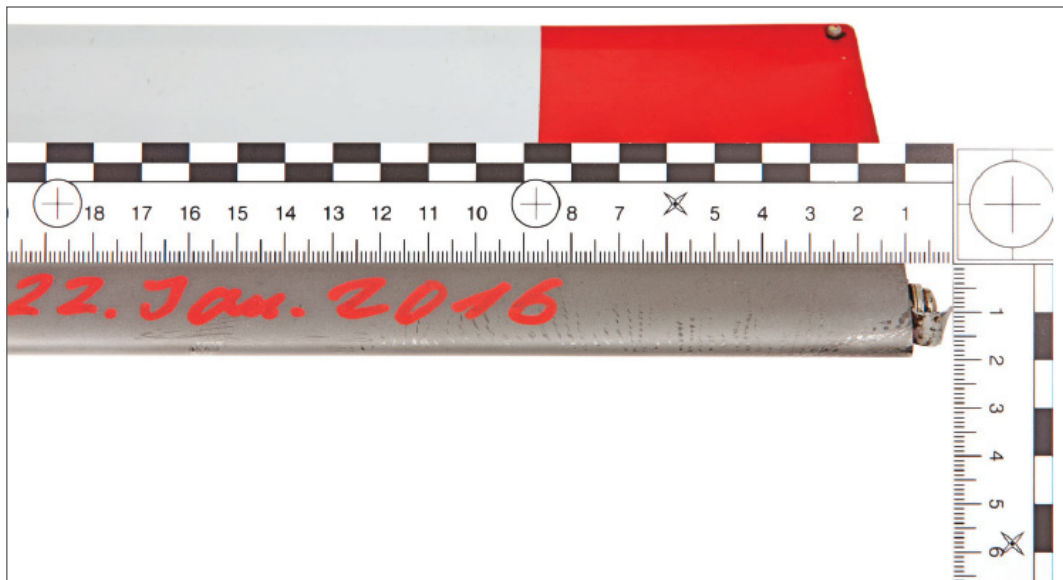
Illustration 10: Contact marks on the tail rotor blade's leading edge (no. 2) and bent strike indicator

With the left anti-torque pedal fully applied, the distance between the control cable and tail rotor blade tip was approximately 40 mm. When the tail rotor blade was pressed against the static stop's rubber teeter stop bumper with a small amount of force, the distance was reduced to 25 mm.

A slight increase in lateral force, caused by dynamic effects, resulted in the tail rotor blade tip to come into contact with the left control cable.

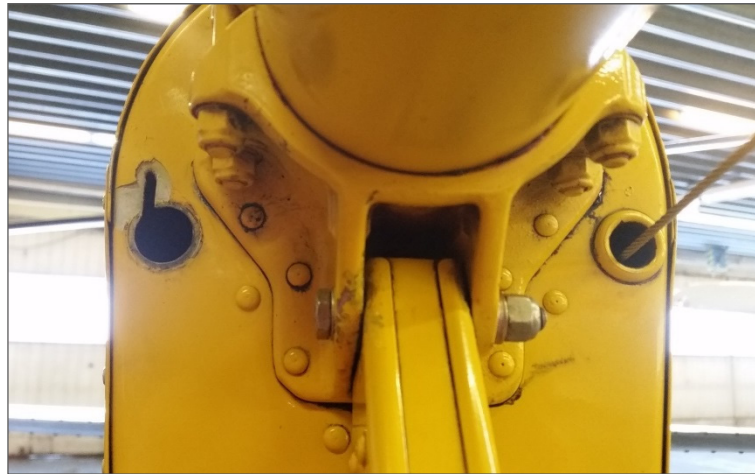
The incision running upwards from the left fairlead showed signs that it had been caused by the control cable. The left fairlead's edge protection was no longer present. A part of the protection was found near the take-off area.

Illustration 11: The tail boom's rearmost bulkhead with the incision in the left fairlead.

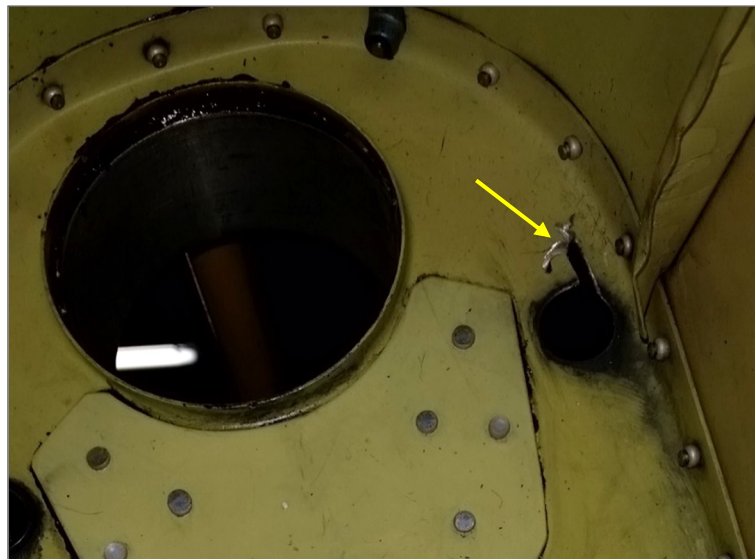
A splinter was found on the inside of the bulkhead. This pointed towards the inside of the tail boom (see illustration 12).

Illustration 12: The inside of the bulkhead. The splinter can be seen at the edge of the incision (yellow arrow).

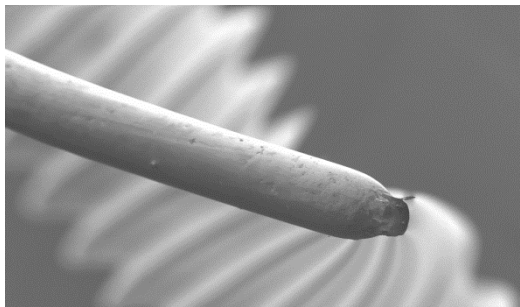
The fractures showed significant necking, some were funnel-shaped, some had a shear lip on one side (see illustration 13). Fracture combs could be seen across the entire fracture cross-section. The pattern matched that of a ductile shearing stress fracture. Fatigue could not be proven.

Illustration 13: Significant necking

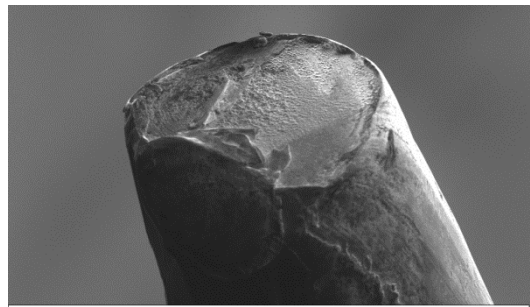
Another fracture was consistent with fatigue damage. However, vibration marks could not be proven, although this is not unusual in wire fractures with small wire diameters and high strain hardening (see illustration 14).

Individual wires of the left control cable's strands fractured over a long period of time as a result of fatigue. This led to mechanical weakening of the cable.

Illustration 14: Fatigue damage

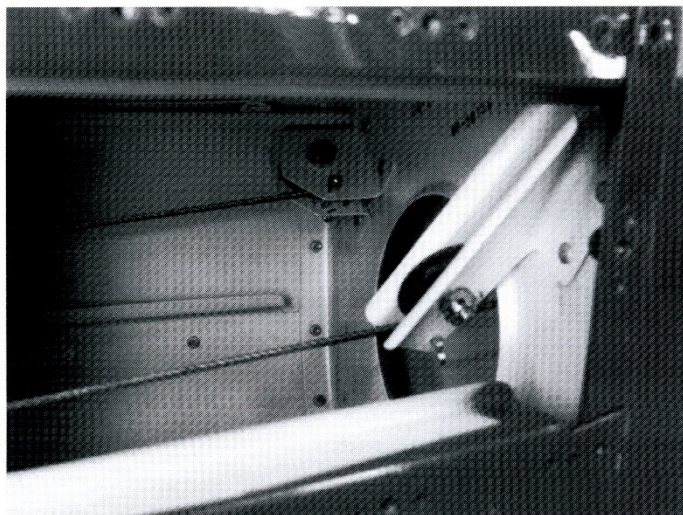
Figure 1. Tail Rotor Control Cable Pulley Installation

Enstrom has received reports from inspection personnel in the field of frayed and worn tail rotor control cables. The reports indicate that the wear is occurring at the pulleys (See Figure 1) in the tailcone located aft of the horizontal stabilizers. These pulleys are installed in tailcone assemblies installed on all 280FX model aircraft and F-28F model aircraft, S/N 744 and subsequent.

Maintenance personnel should pay particular attention to this area during subsequent 100 hour/annual inspections. Enstrom recommends using the procedure outlined in paragraph 5.1 for cable inspections in this area. This is especially important on aircraft which have a history of cable wear.
